MARINE ACCIDENT
INVESTIGATION BRANCH

SAFETY DIGEST

Lessons from Marine
Accident Reports
1/2014

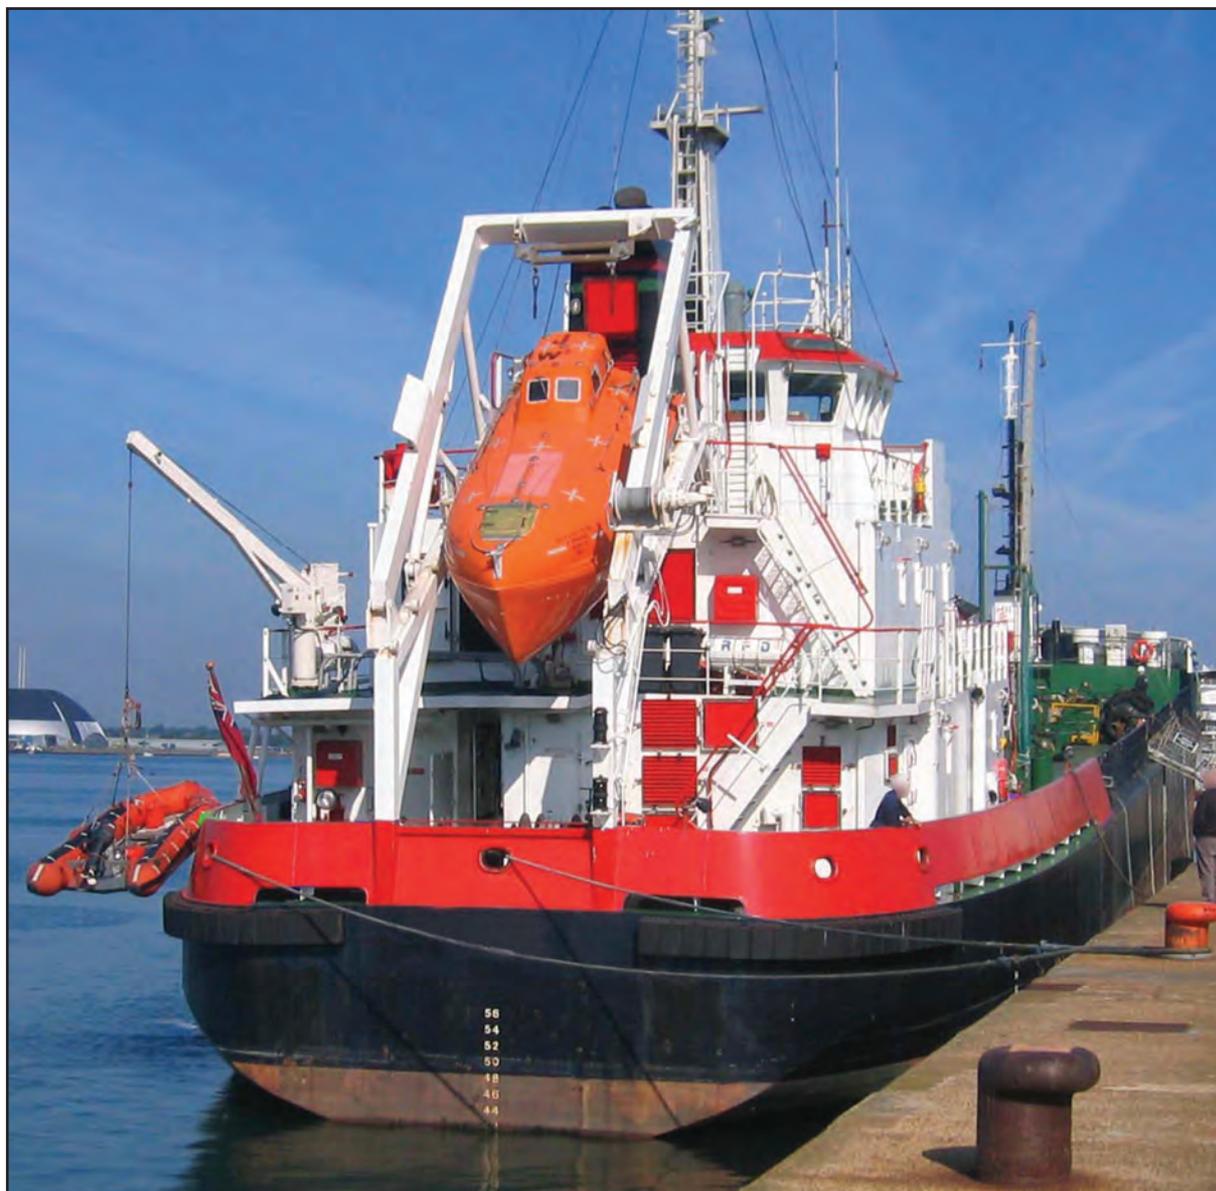
Figure 1: View of lifeboat in housed position

The lifeboat was thoroughly ventilated and, once clear of gas, a permit to enter was issued to allow the crew to investigate the source of the gas. It was subsequently discovered that a faulty battery charger had overcharged the boat's batteries (Figure 3), which produced the hydrogen sulphide gas.

1. The interior of an enclosed lifeboat is not one that mariners would intuitively class as an enclosed space. However, this incident demonstrates that the potential risks of entering an enclosed lifeboat, without first checking that the atmosphere is safe to breathe, are severe. Exposure to hydrogen sulphide gas at the concentration found in this incident has the potential to cause permanent eye damage.

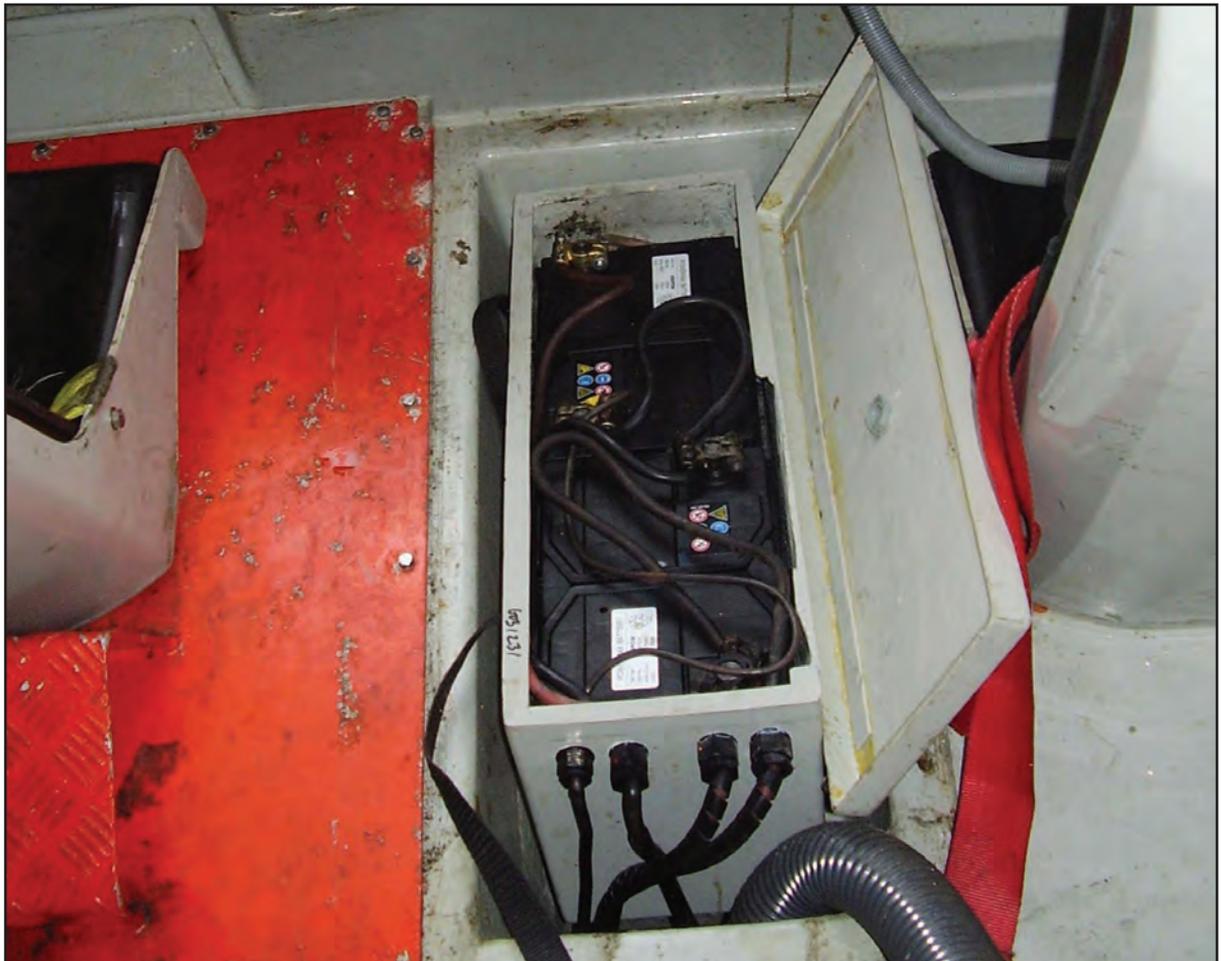
Figure 3: Battery locker

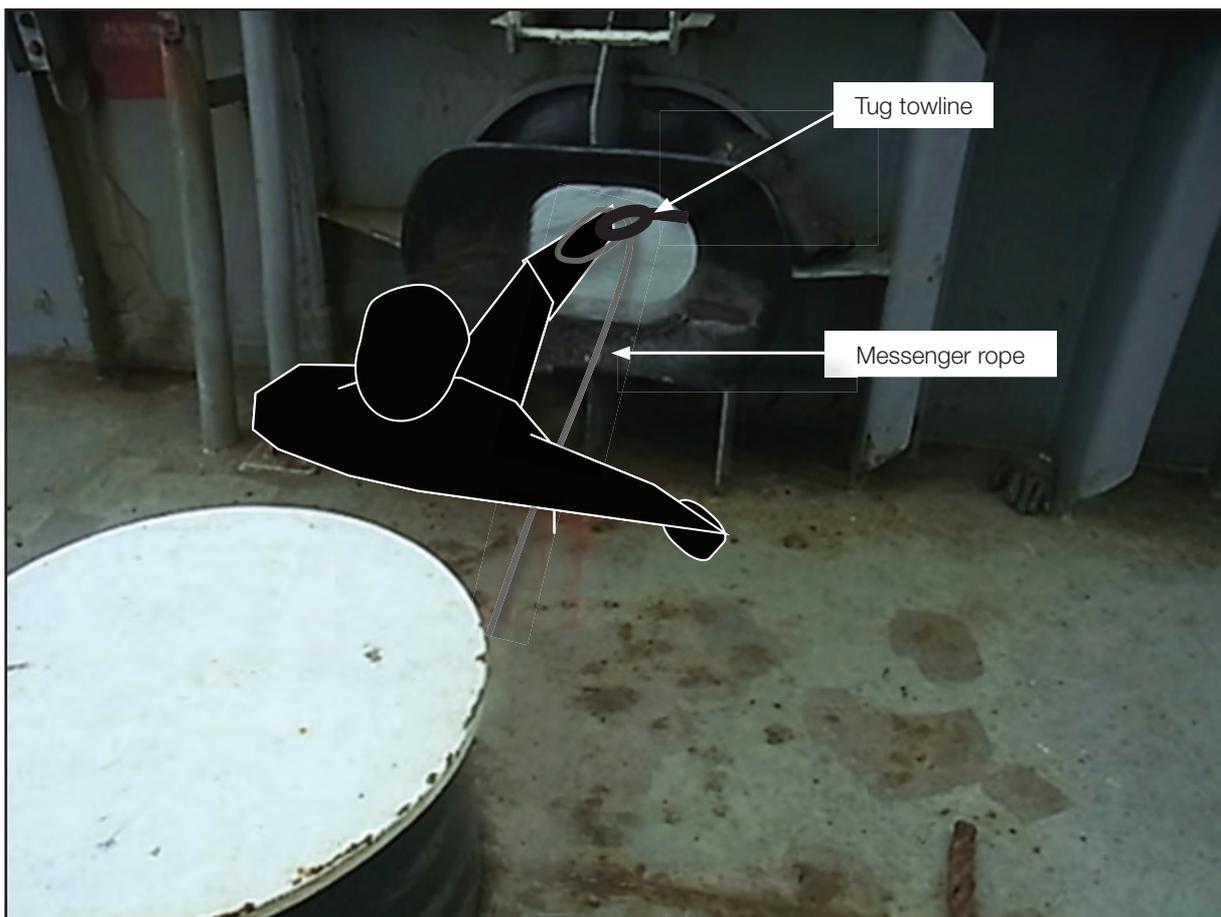
The engineer then noticed the messenger rope tighten, and at the same time the 2nd mate heard a frantic shout from the AB controlling it. He saw the AB's left leg become entangled with the messenger rope, him being dragged along the deck, and his left leg being pulled through the Panama fairlead as the tug winch tension continued to be applied (Figure 2). The mooring party shouted to the tug's crew to stop hauling, but the tug's skipper and engineer had already noticed the problem. The engineer had veered the winch, which caused the messenger rope to slacken and fall onto the tug's deck.

The mooring party saw that the AB's leg was very badly damaged and applied a tourniquet as both the pilot and tug's skipper alerted the VTS control room to request an ambulance. The AB, who was by now unconscious, was quickly transferred to hospital, but his left leg was severely damaged, requiring it to be amputated below the knee.

Figure 2: AB's leg pulled through Panama fairlead

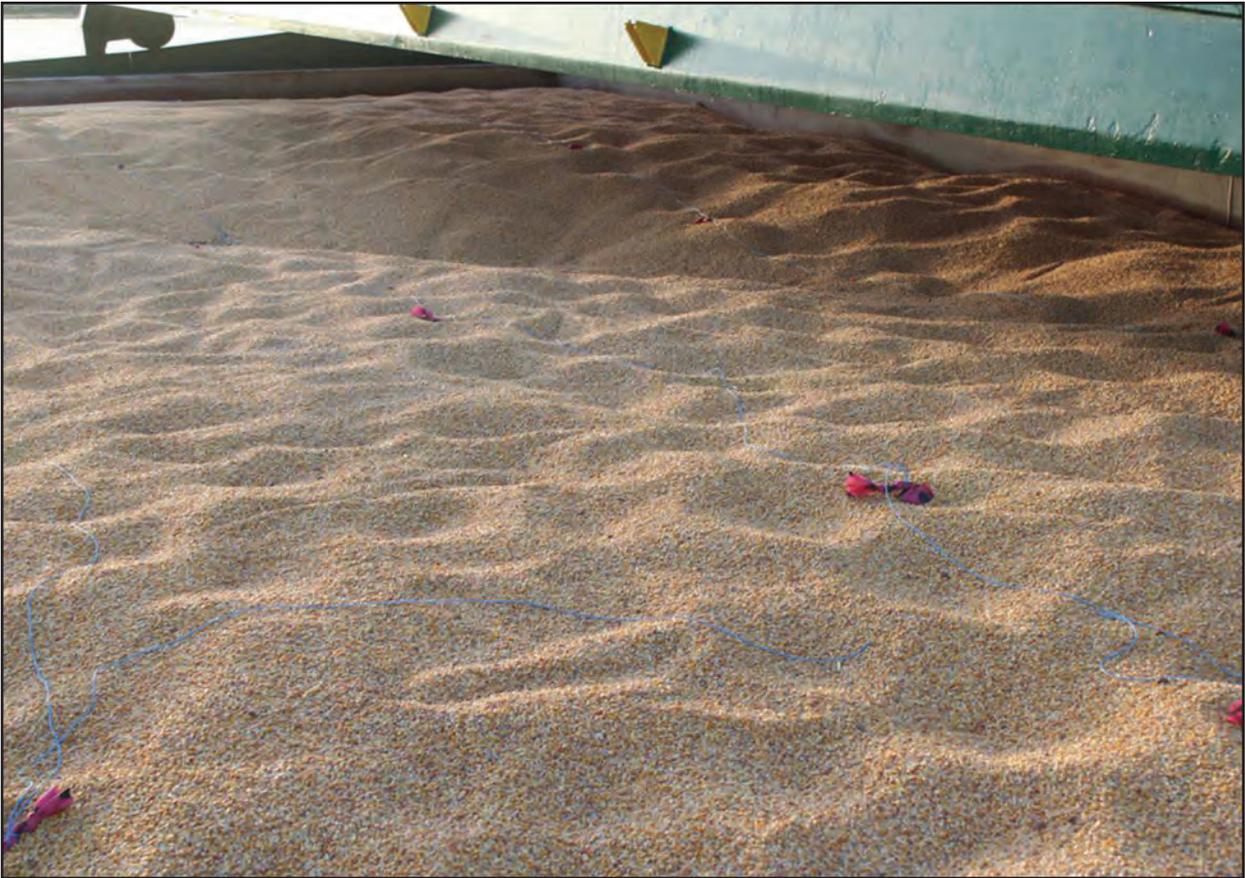
Figure 1: Bags of fumigant on top of the maize cargo

1. Fumigants are dangerous if not handled correctly and appropriate precautions are not taken. A number of factors may cause a fumigant to remain active, regardless of the length of voyage. Therefore, where possible, all fumigant residues should be removed from the cargo holds by a qualified fumigator before cargo discharge commences.

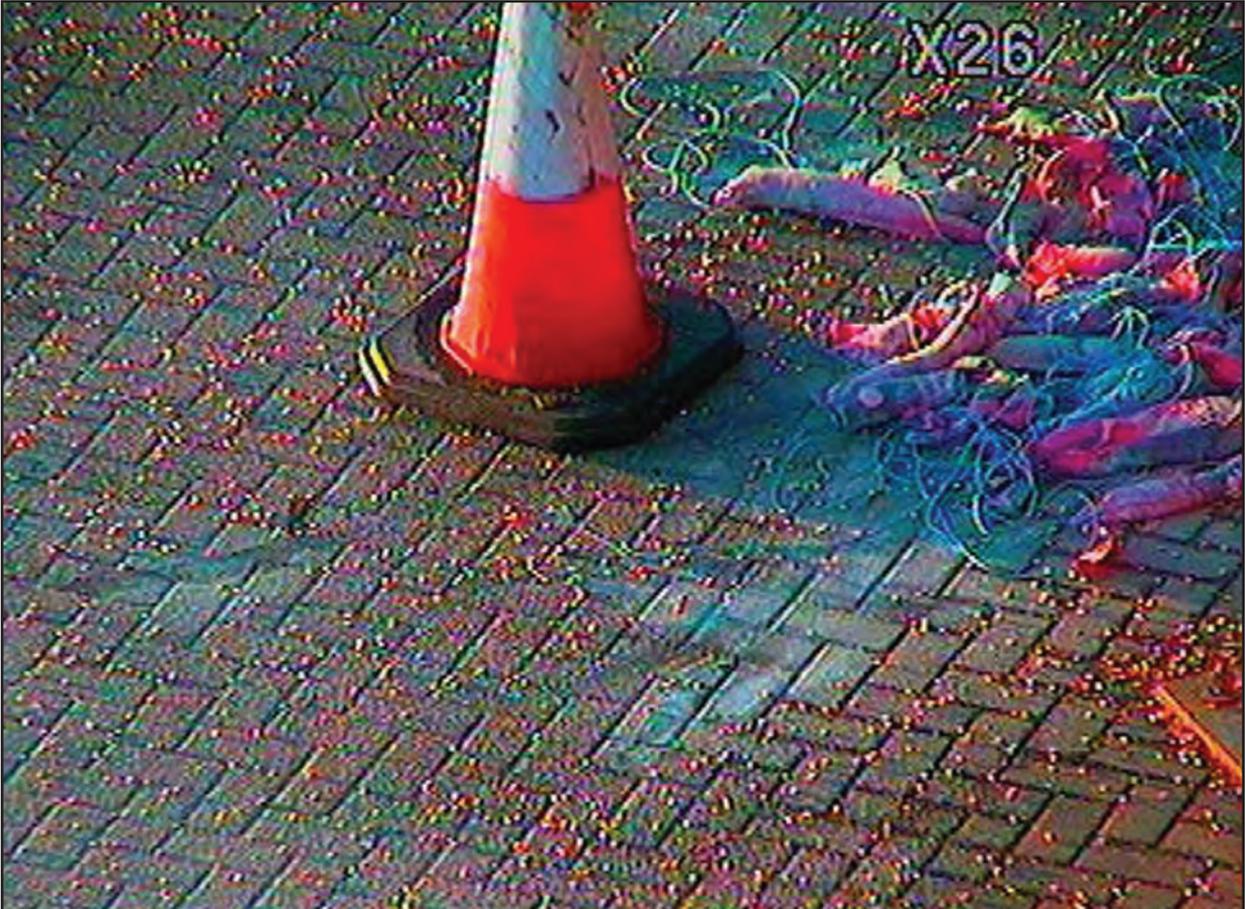
Figure 2: Spilled fumigant

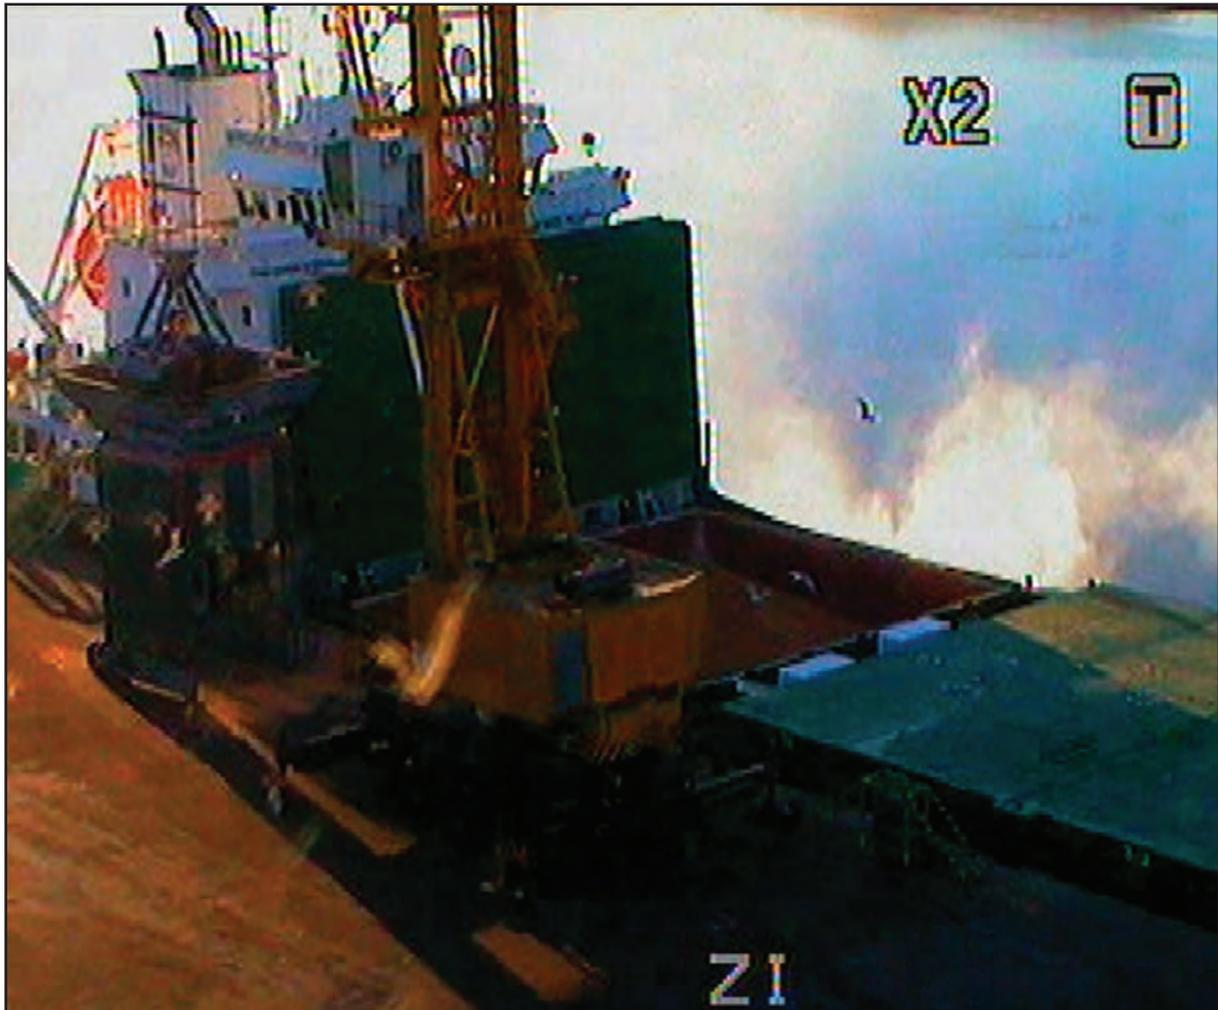
Figure 3: Smoke from fumigant

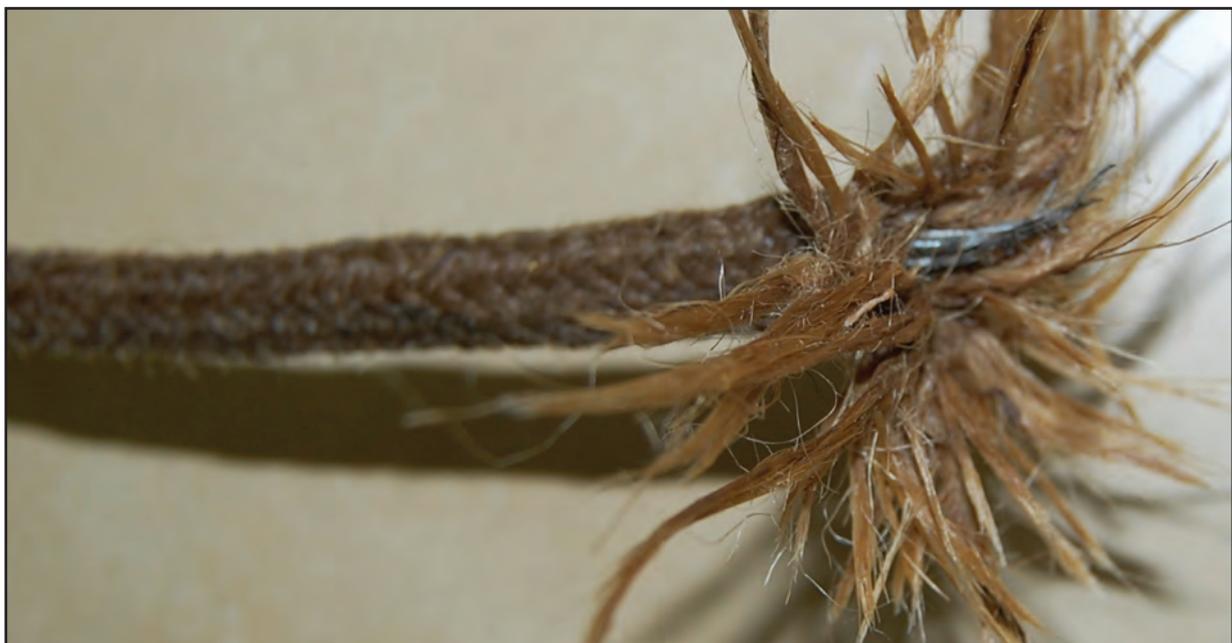
Parted end of firefighter's lifeline

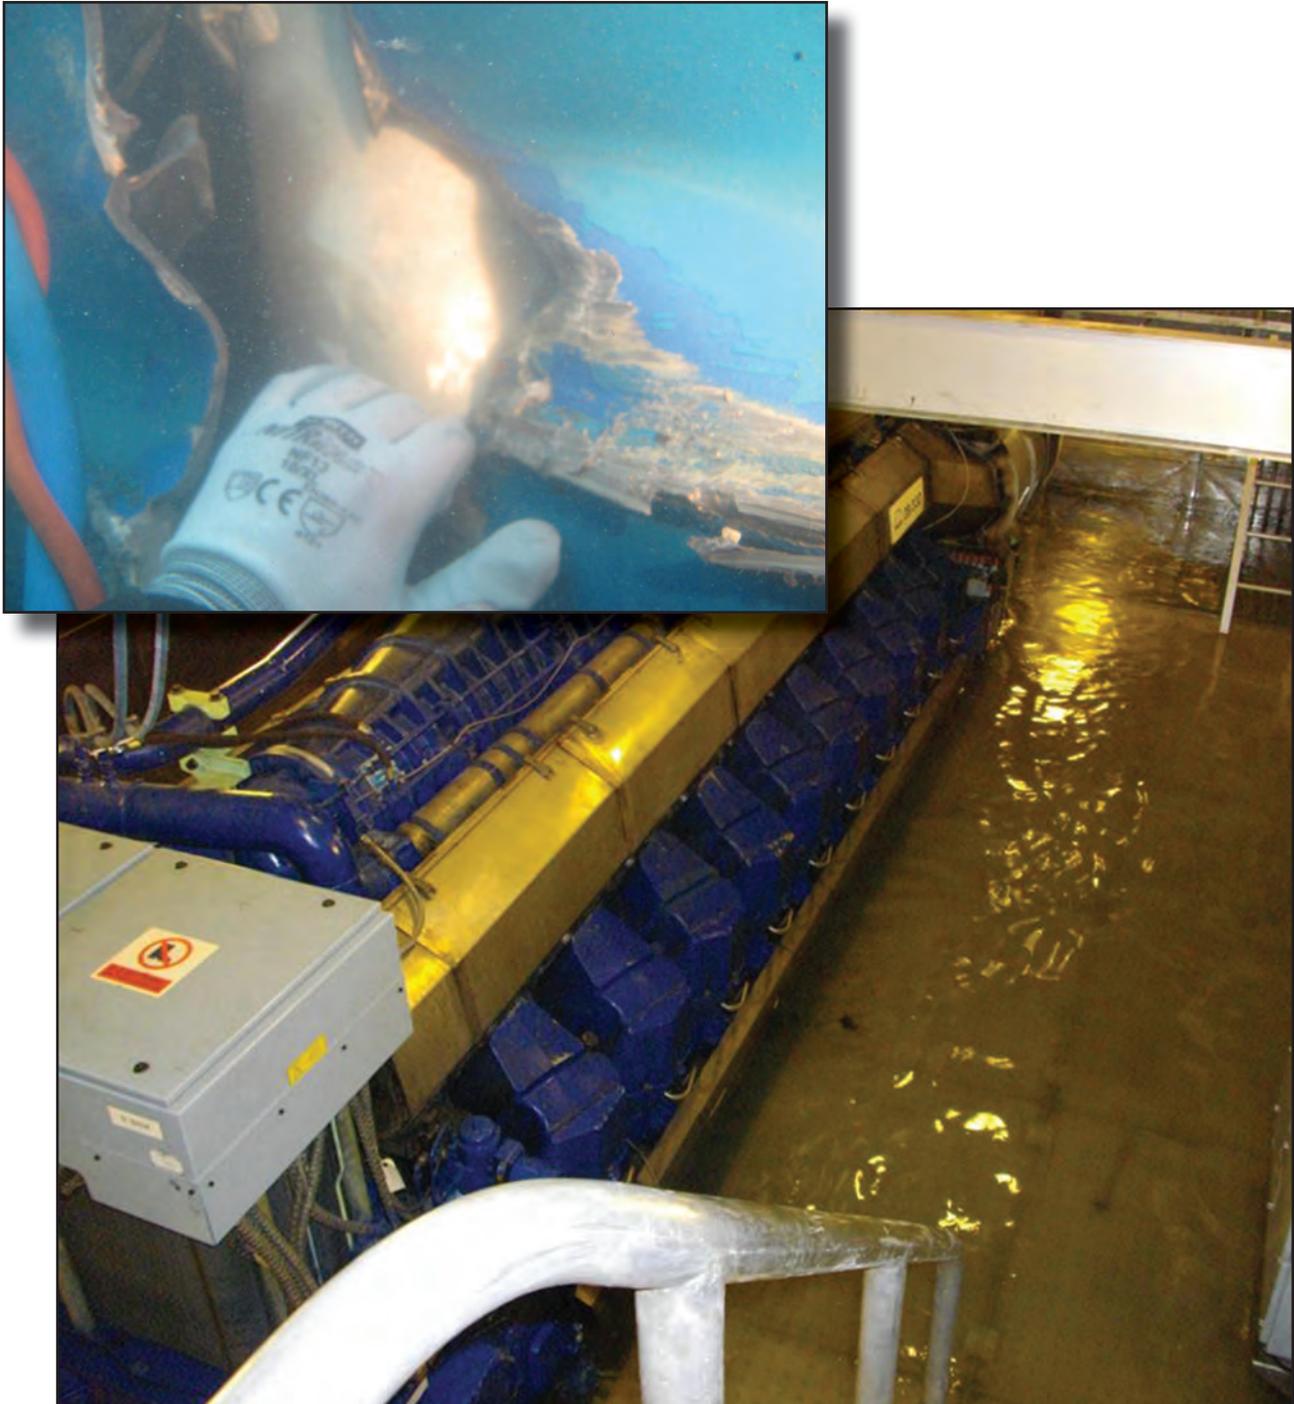
Figure 2: Diver's view of the hole in the aluminium hull, which resulted in a flooded engine room

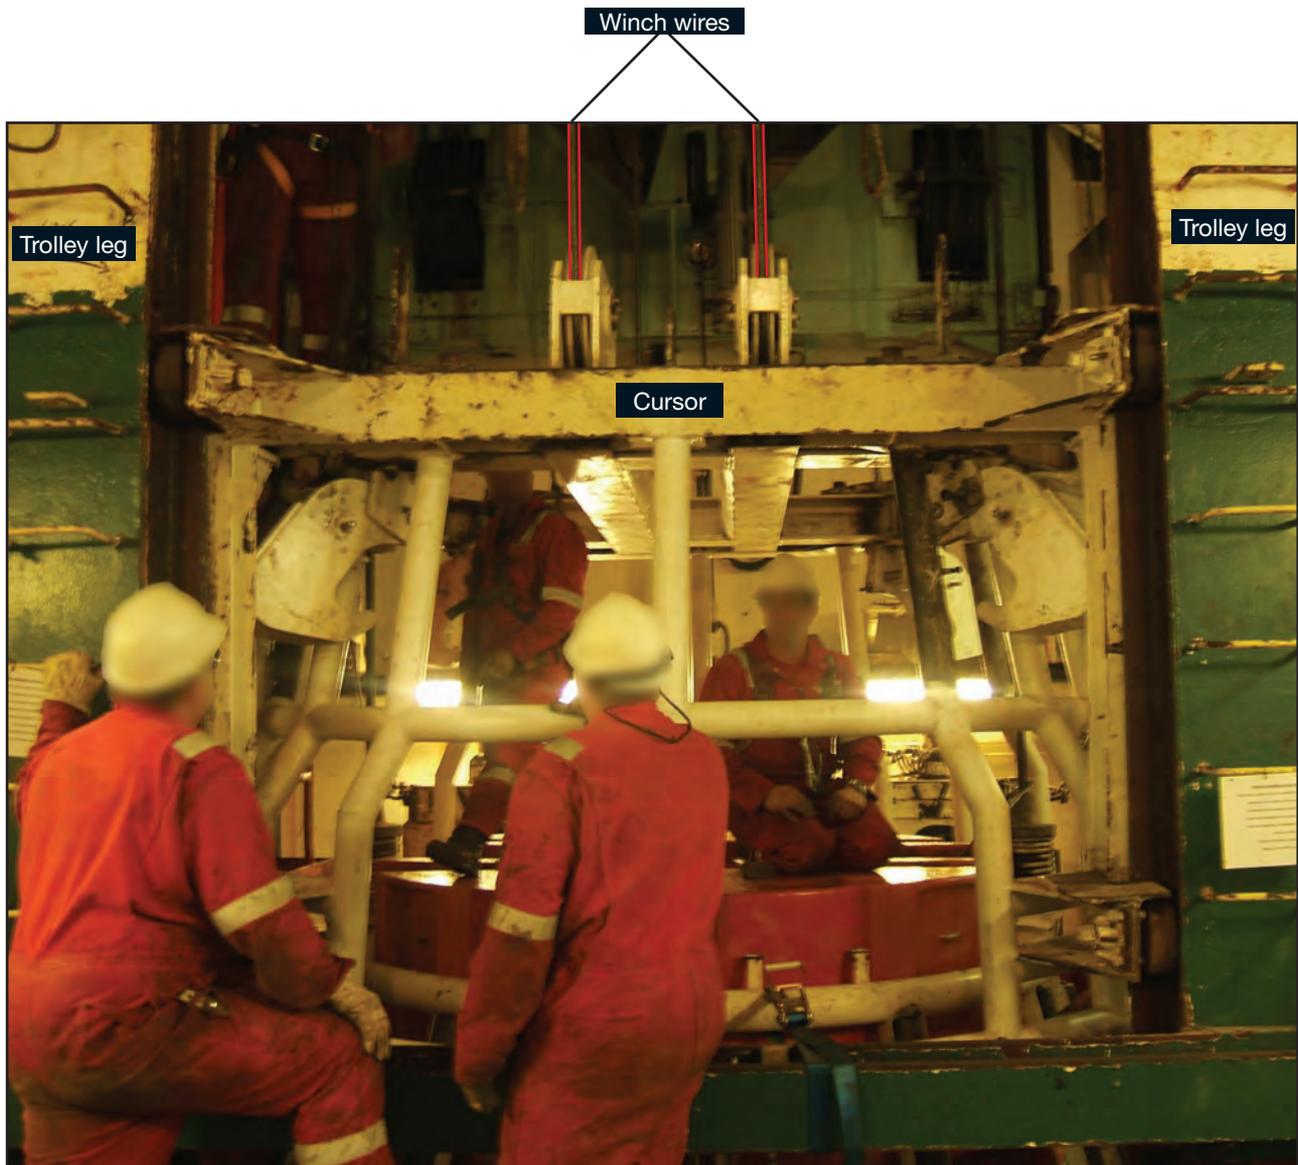
Figure 4: Technicians working below the suspended 4 tonne cursor, supported only by its winch wires

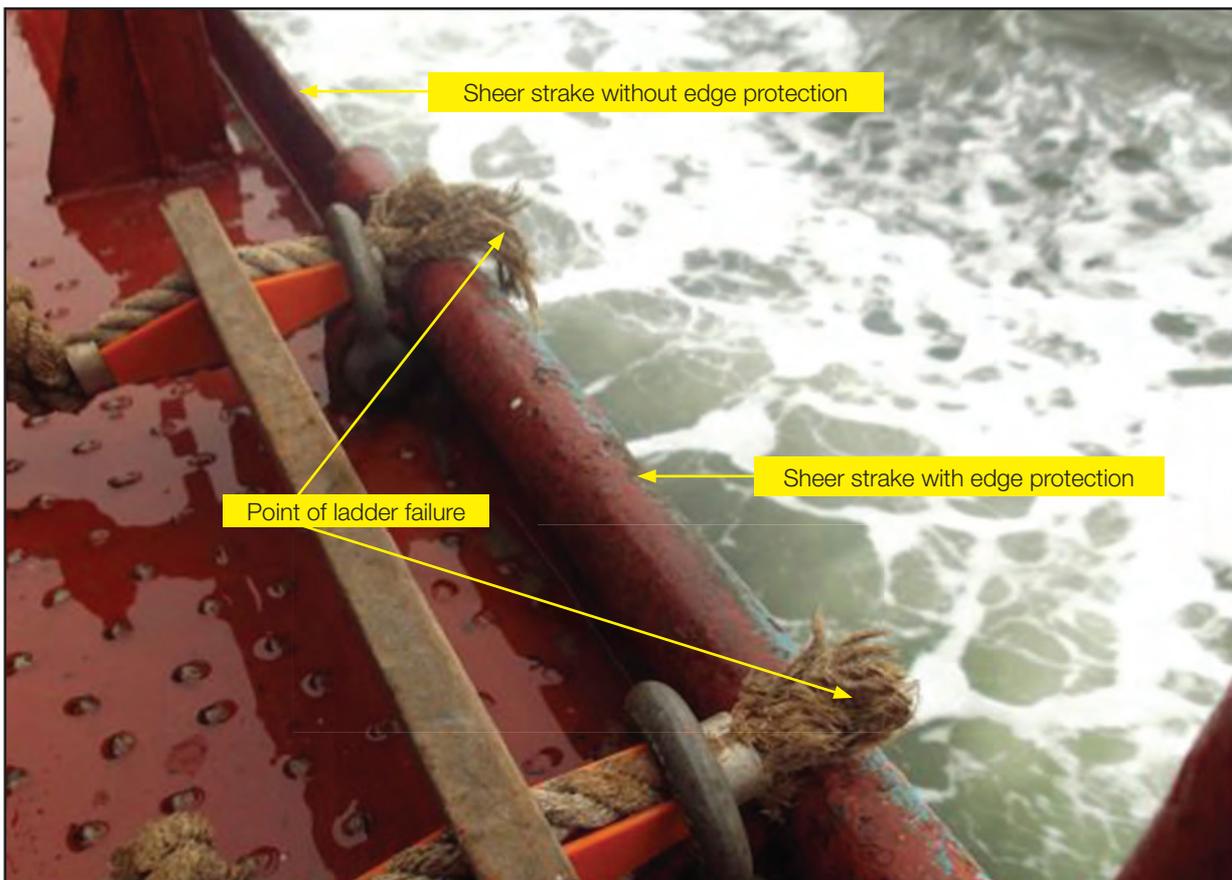
Figure 1: Vessel 1 - Pilot ladder failed at sheer strake

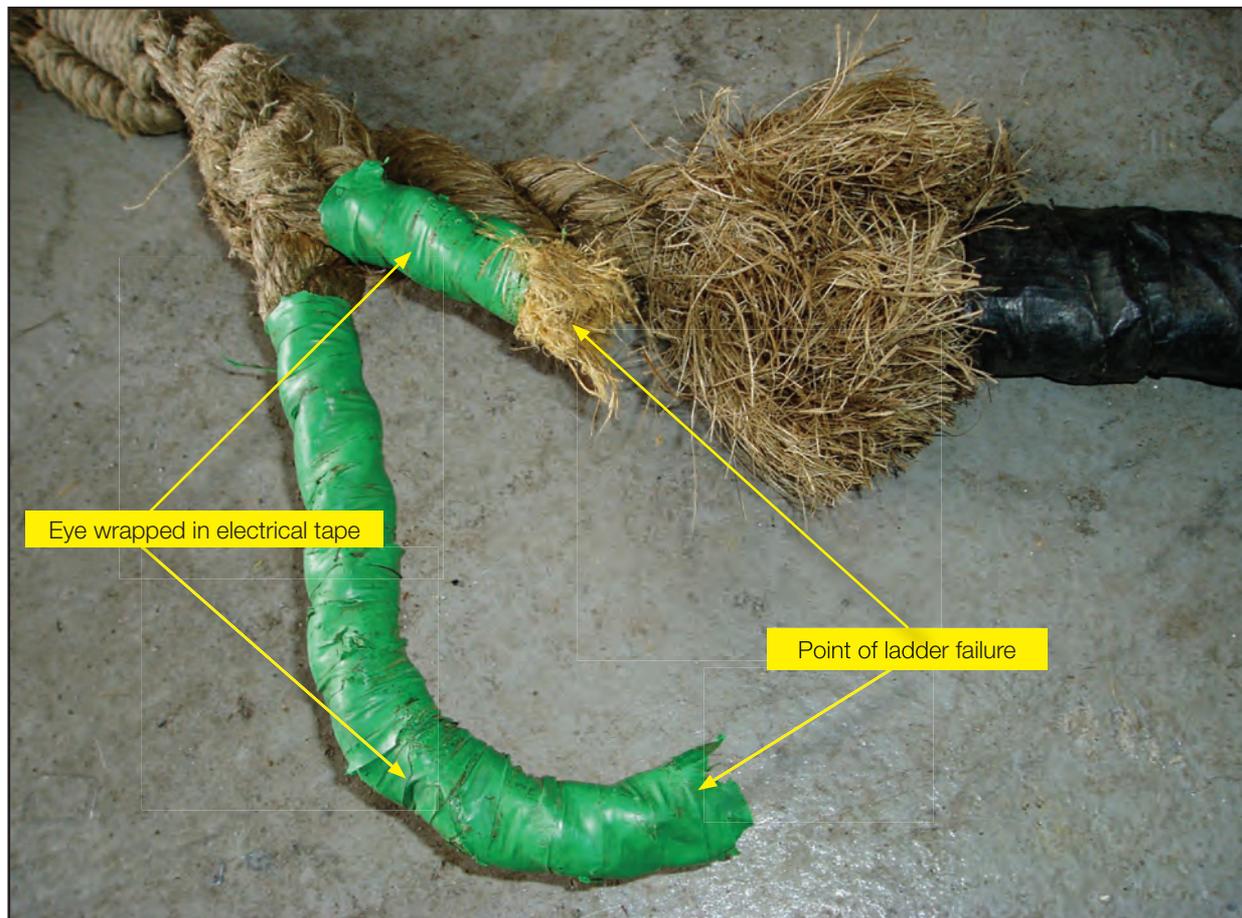
Figure 2: Vessel 2 - Pilot ladder failed at soft eye used to secure ladder

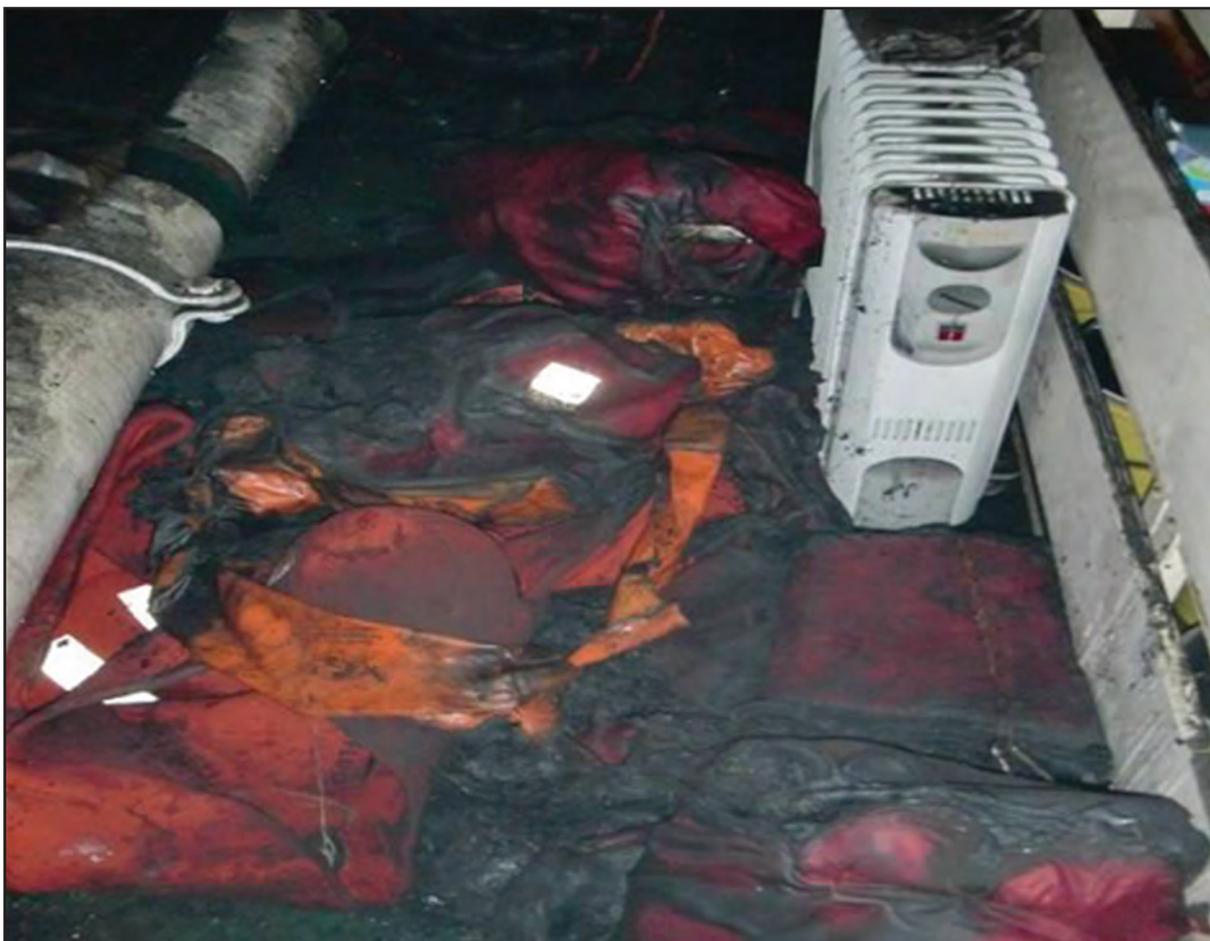
A short time later, the BA team entered the dry store and found that a number of old immersion suits stowed there had partially melted, causing the heavy smoke (Figures 2 and 3). The boundary cooling water, pouring in from above, had cooled the suits and there was no evidence of other fires in the compartment. The local fire and rescue service also attended the vessel and deployed BA teams, who confirmed that there were no fires or areas of excessive heat.

Figure 2: Partially melted immersion suits

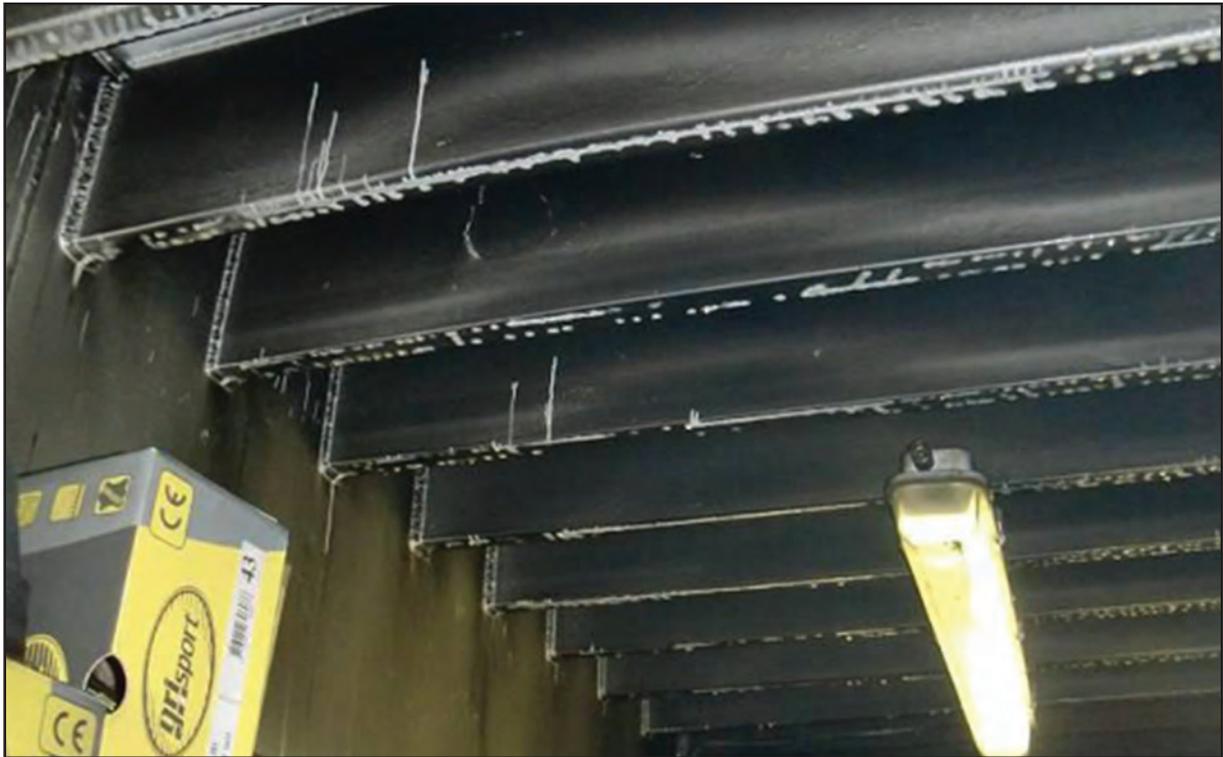
Figure 3: Compartment smoke damage

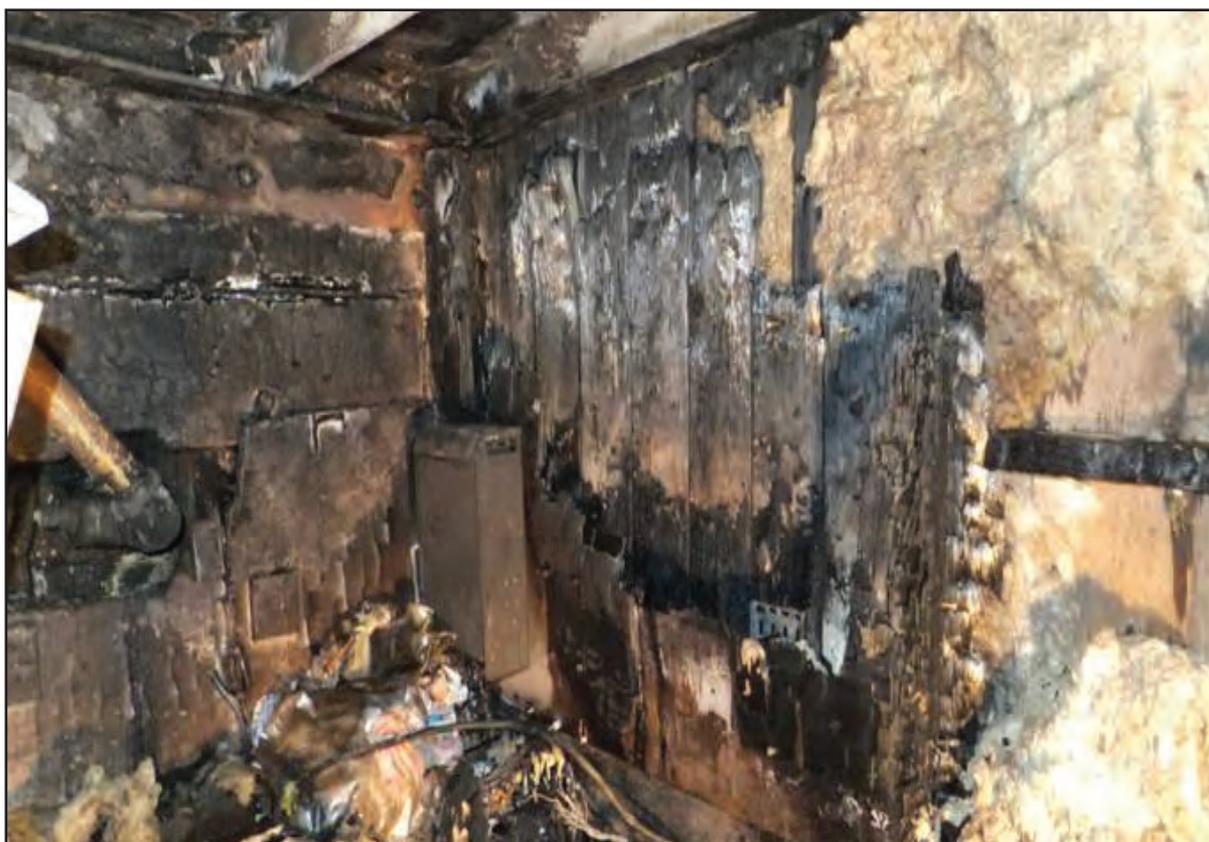
The engine room suffered widespread fire damage, particularly at the forward end (Figure 3).

From the description, the fire was liquid fuel-based and was located under the auxiliary engine. It was found that the engine fuel supply pipe was totally unsupported throughout its length and that the braided flexible pipe connected to the engine fuel lift pump had suffered severe chafing and electrical arc damage. The internal polymer pipe was also melted and so the true, pre-fire condition could not be determined. However, all the indications pointed to a failure of the pipe, which allowed fuel to build up in the bilge. From the survey, it was found that a large overhead 110 volt electrical cable had been arcing against the sharp edges of the steel cable carrier, and this was the most likely ignition source.

Figure 3: Engine room - forward bulkhead damage

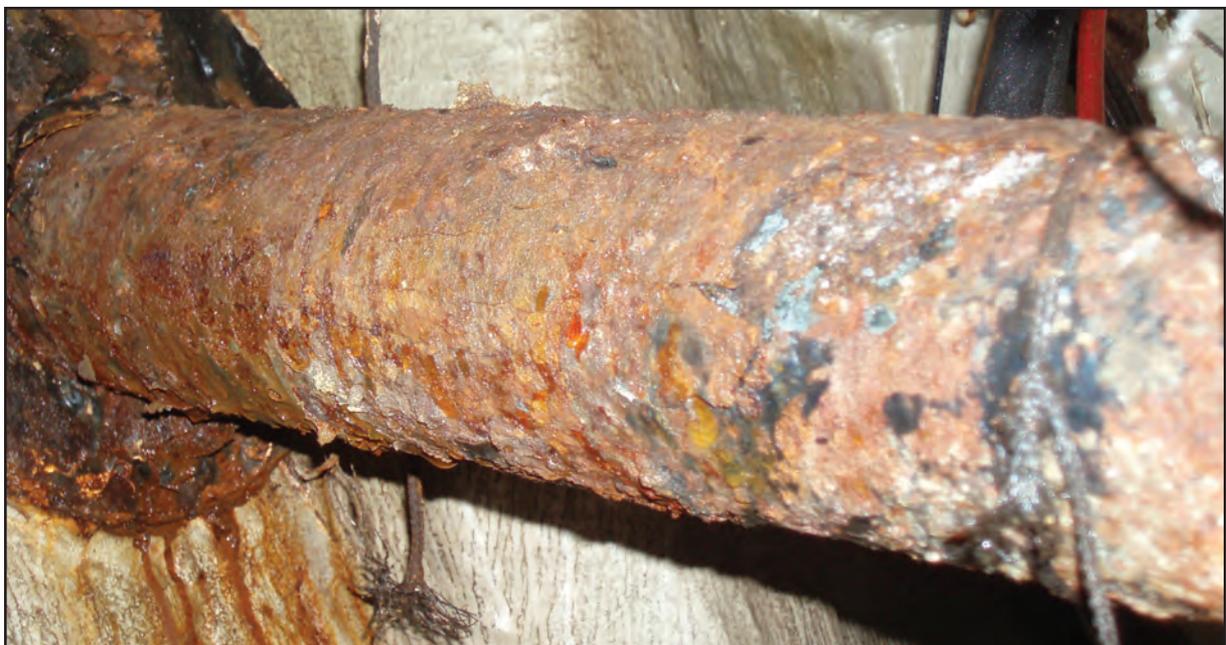
The exact cause of the flooding is unknown. However, some of the vivier pipework, which had been found to be heavily corroded, had recently been repaired using a GRP bandage.

Vivier pipework prior to temporary repair with GRP bandage

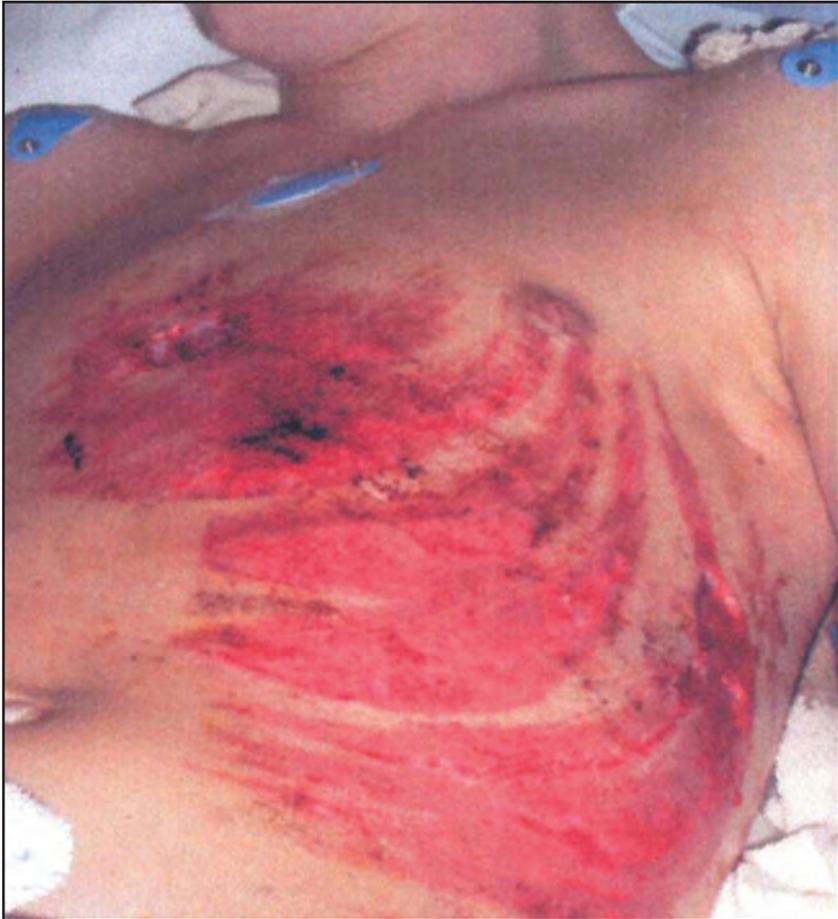
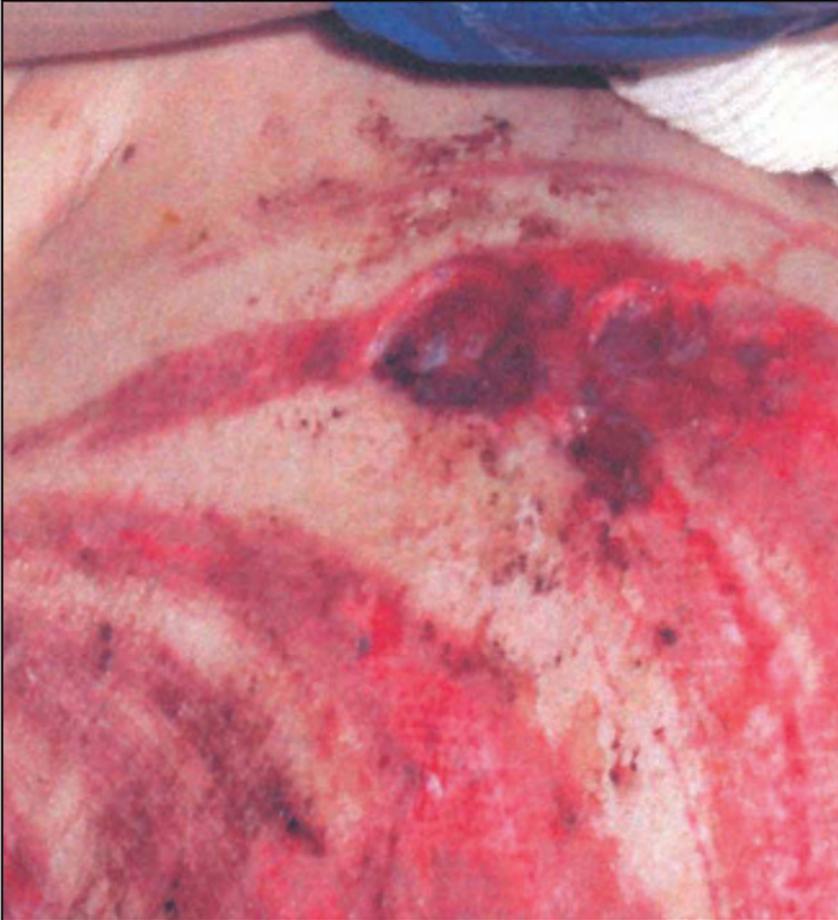
Figure 2: Injuries to passenger

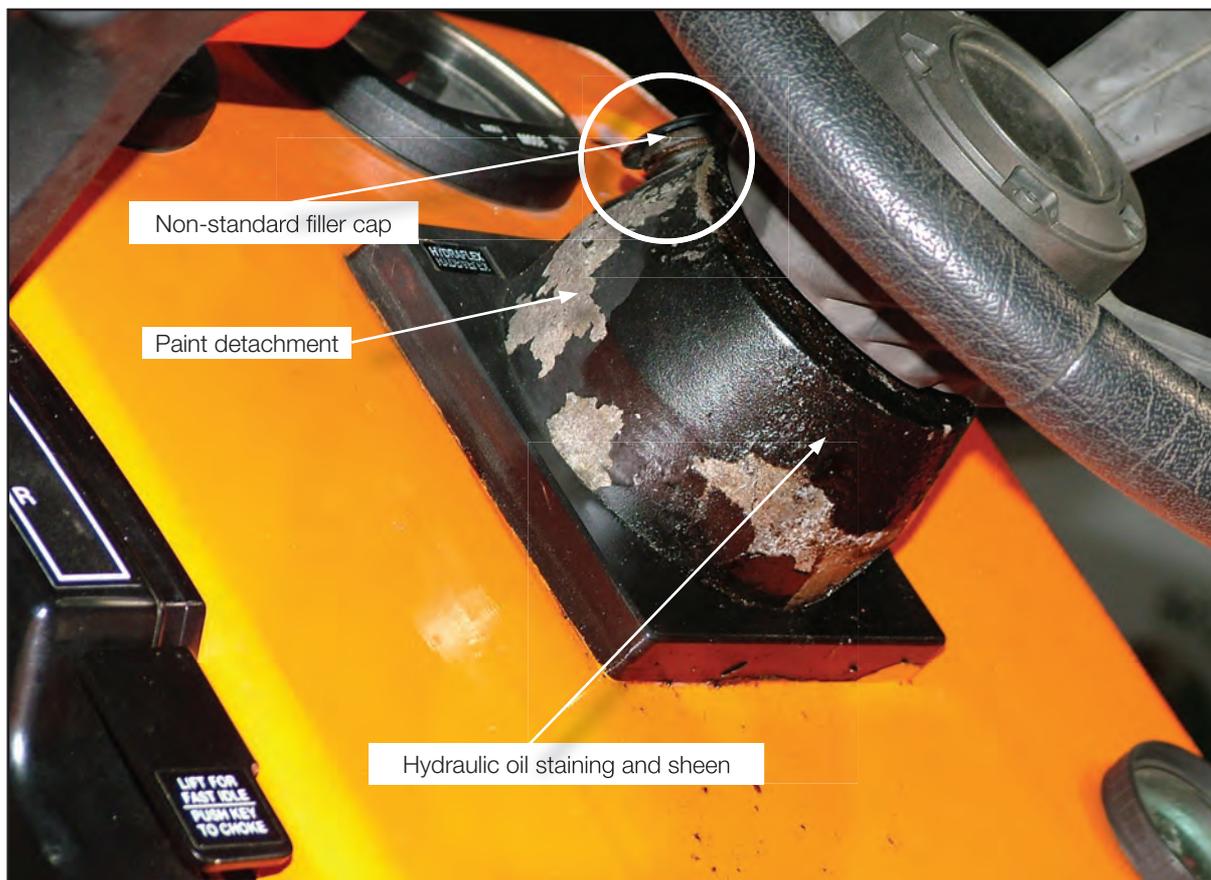
Figure 3: A view looking up from underneath the helm pump boss, showing leakage of hydraulic pump

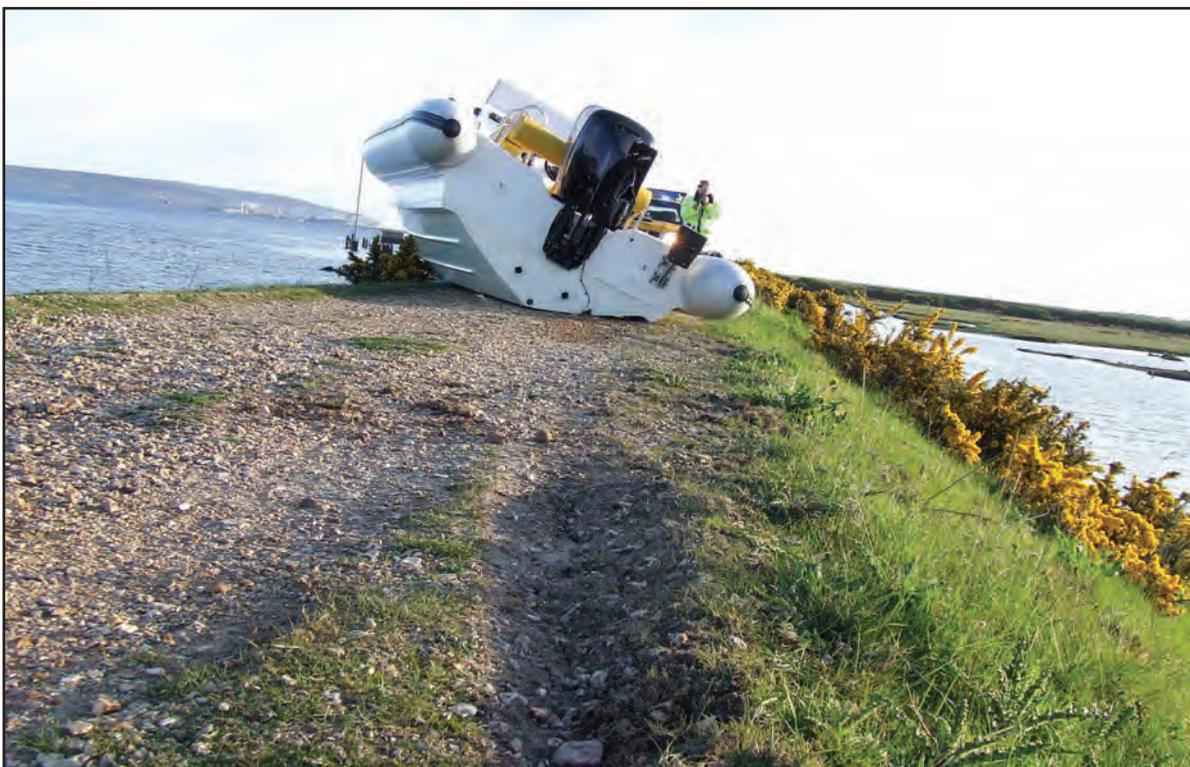
The RIB continued at high speed, constantly turning in a spiral and, fortunately, moving away from the people in the water. It grounded at speed and climbed to eventually come to rest on a footpath on top of a sea wall (see photograph).

Figure 1: RIB photographed after accident

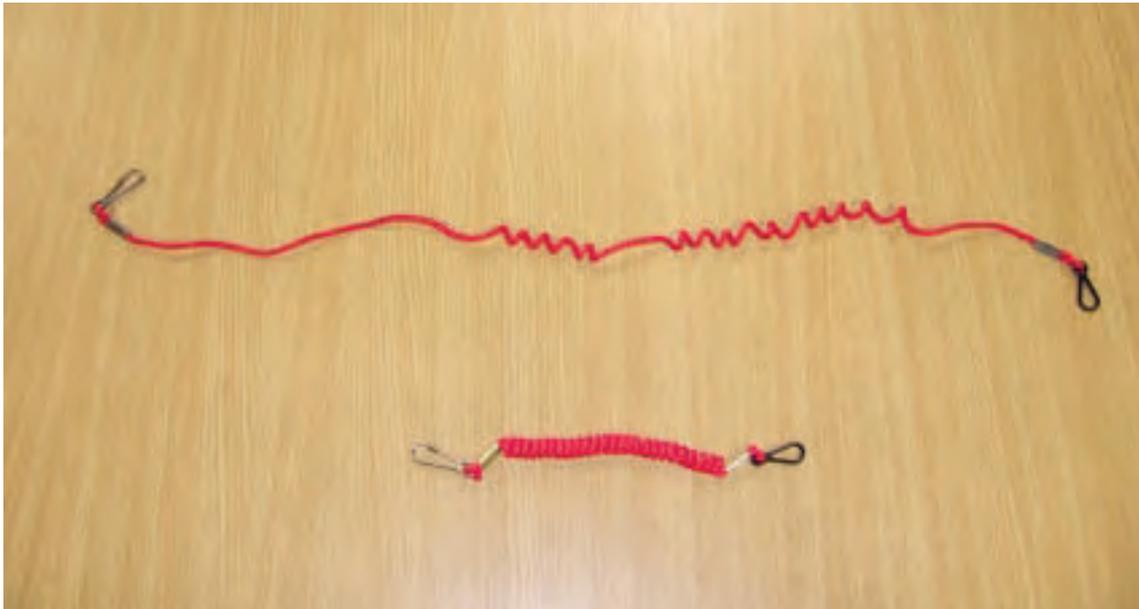
Stretched kill cord in comparison with new item
