MARINE ACCIDENT
INVESTIGATION BRANCH

SAFETY DIGEST

Lessons from Marine
Accident Reports
1/2014

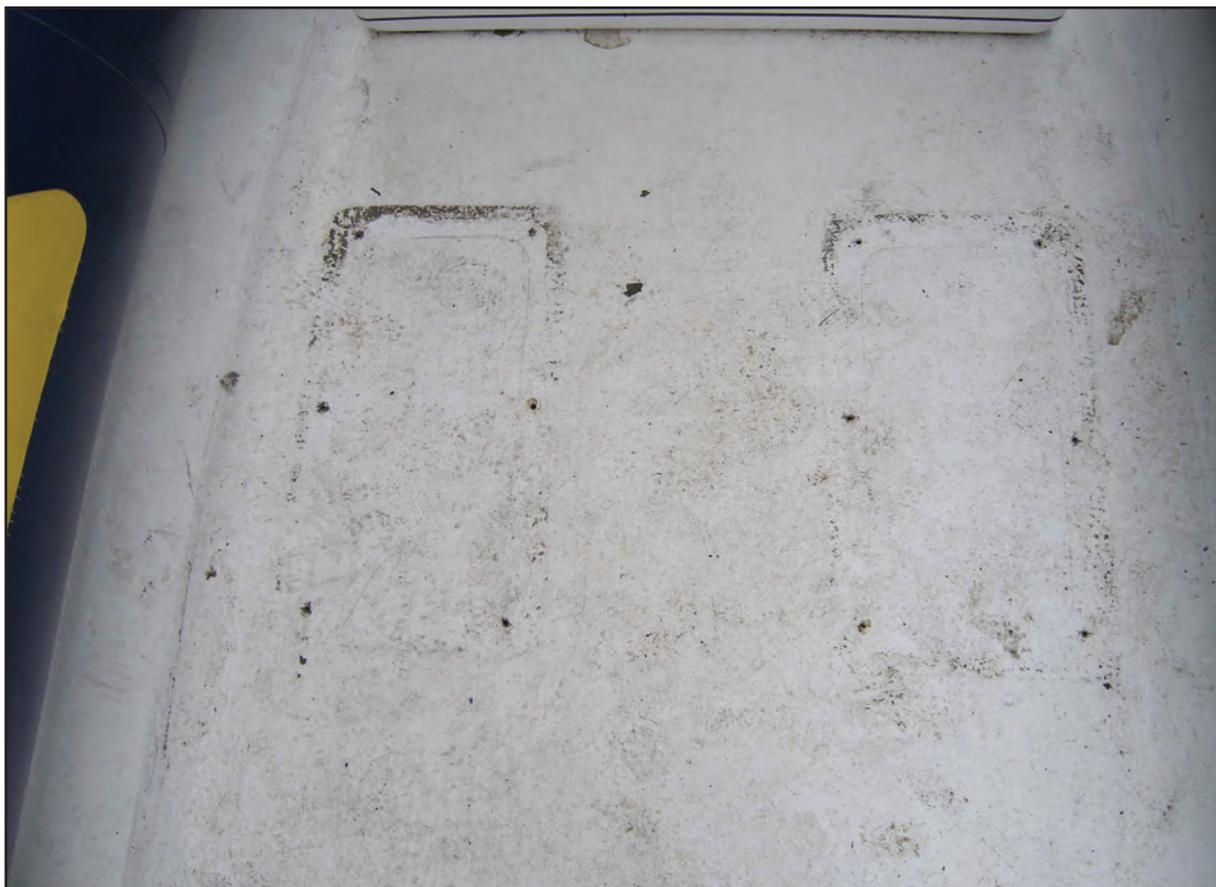
With no one at the helm, the boat careered on out of control because the kill cord had fallen off the helmsman's wrist, and not operated. The RIB then collided with another vessel during which the console top was broken free

Figure 1: Vessel's deck showing outline of consoles - note lack of preparation and adhesive

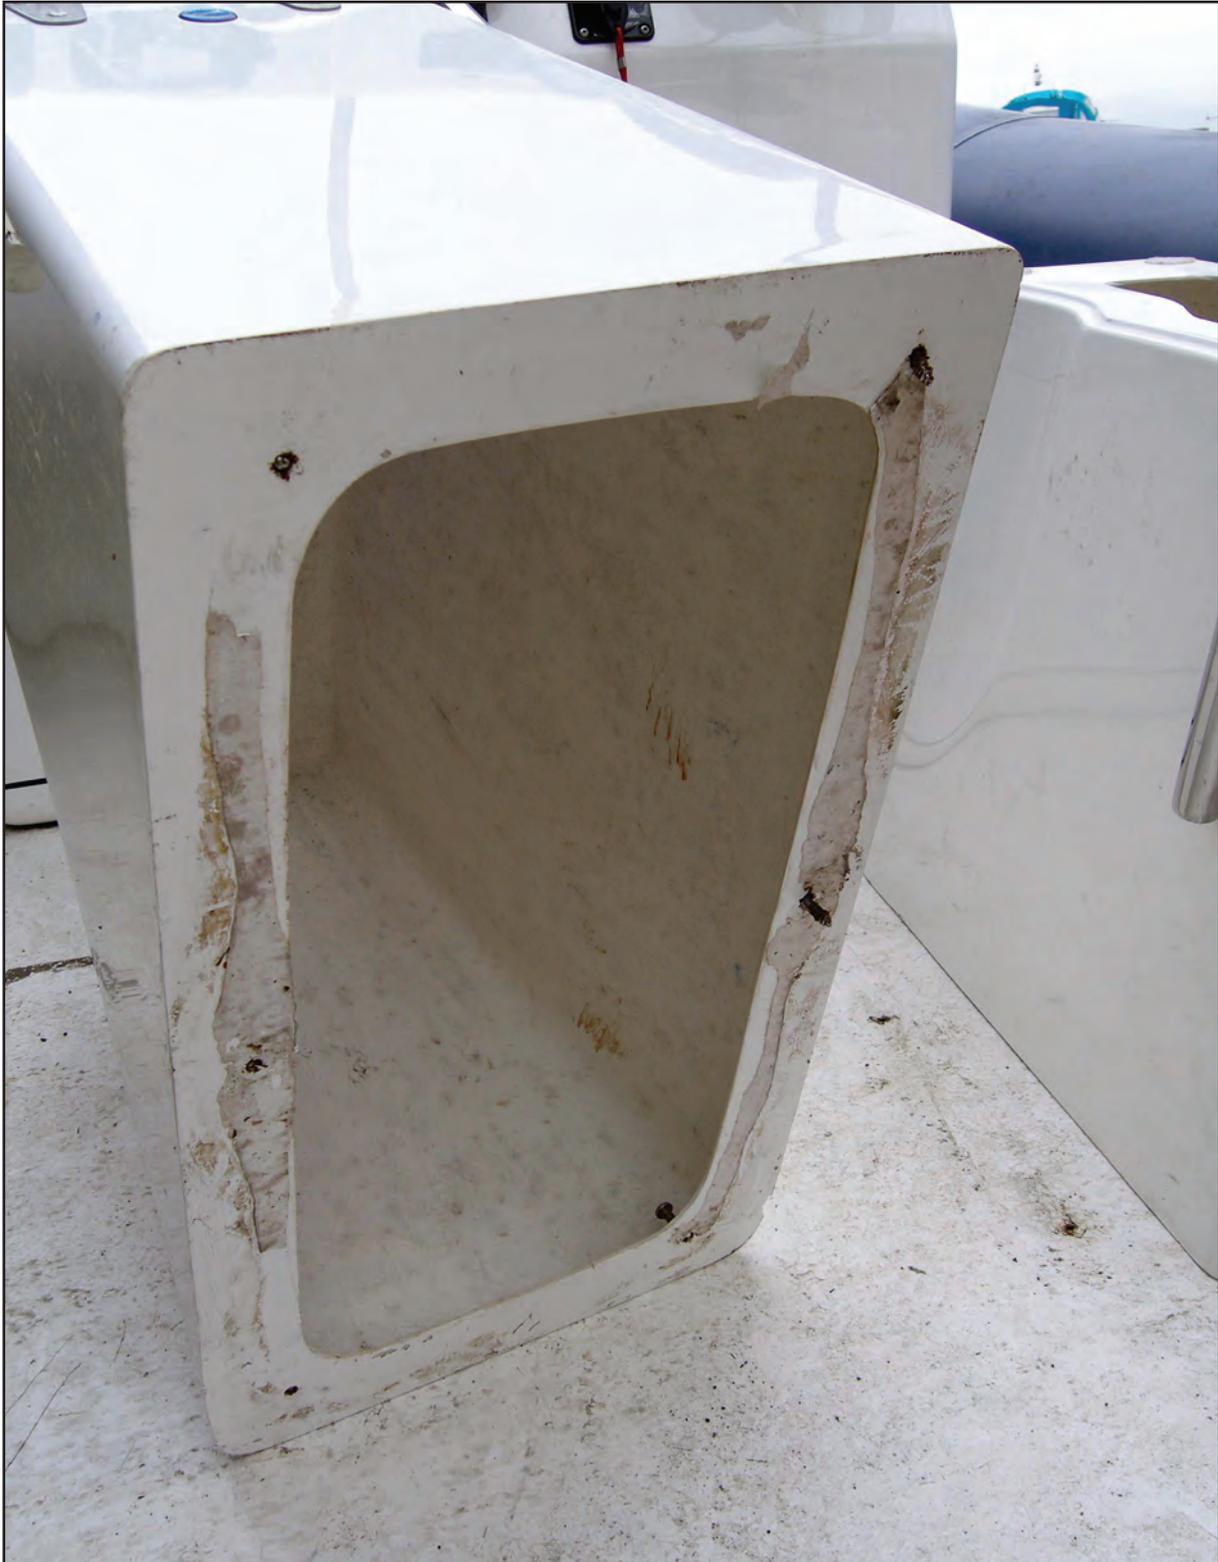
18mm plywood, with a 2-3mm GRP skin which was impregnated with small plastic granules to create a non slip surface. Analysis of the sealant was unable to positively identify it as any particular product, but it was established that it was polyurethane-based. Polyurethane adhesive sealants normally provide good adhesion, but in this case poor surface preparation had resulted in ineffective adhesion to the deck, leaving the self-tapping screws as the only means of securing the seats. Over time, water had seeped into the six screw holes and softened the plywood, resulting in the screws pulling out as the RIB turned to starboard, and the weight of the occupants was forced laterally against the seats.

Figure 3: Vessel's seat
note: wide spacing of securing screws and poor coverage of sealant

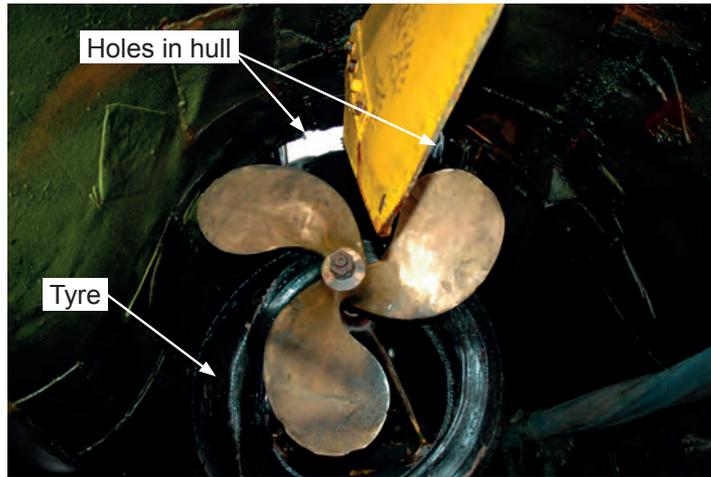
Figure 1: Holes torn into *WQ1*'s hull after the propeller was fouled by a tyre

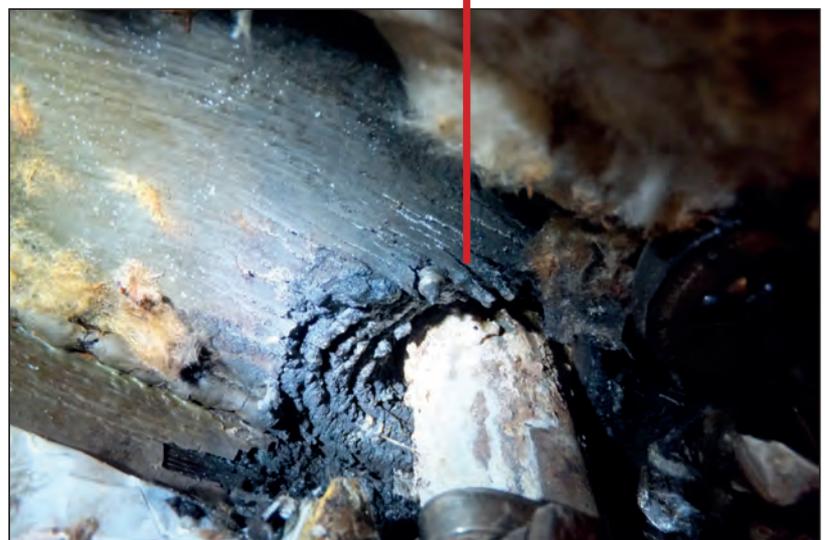
Figure 2b: Scorching under deck on similar vessel
