MARINE ACCIDENT
INVESTIGATION BRANCH

SAFETY DIGEST

**Lessons from Marine
Accident Reports
1/2010**

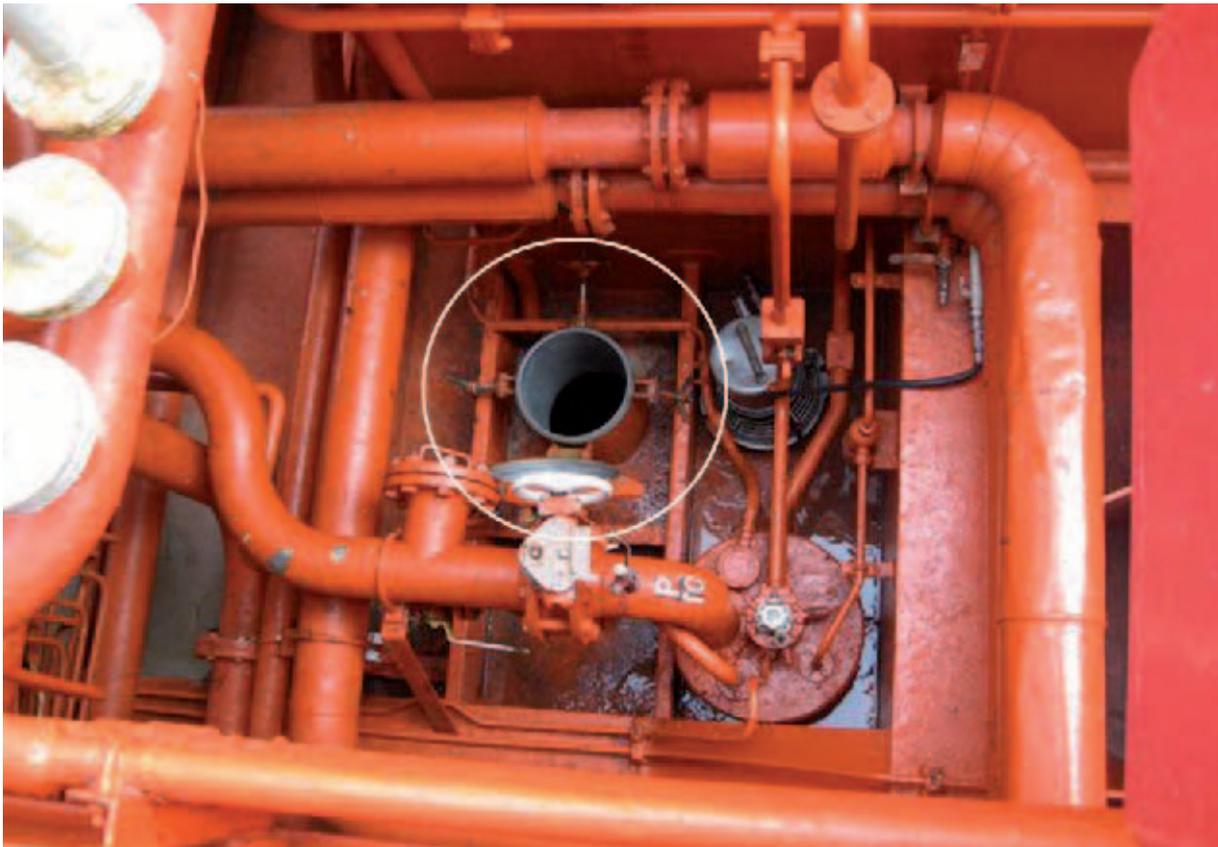
Figure 1: Butterworth hatch

the pungent, heavier than air cargo vapours were driven through the open hatch and accumulated in the vicinity of the hatch.

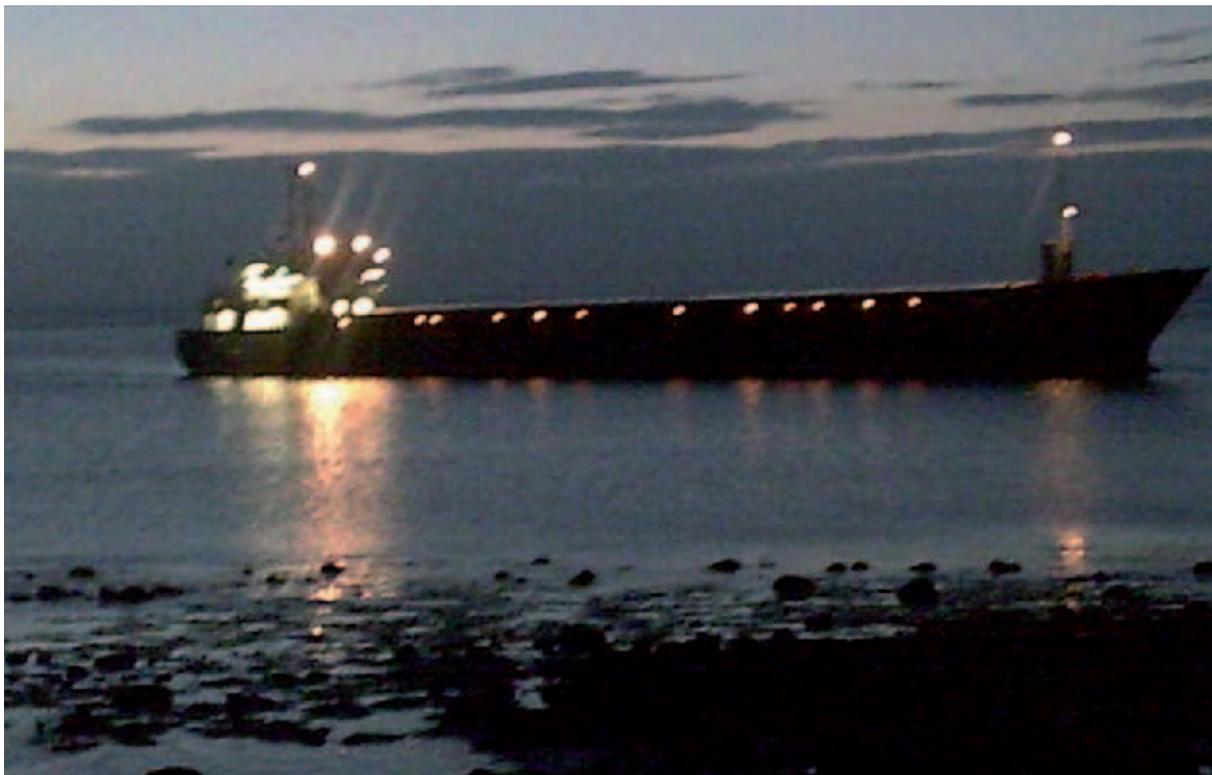
Figure 1: Vessel aground

errors including the failure to post a lookout, and the watch alarm not being activated so as to avoid disturbing off duty personnel. The vessel was refloated a few hours after grounding, on a rising tide, under her own power. Fortunately, nobody was injured and

there was no pollution. However, the vessel's hull suffered indentation damage over 70% of her length, and she underwent 4 weeks of repairs which required 25 tonnes of new steelwork to be fitted before she was approved to resume service.

2. The requirement to post a lookout in addition to the watchkeeping officer, during the hours of darkness and as necessary at all other times, is widely promulgated. All too frequently, the MAIB finds that the lookout is not being consistently posted, often because ABs are instead being required to work long hours, either in port or on general maintenance duties.

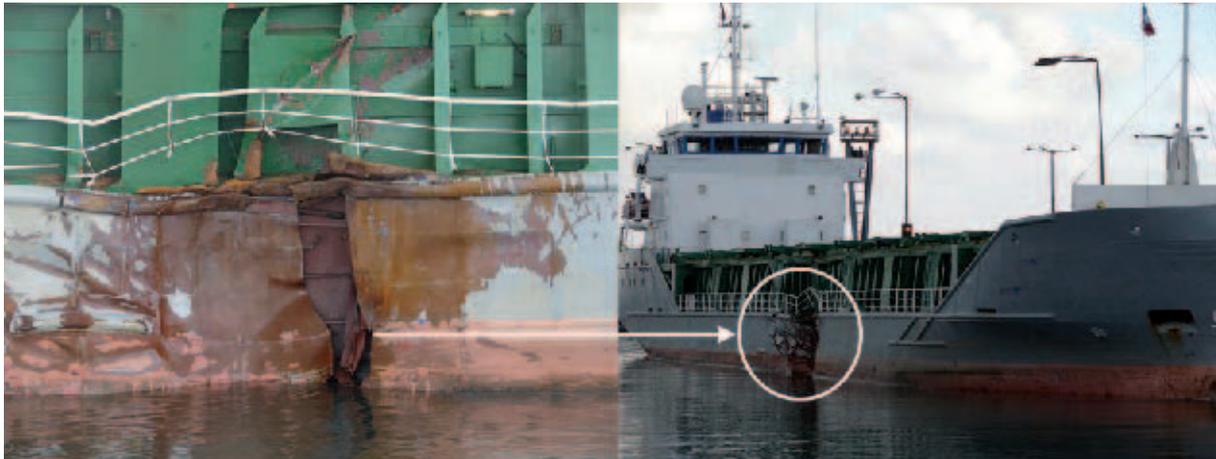
Figure 2: Damage sustained to starboard side of general cargo vessel

After the collision the vessels exchanged details and verified that neither required immediate assistance. The larger vessel then resumed her passage to her next port, where repairs were undertaken, resulting in her being out of service for a week.

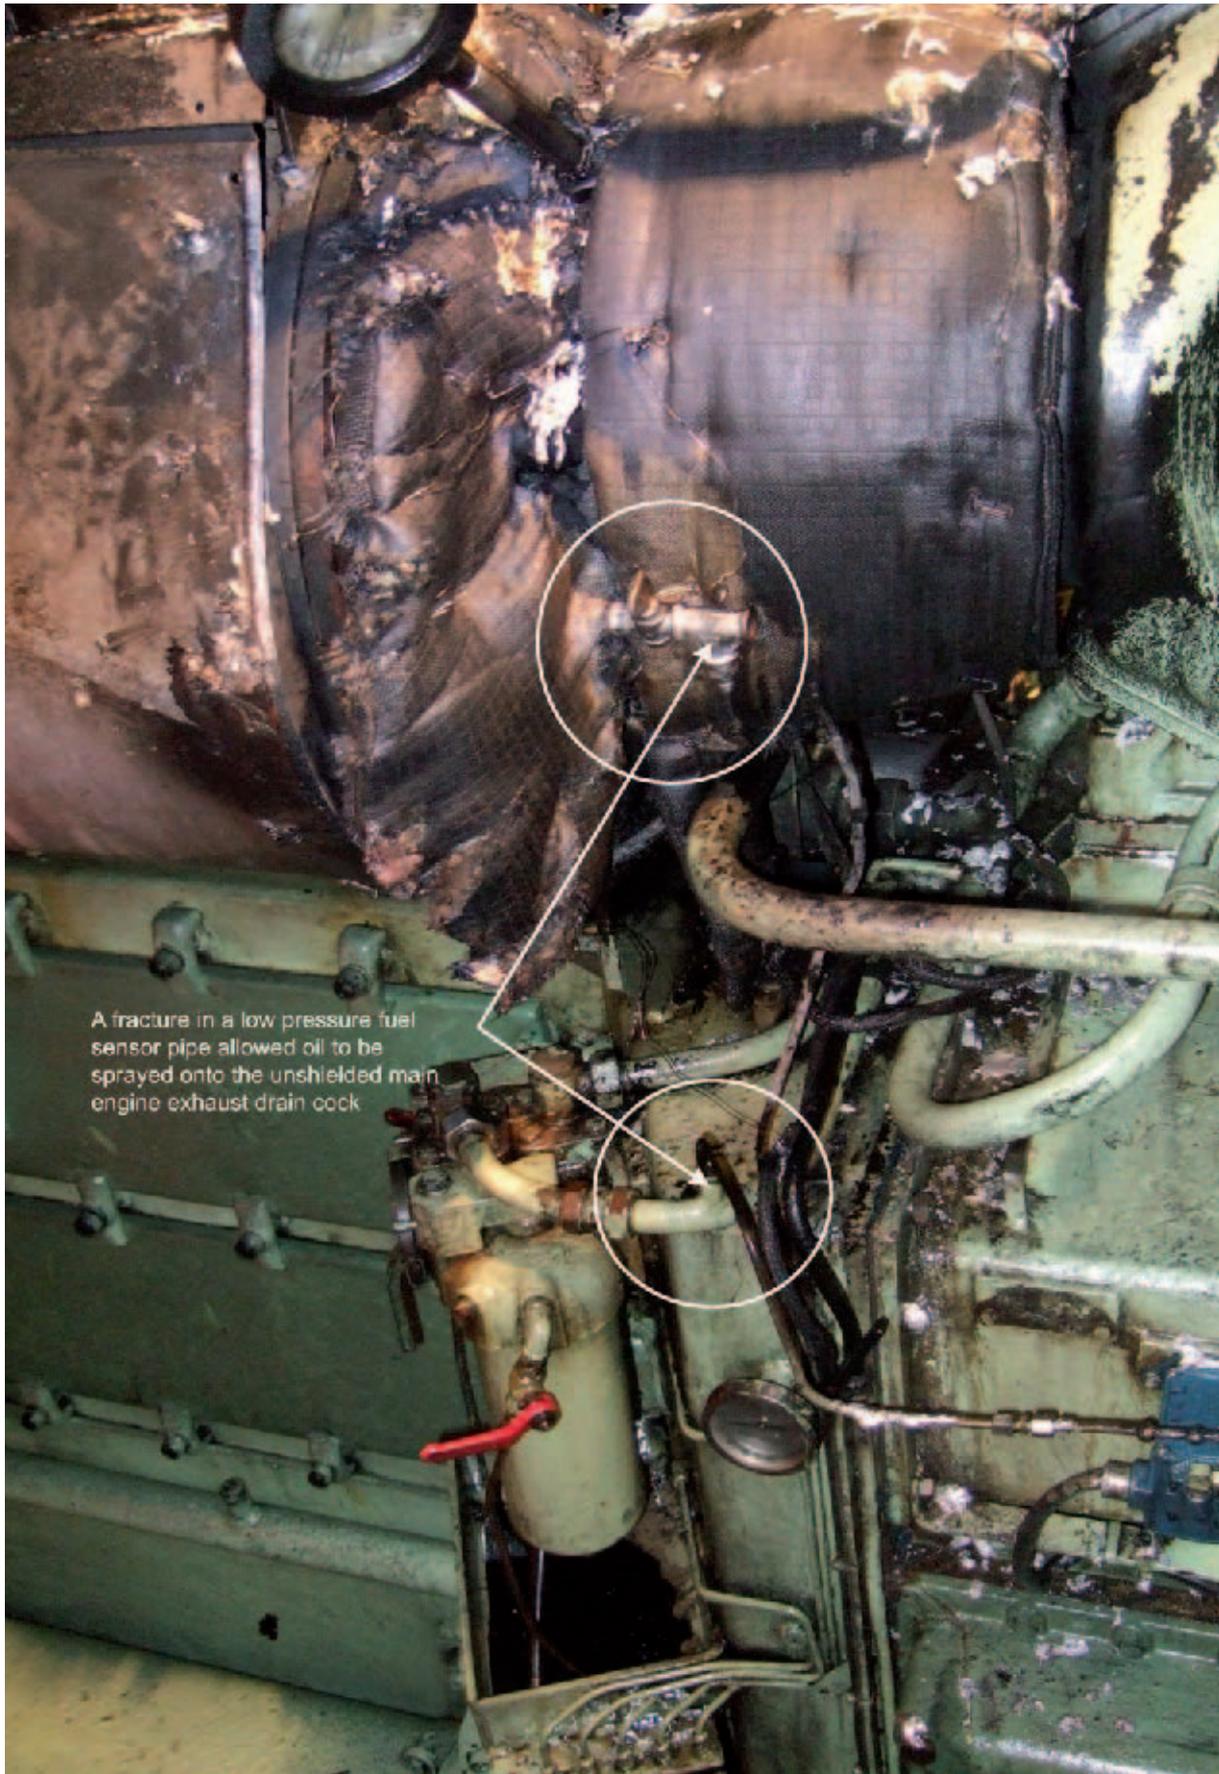
The officers confirmed that the fire had been extinguished and that the atmosphere was safe. The chief engineer identified that the fire had been caused by a fracture in a low pressure fuel sensor pipe coupling, which had resulted in oil spraying onto the unshielded, main engine exhaust drain cock. The drain cock's normal operating temperature of about 350°C was sufficient to cause the oil to auto ignite when it came into contact with the hot surface.

A fracture in a low pressure fuel sensor pipe allowed oil to be sprayed onto the unshielded main engine exhaust drain cock

Detail showing diesel oil filter, pressure alarm and unshielded drain cock

3. Protection of surfaces with temperatures above 220°C is a requirement of SOLAS, Chapter 2 Regulation 4 2.2.6. In this case a regularly used drain cock was not protected as it should have been, and the fuel pipe below the cock was not adequately supported. Any fire on board is a potentially serious incident, and precautions must be taken to prevent fuel impinging on hot surfaces.

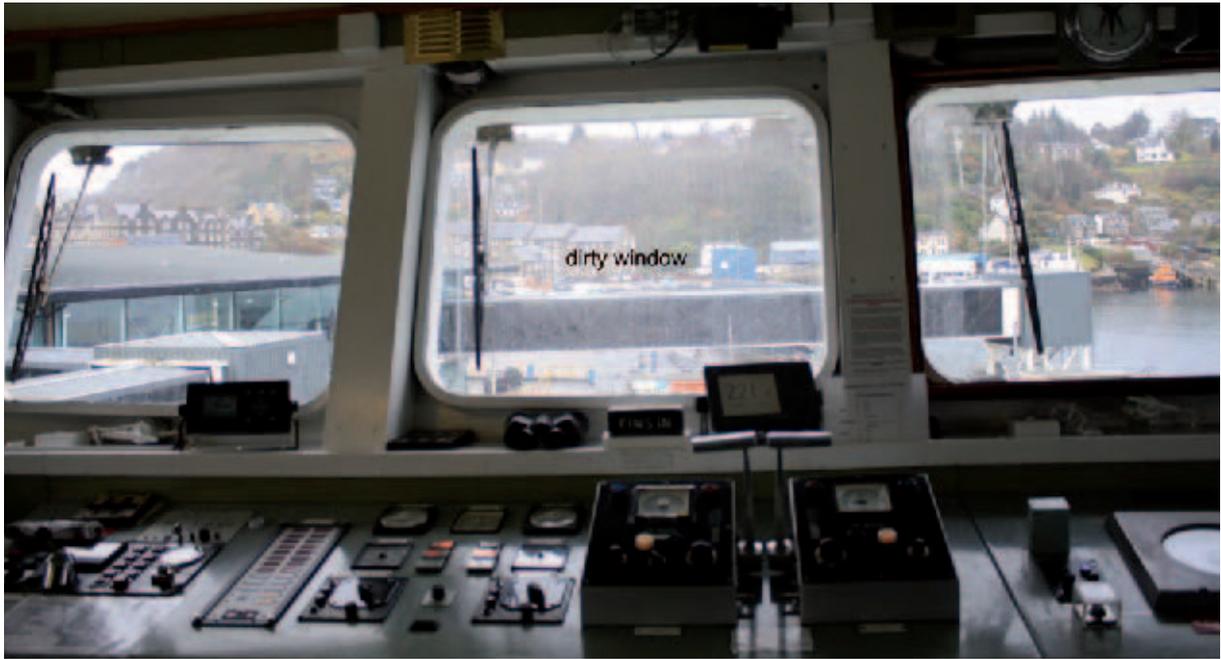
However, the master found it difficult to see directly ahead because the centre bridge window was dirty (Figure 2) and the vessel was heading directly towards the low, bright sun. As the window washer was not working, the master instructed the cadet to clean the window; he also increased speed to 8 knots. Unfortunately, the cadet was not familiar with the whereabouts of the cleaning equipment or access to the outside of the bridge windows, and his questions regarding these matters briefly required the master's attention.

Figure 2: The windows on the bridge of the vessel

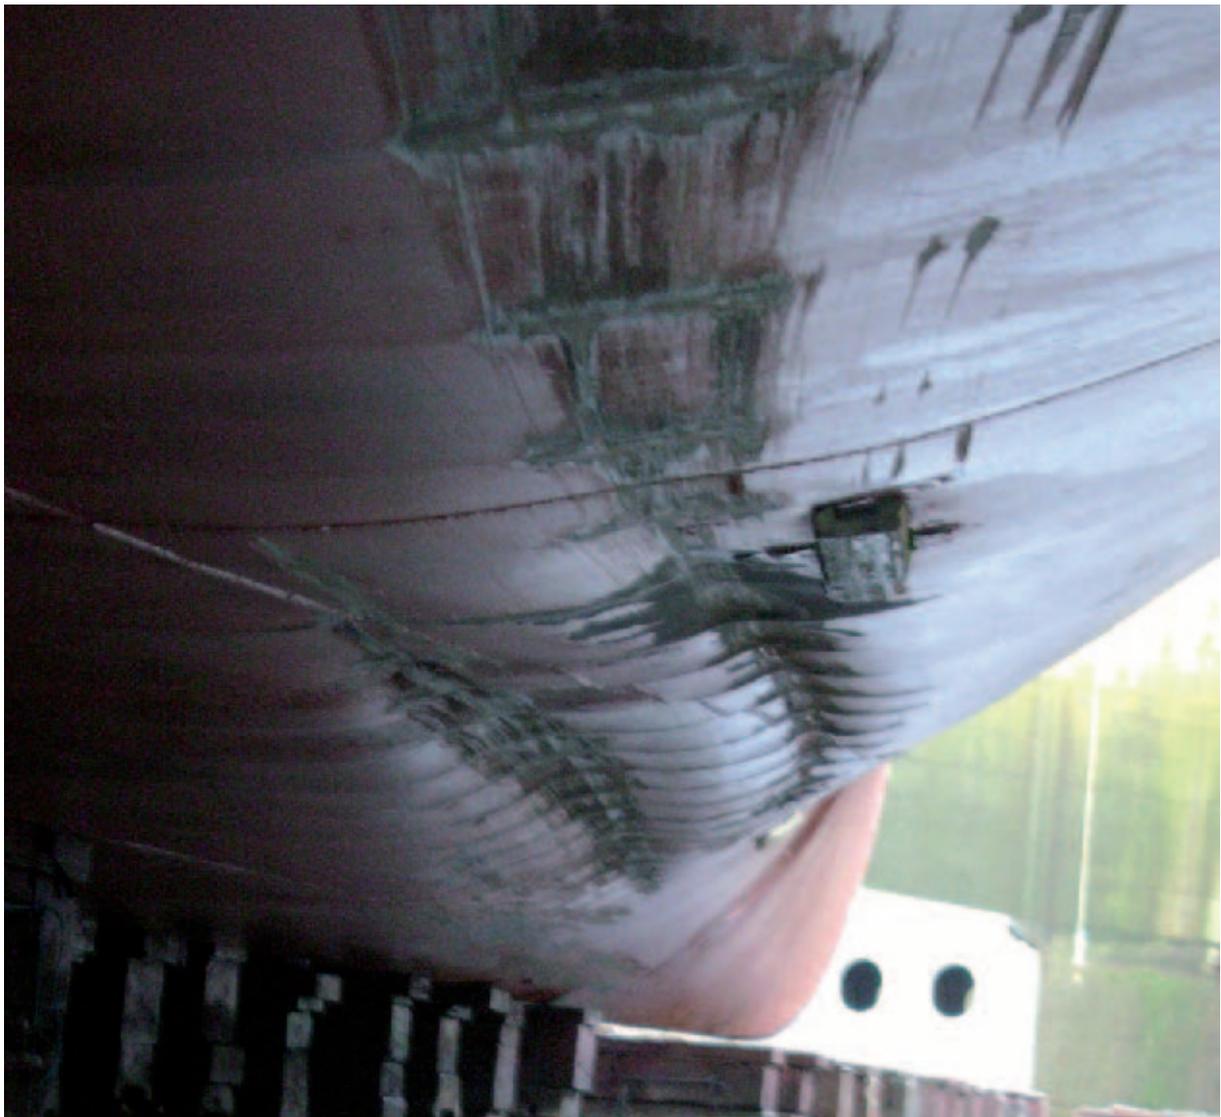
Figure 3: Hull damage

The master immediately applied full astern pitch and full port thrust. However, this did not prevent the vessel from momentarily grounding on the reef just 6 minutes after slipping. The ferry suffered substantial hull damage (Figure 3), but was able to return alongside without assistance.

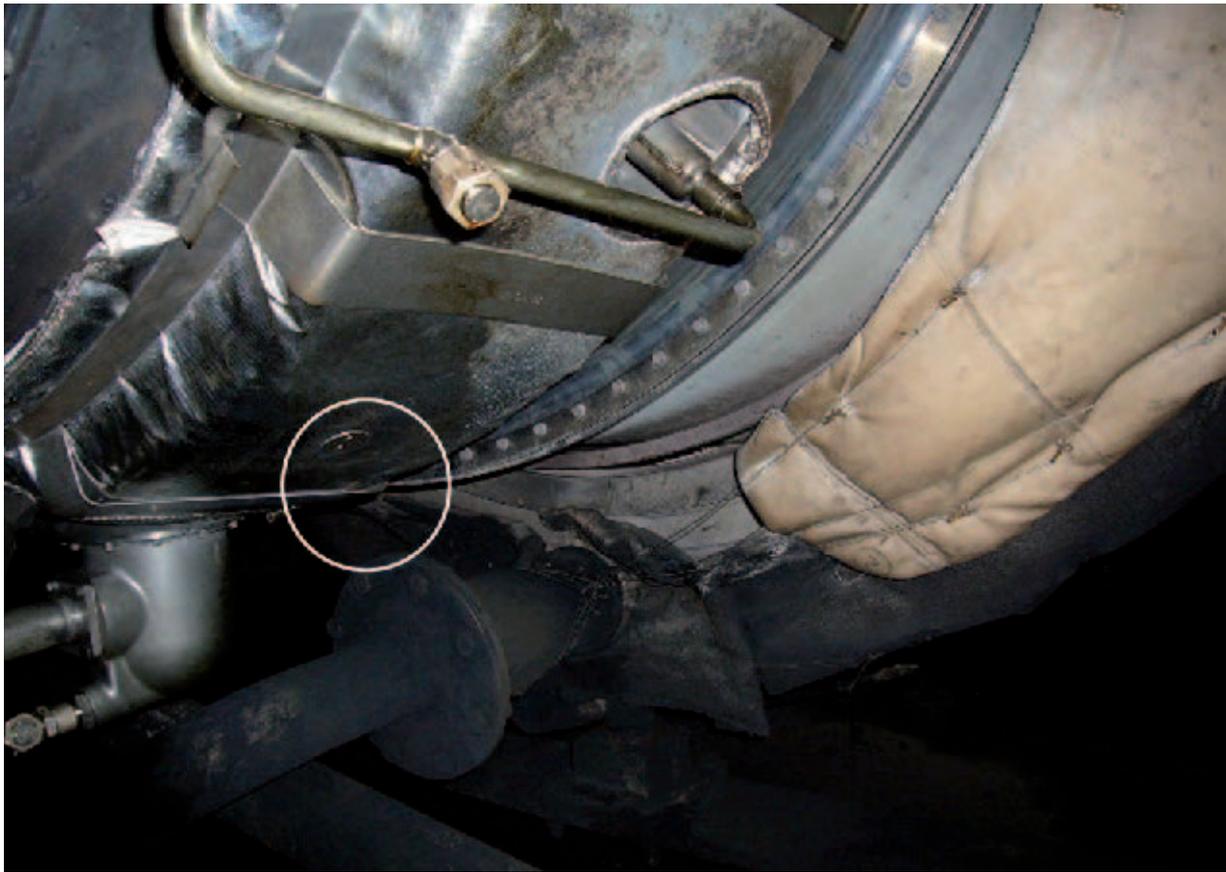
Figure 2: Position of plenum seal leak

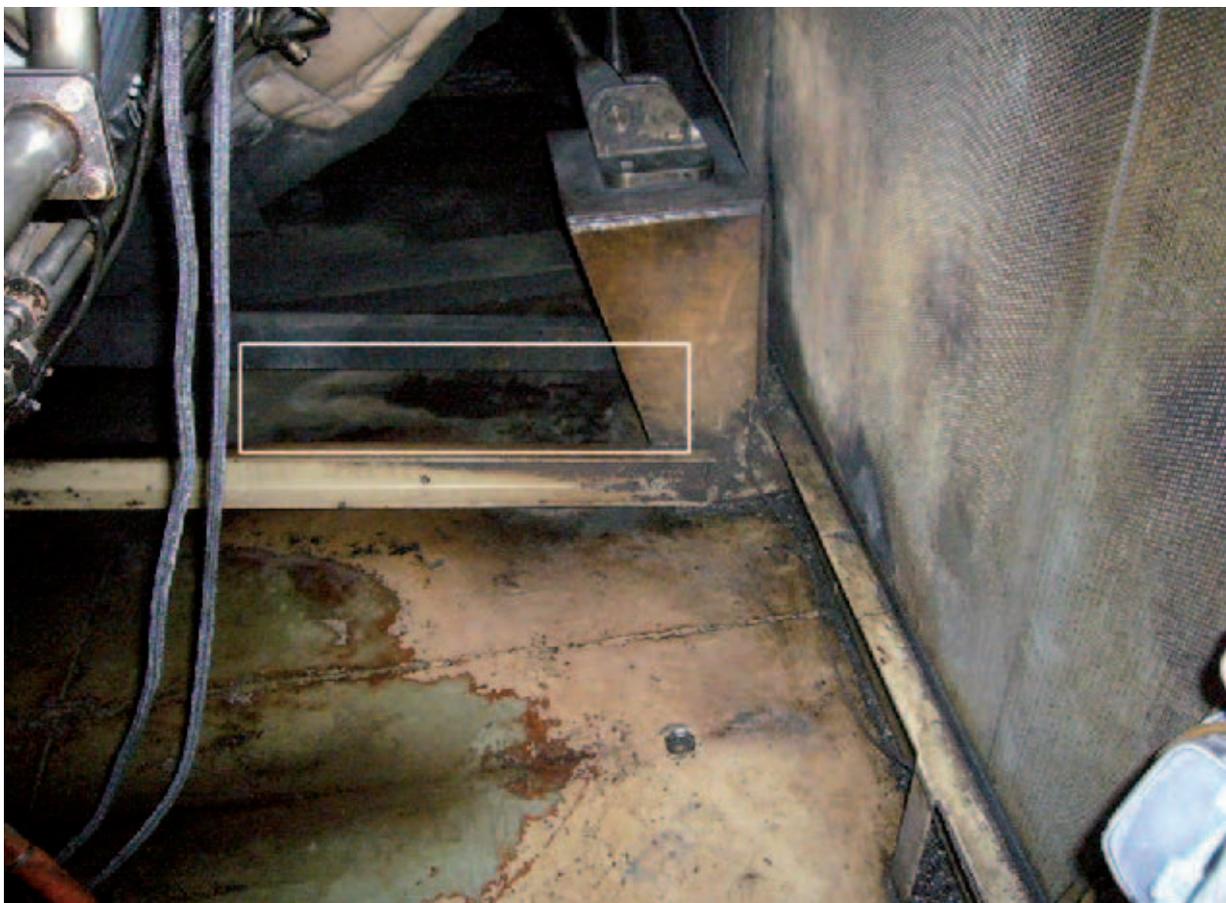
Figure 3: Scorch damage

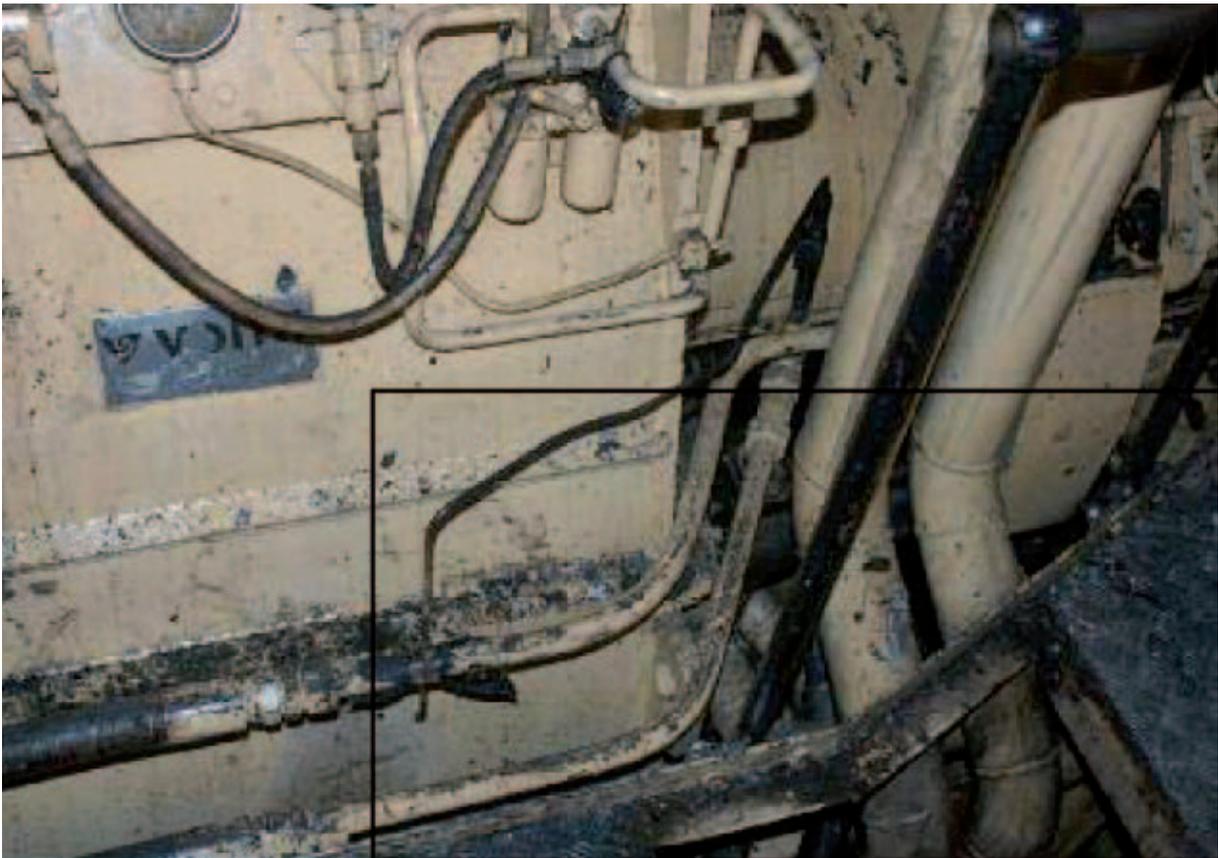
Figure 1: Burnt area

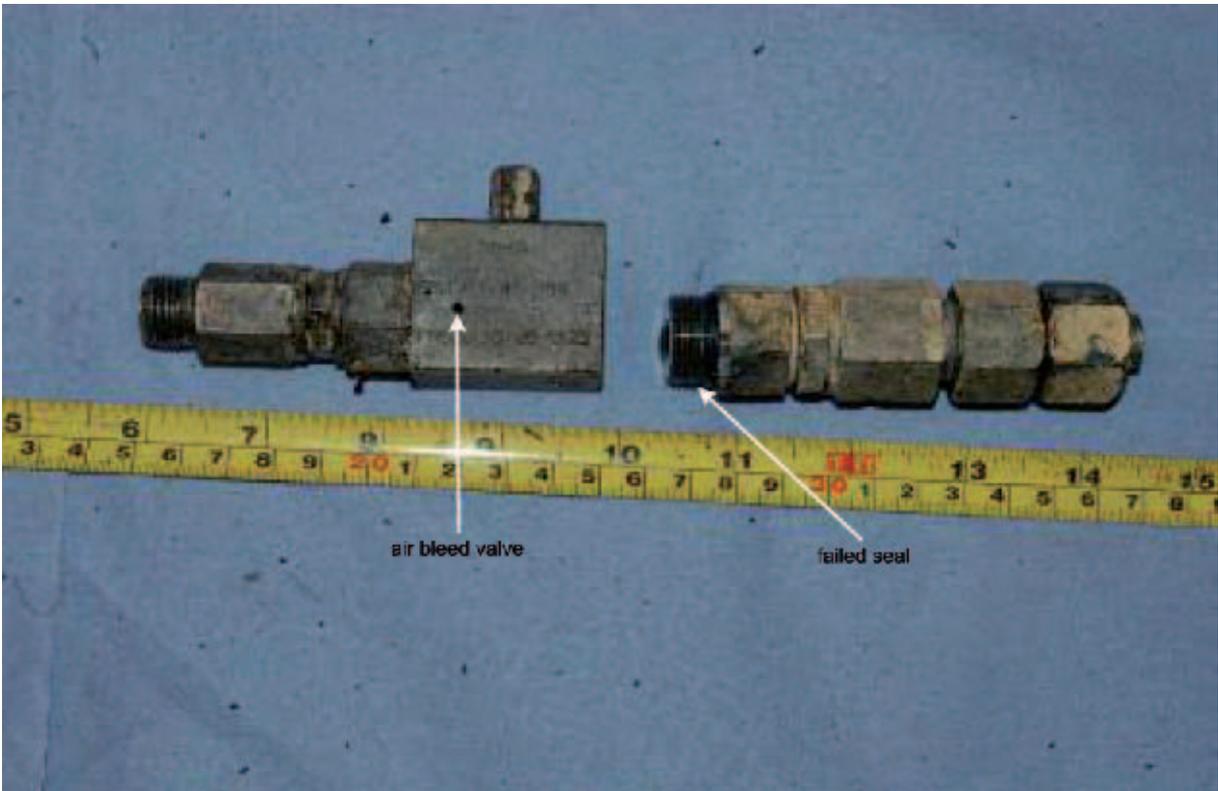
Figure 2: Air bleed valve and pipe connection

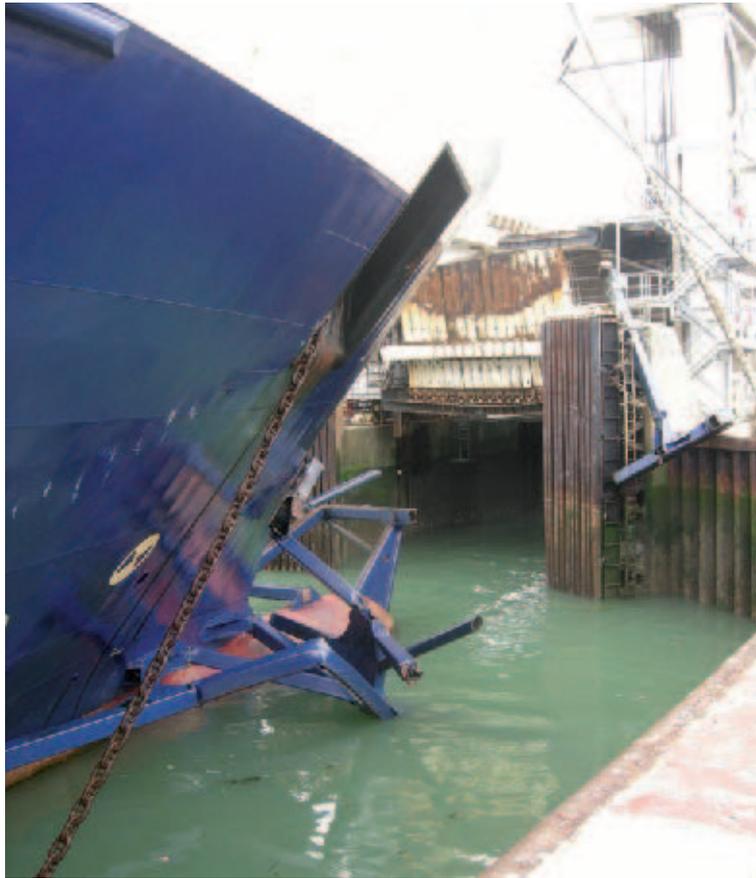
The vessel hit the quay, and then the link span, causing significant damage to both the ferry (Figure 1) and the port facilities (Figure 2). Fortunately there were no injuries and no pollution as a result of the accident.

Figure 1: Damage sustained to ro-ro passenger ferry

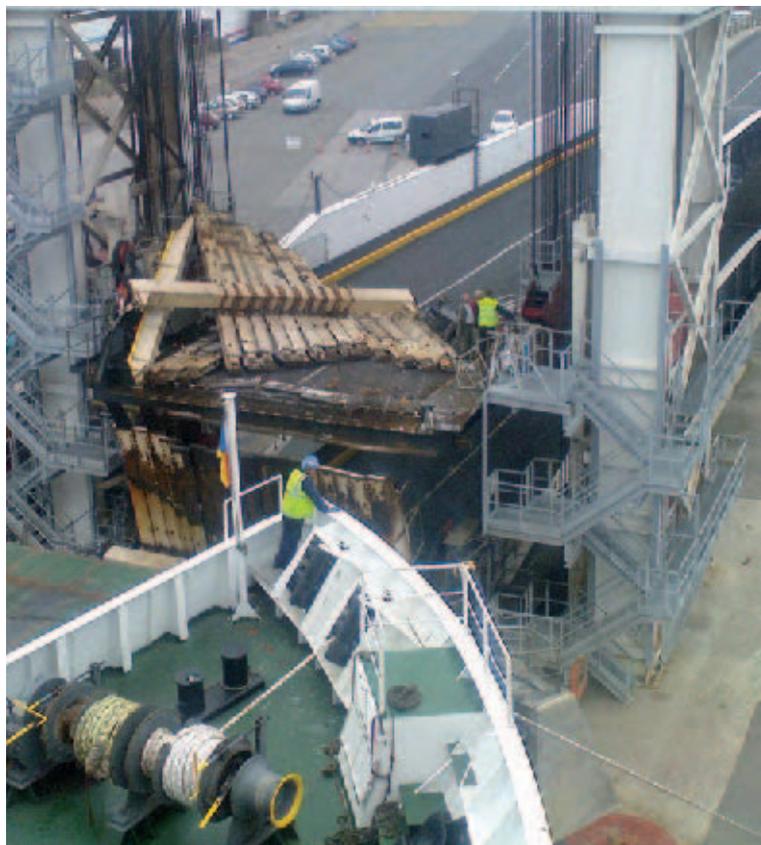
Figure 2: Damage to the port facilities

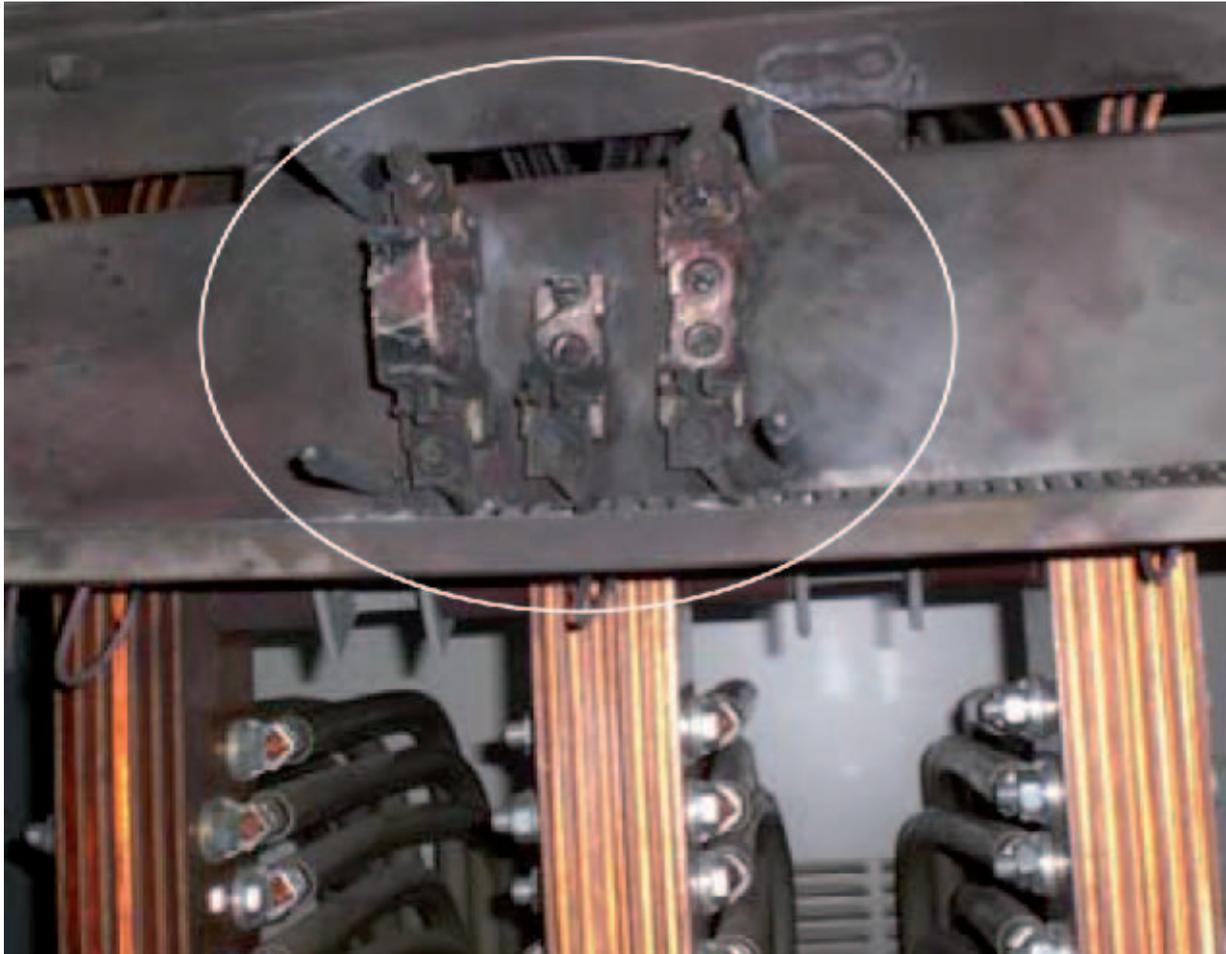
Figure 3: Destroyed fuse carriers

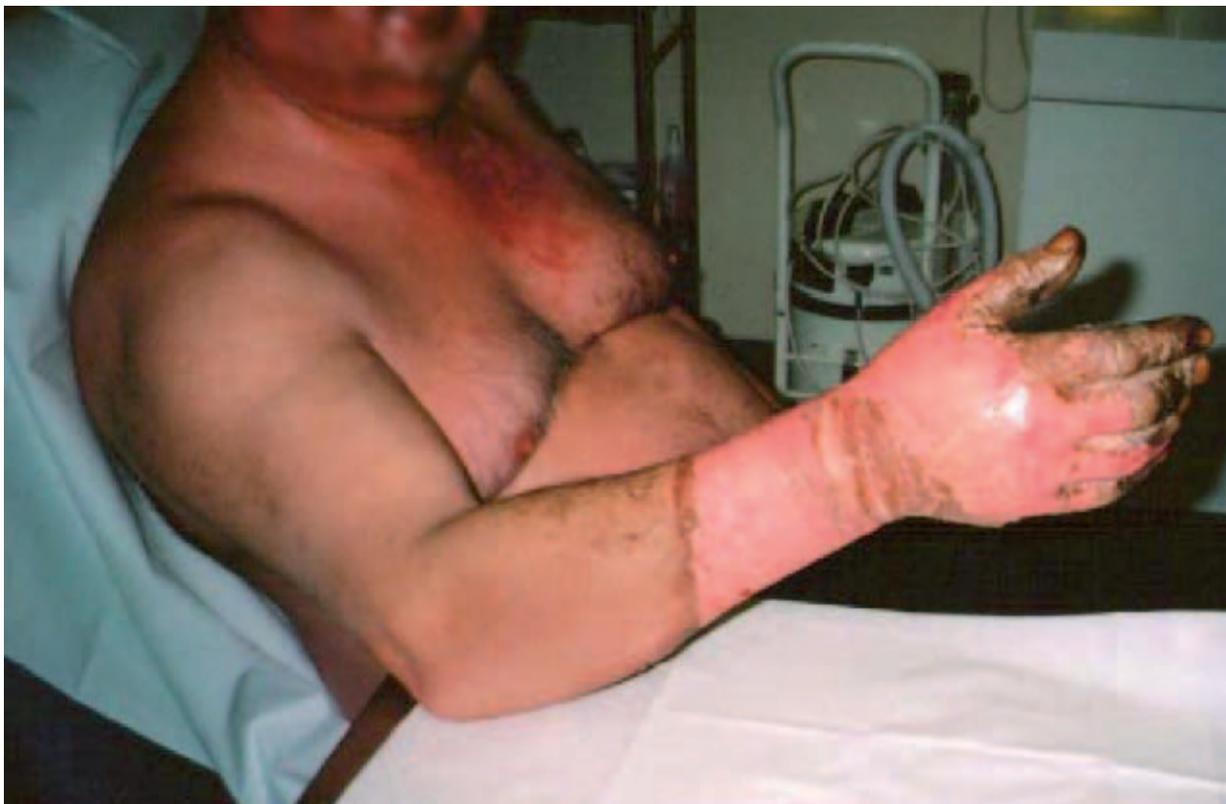
Figure 4: Chief Engineer's injuries

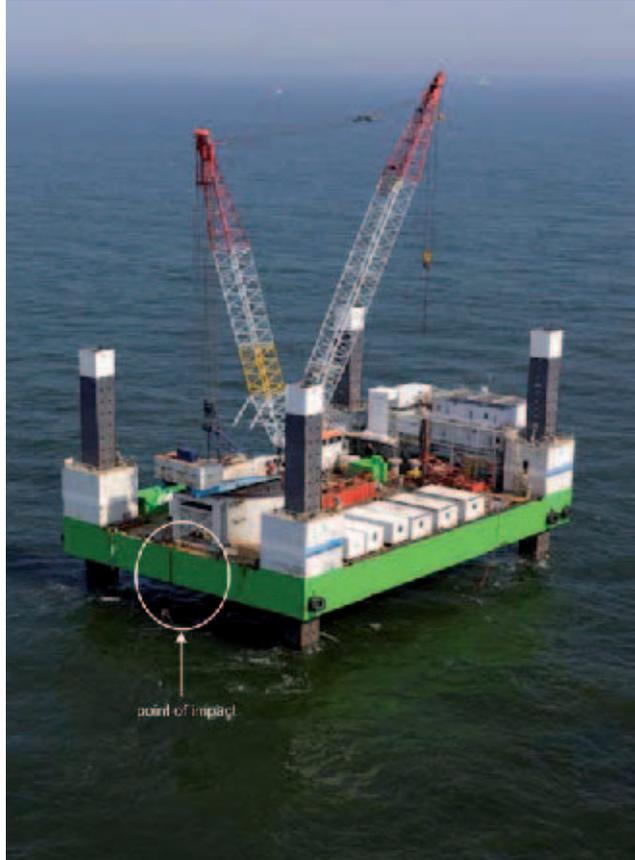
adjacent to the whaleback and to guardrails (Figures 2 and 3) – the damage could so easily have been far greater, and resulted in the loss of the vessel and possibly the lives of those on board.

Figure 2: Jack up barge - point of impact

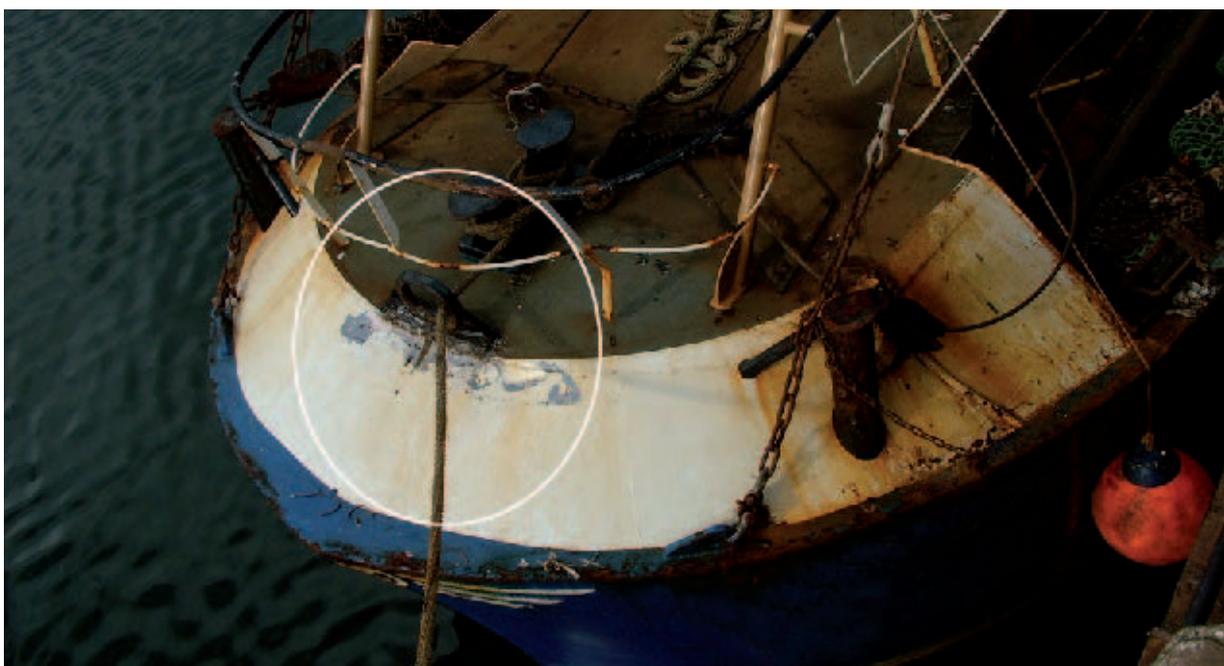
Figure 3: Damage to the stern of the fishing vessel

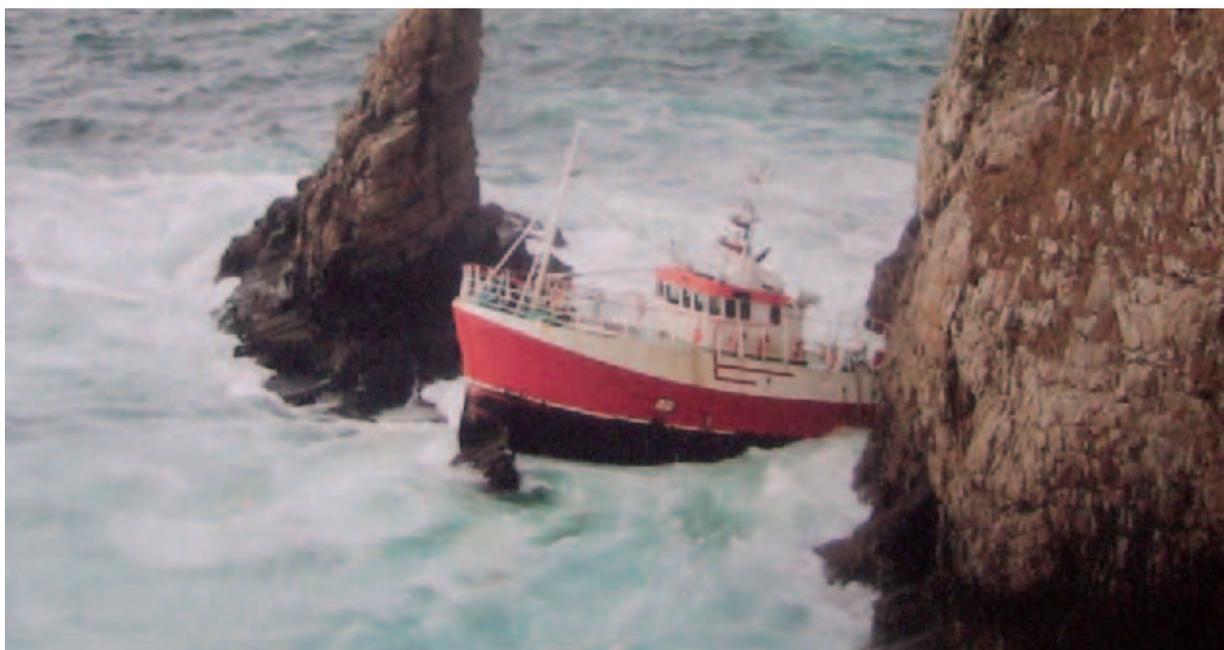
The vessel was subsequently declared a constructive total loss.

Figure 1: Vessel aground on the rocks

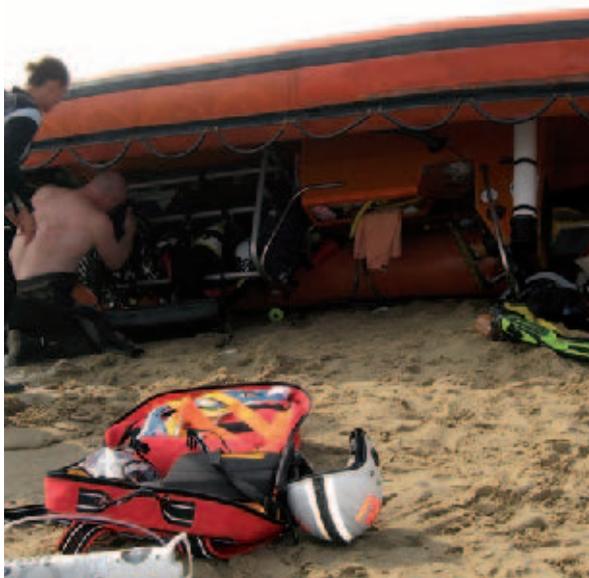
Dive RIB inverted on the beach
