MARINE ACCIDENT
INVESTIGATION BRANCH

SAFETY DIGEST

Lessons from Marine
Accident Reports
1/2014

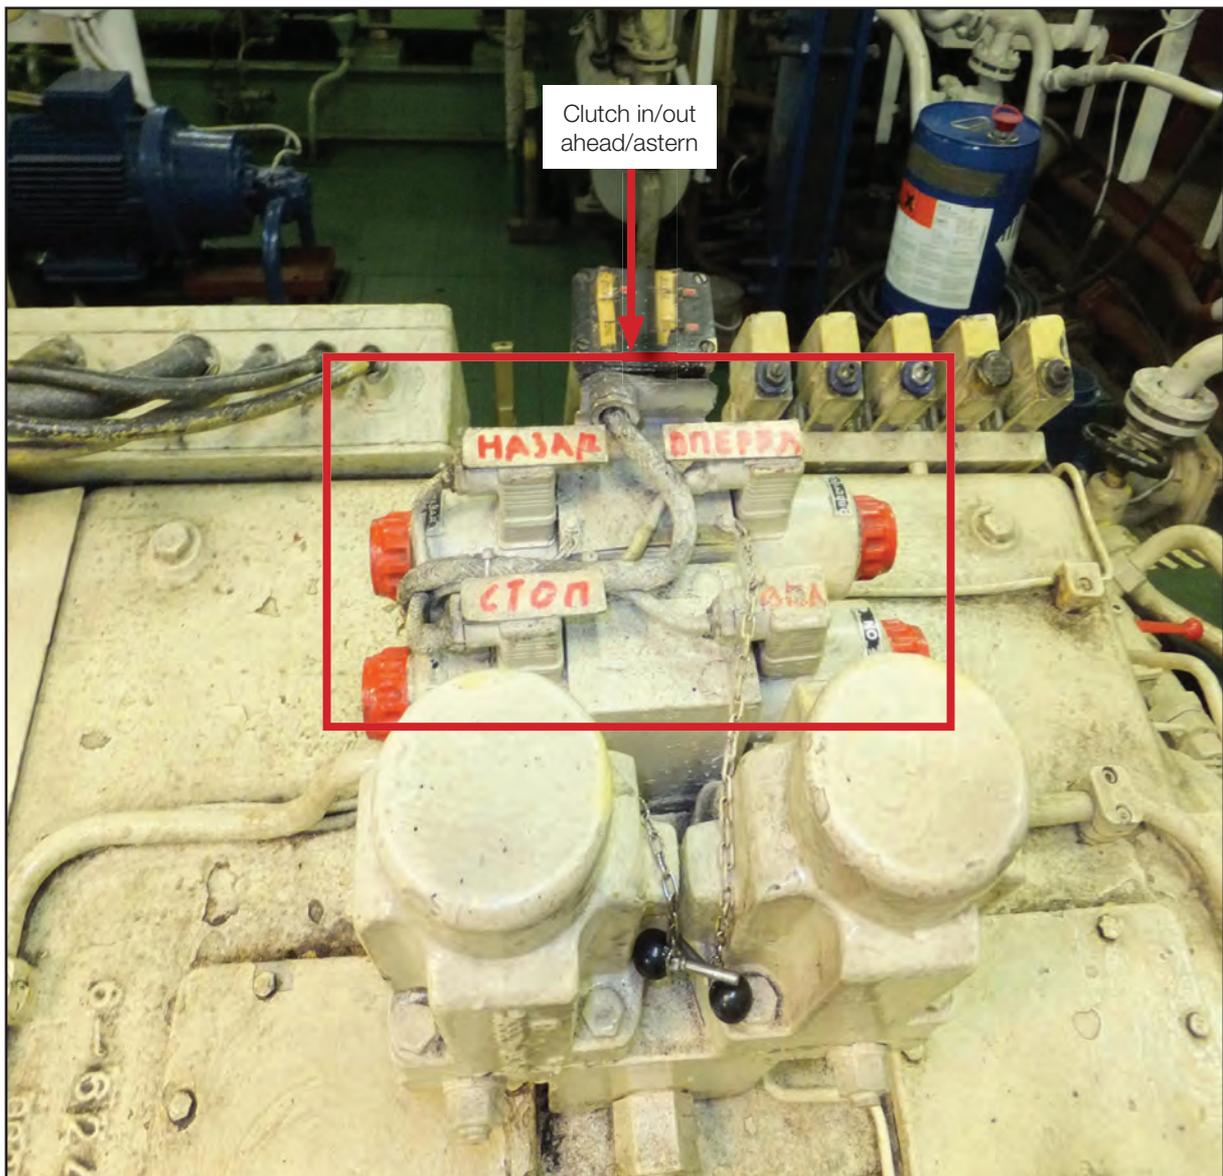
In manual control, engine orders were passed from the bridge to the engine room via the engine telegraph. The orders were acknowledged by the ship's electrician using the telegraph repeater in the engine room. He then indicated the intended direction of movement by pointing either forward or aft. The chief engineer operated the gearbox and clutch solenoid controls (Figure 1) and the second engineer adjusted the engine governor (Figure 2) to control the engine's speed. A shaft speed and direction indicator was not fitted in the engine room.

Figure 1: Gearbox solenoid controls

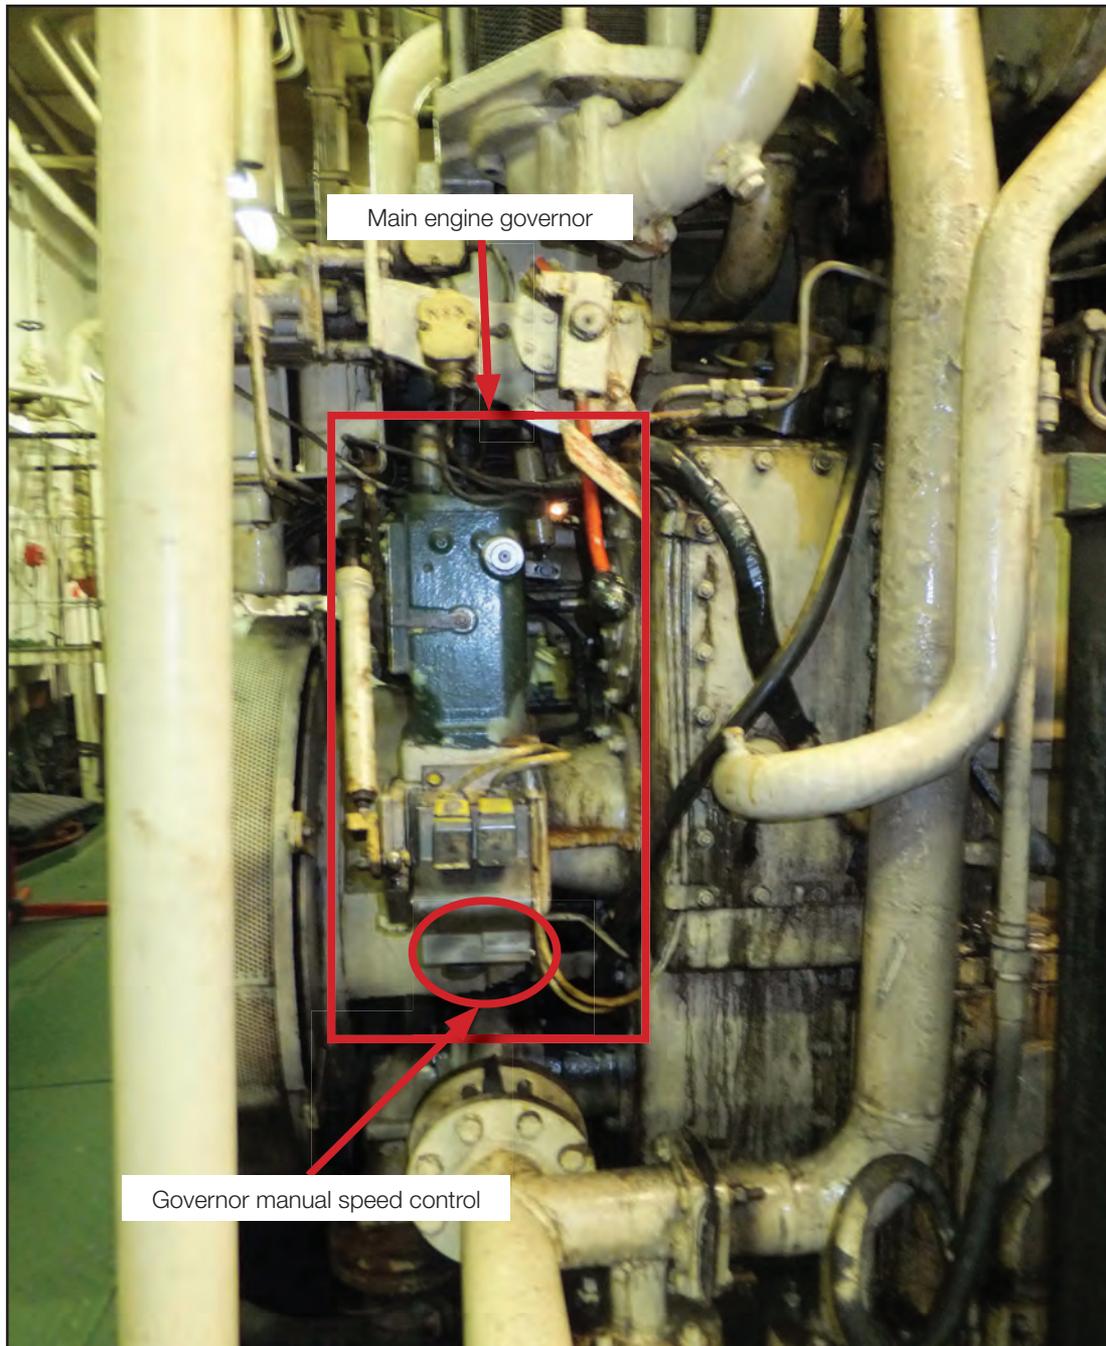
Figure 2: Main engine governor

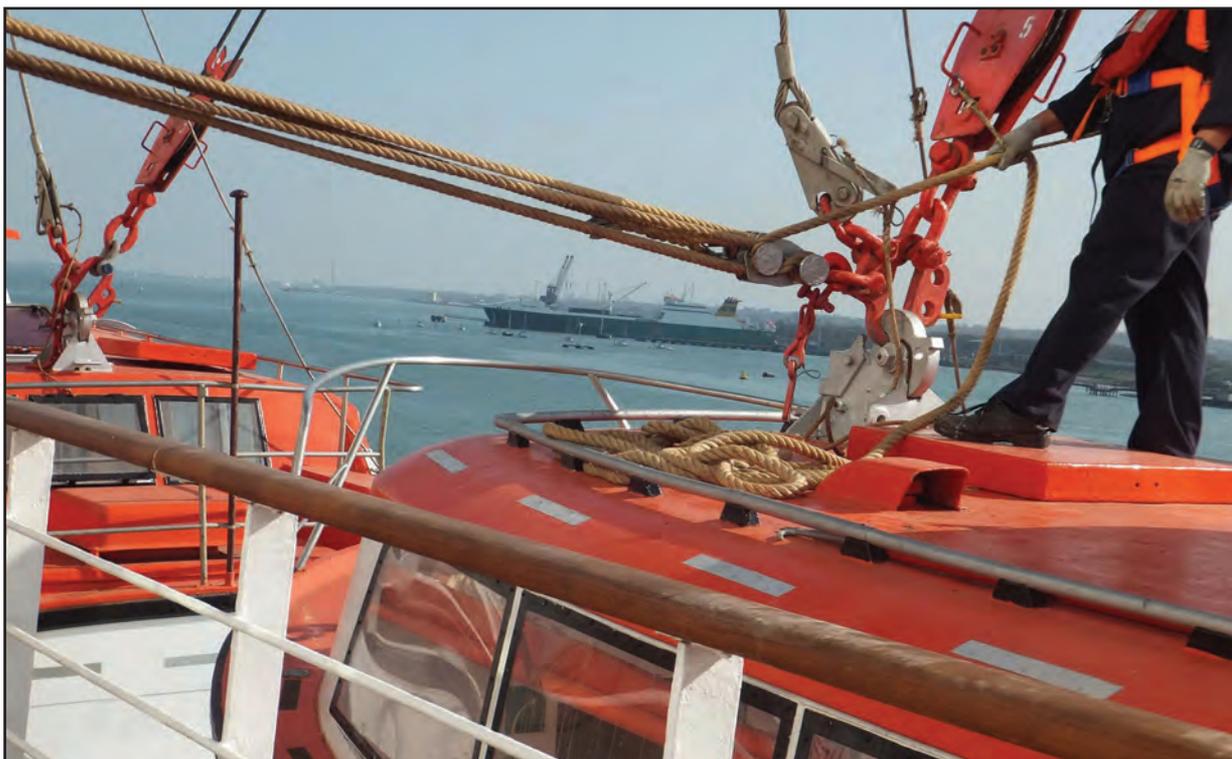
On the day of the inspection, a drill was initiated. As the fire teams prepared to tackle the fire, the lifeboat preparation teams mustered under the direction of the fourth officer. The teams wore lifejackets, safety helmets and safety shoes, but none of them wore a safety harness and tether. The starboard side open lifeboats and tenders were lowered, under gravity, and were automatically brought alongside the embarkation deck by their tricing pennants. The bousing tackles were then rigged by crew who were required to stand on the tenders' smooth coach roof, none of which had a non-skid finish applied (Figure 3) to improve traction.

Figure 3: Rigging bousing tackles

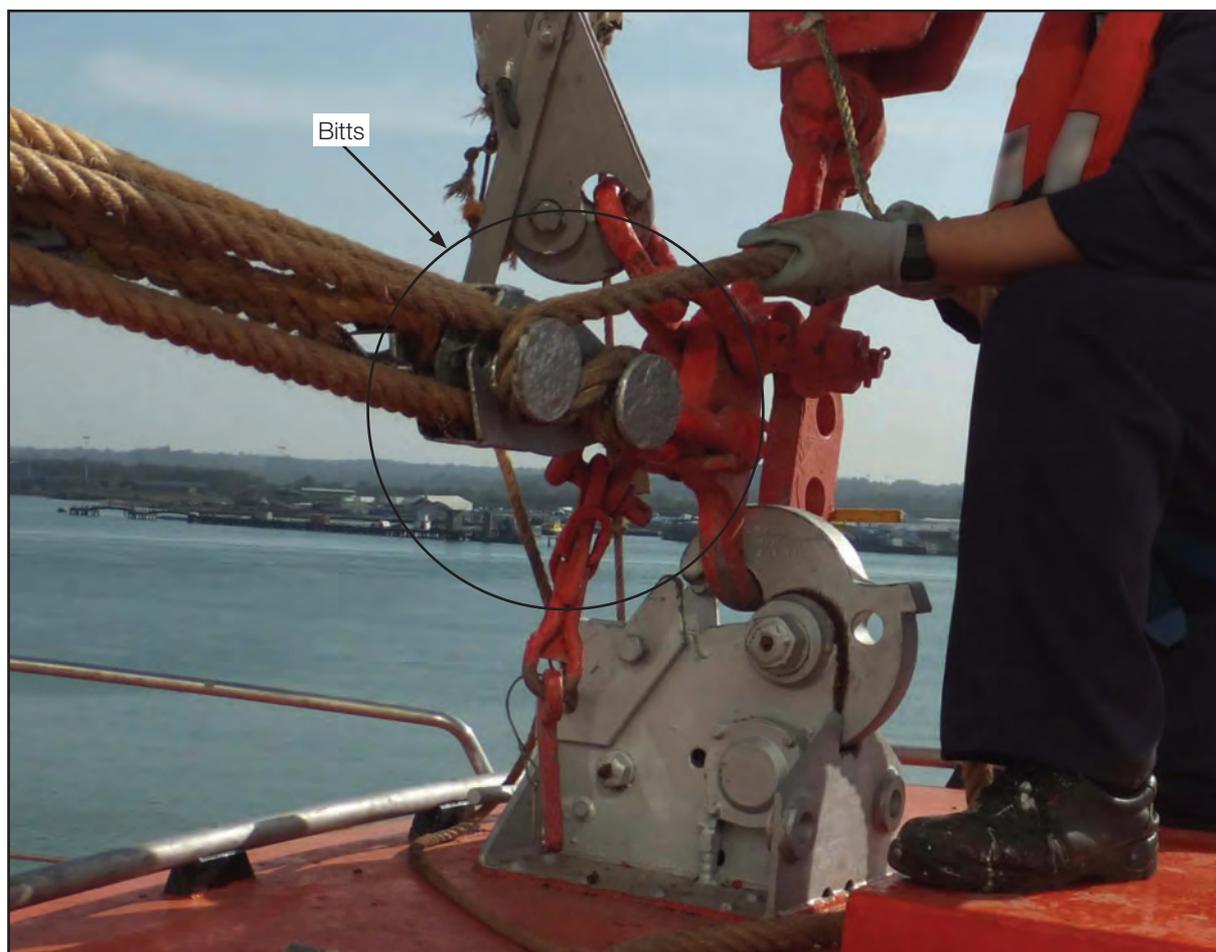
Figure 4: Bowsing rope turned up on the bits

However, this was the first time the first cook, who was the forward crewman of one of the tenders, had been to sea and, to make matters worse, he had received no specific practical training for his role. Consequently, he was unsure what was expected of him. With advice from the crew on the deck, the first cook tried to tension the bowsing tackle. He had great difficulty doing so because the manila rope was oversize and jammed in the throat of the bowsing tackle block. (The problem had been identified during the refit but the rope had not been changed for one of the correct size.) The first cook persevered and managed to take a turn around the securing bits attached to the bowsing tackle block (Figure 4). He could not take a further full turn around the bits because of the oversize diameter of the rope.

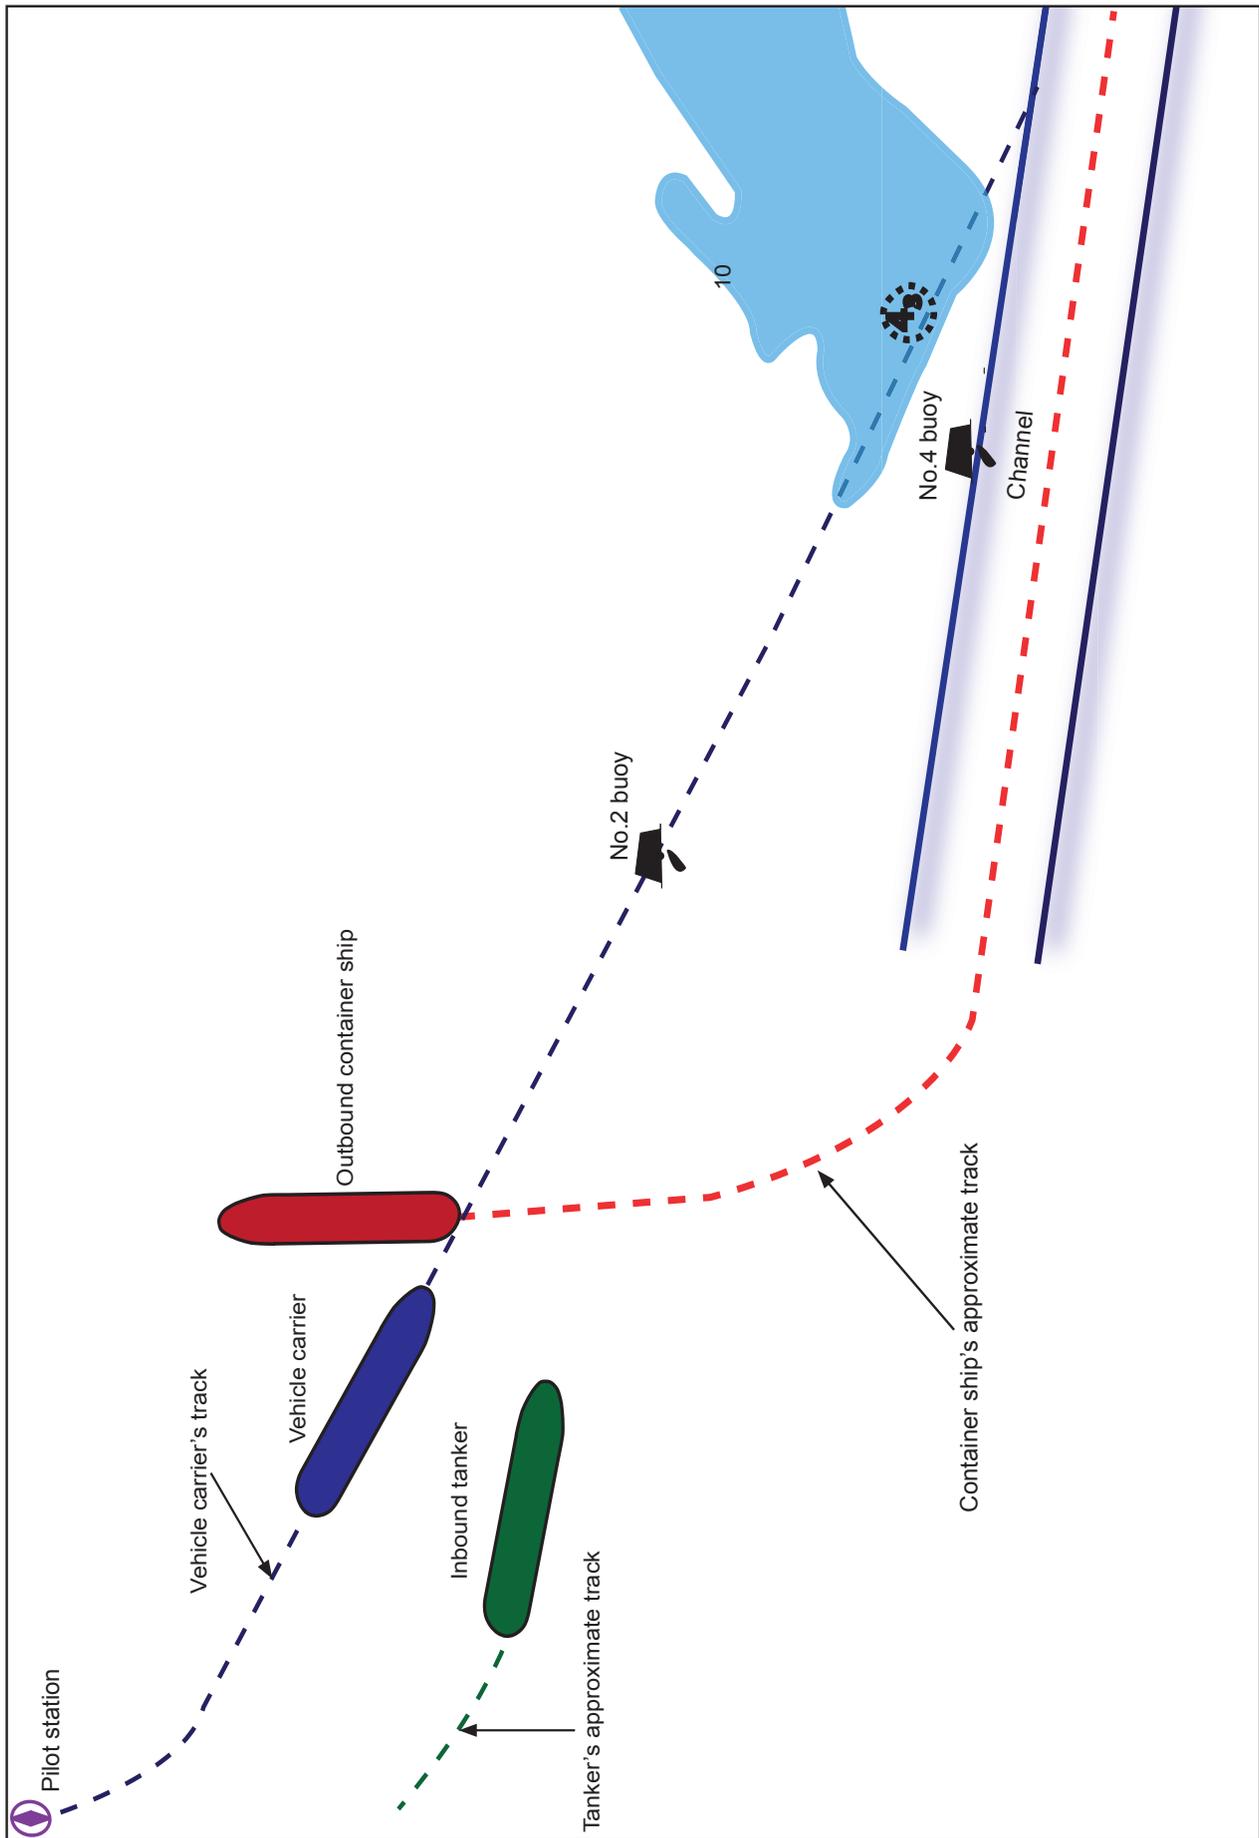
The new course took the vessel almost directly over No.2 buoy. The pilot began a series of course alterations to port as the vessel approached the channel, but remained outside it. He explained that he was keeping to the north of No.4 buoy to allow for the effect of the wind. This was acknowledged by the master, but the bridge team failed to notice the charted wreck and shallow water on the pilot's intended track.

As the vessel passed to the north of No.4 buoy, a loud scraping sound was heard, followed by a sharp reduction in speed and a reported 15-20 degree heel to starboard. The heel quickly corrected itself and, after rejoining the channel, the vessel continued to her berth without further incident.

Diagram showing track of vehicle carrier and other vessels

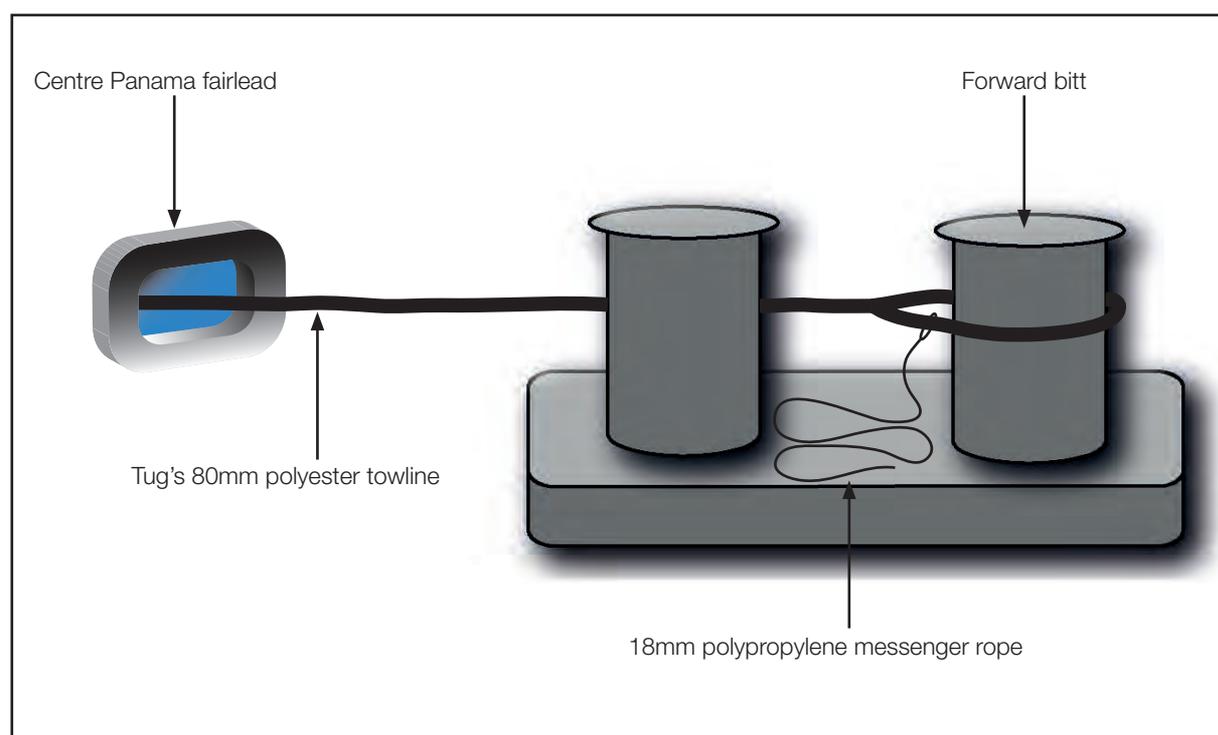
forward bitt and an 18mm polypropylene messenger rope, which was attached to the towline’s eye, was flaked down between the bitts (Figure 1).

Figure 1: Position of tug's towline and its messenger rope

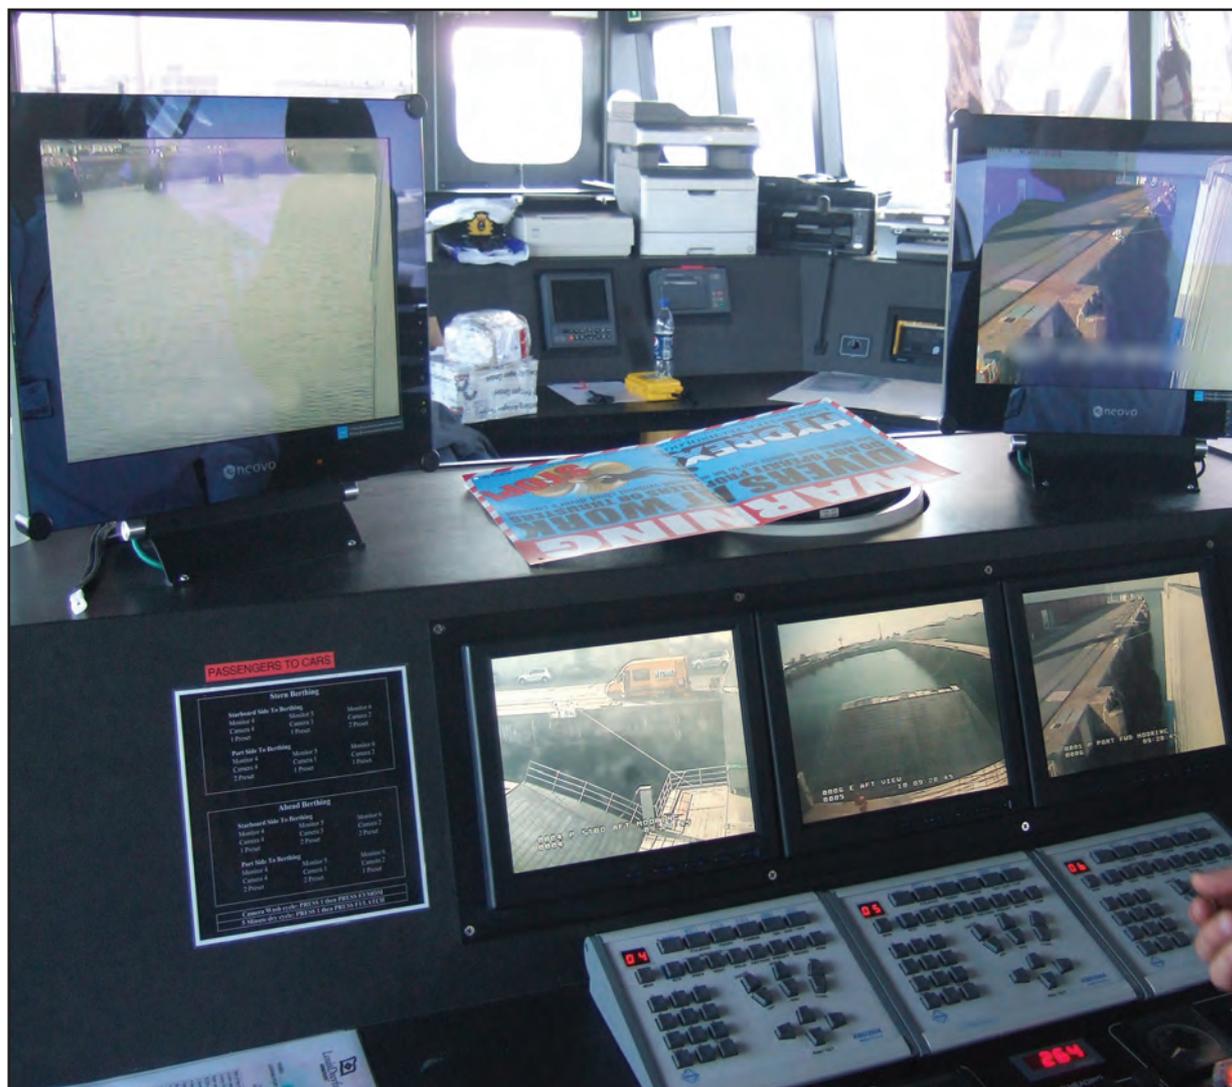
of the stern. Furthermore, when proceeding stern foremost, which was the vessel's normal berthing approach, the master had to turn around to observe key navigational displays, all of which dramatically reduced his situational awareness leading up to the accident.

Figure 1: Master's view aft, from the manoeuvring station

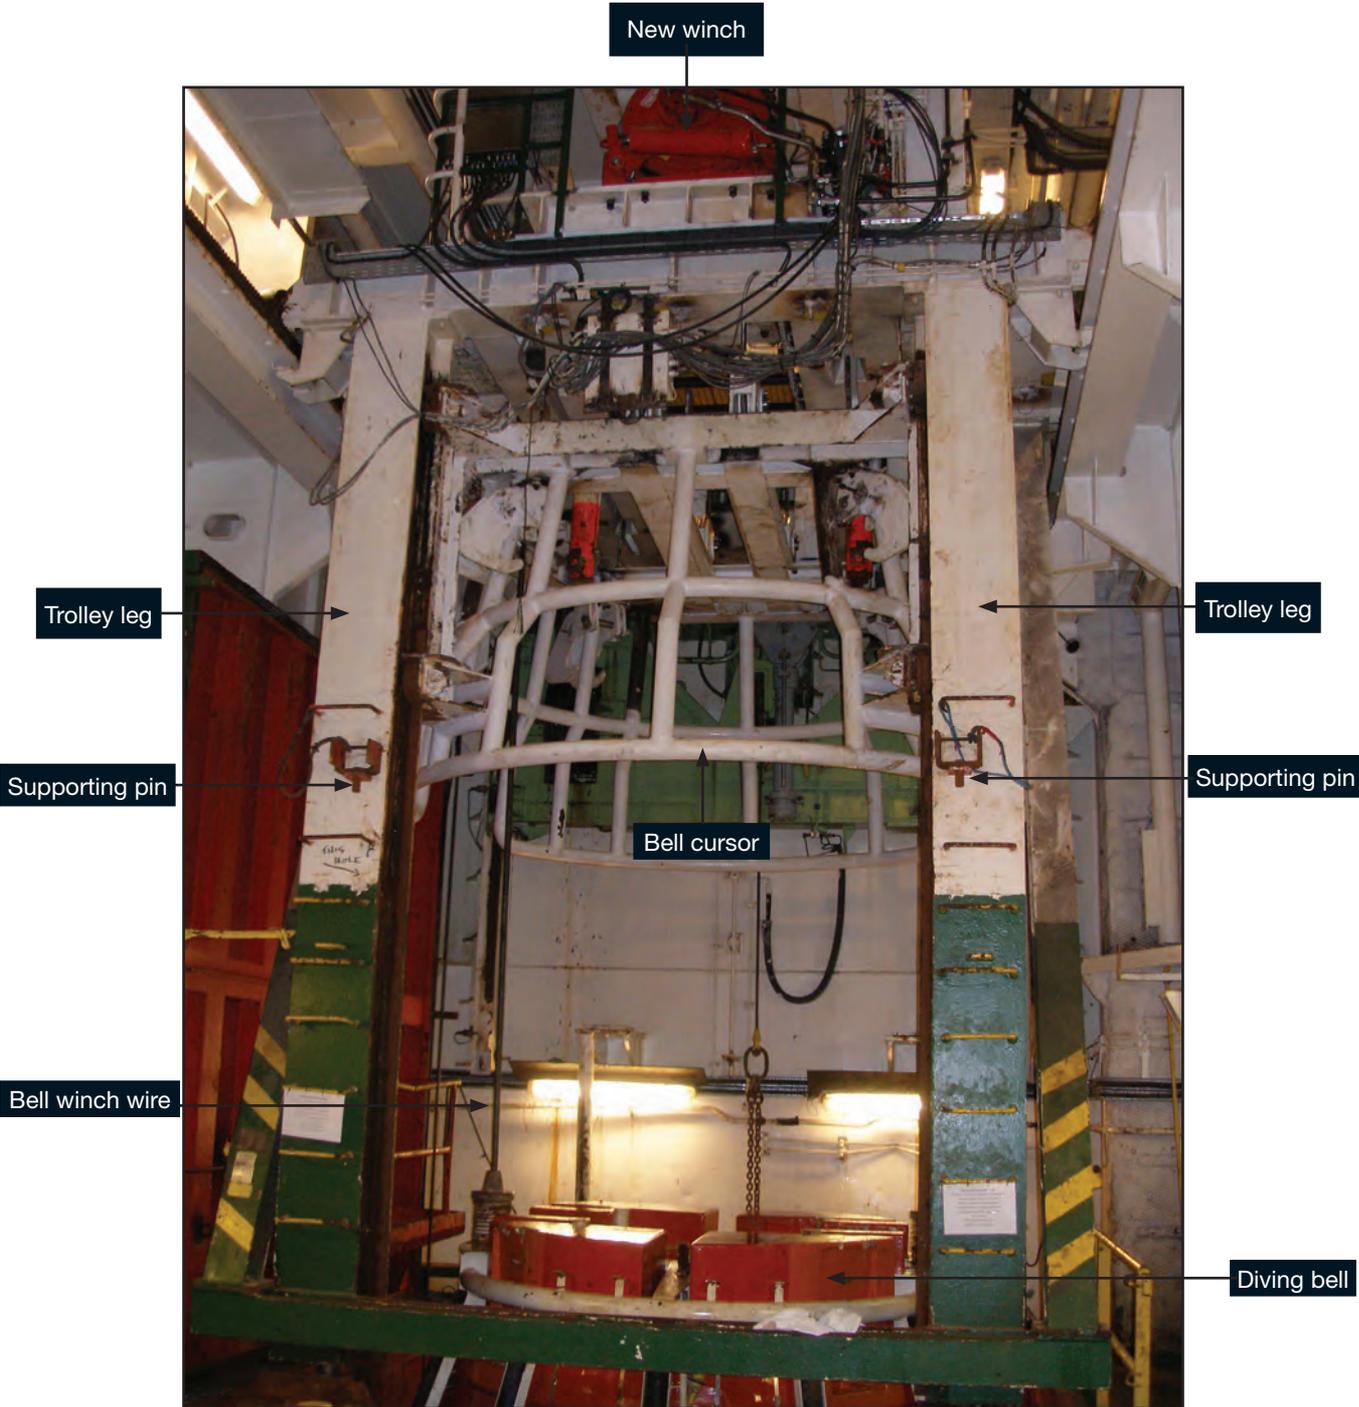
The cause of the winch failure was attributed to a faulty pilot valve in the cursor's winch control system, which prevented the winch brakes from applying once hydraulic power was removed.

Figure 1: Diving bell trolley and components

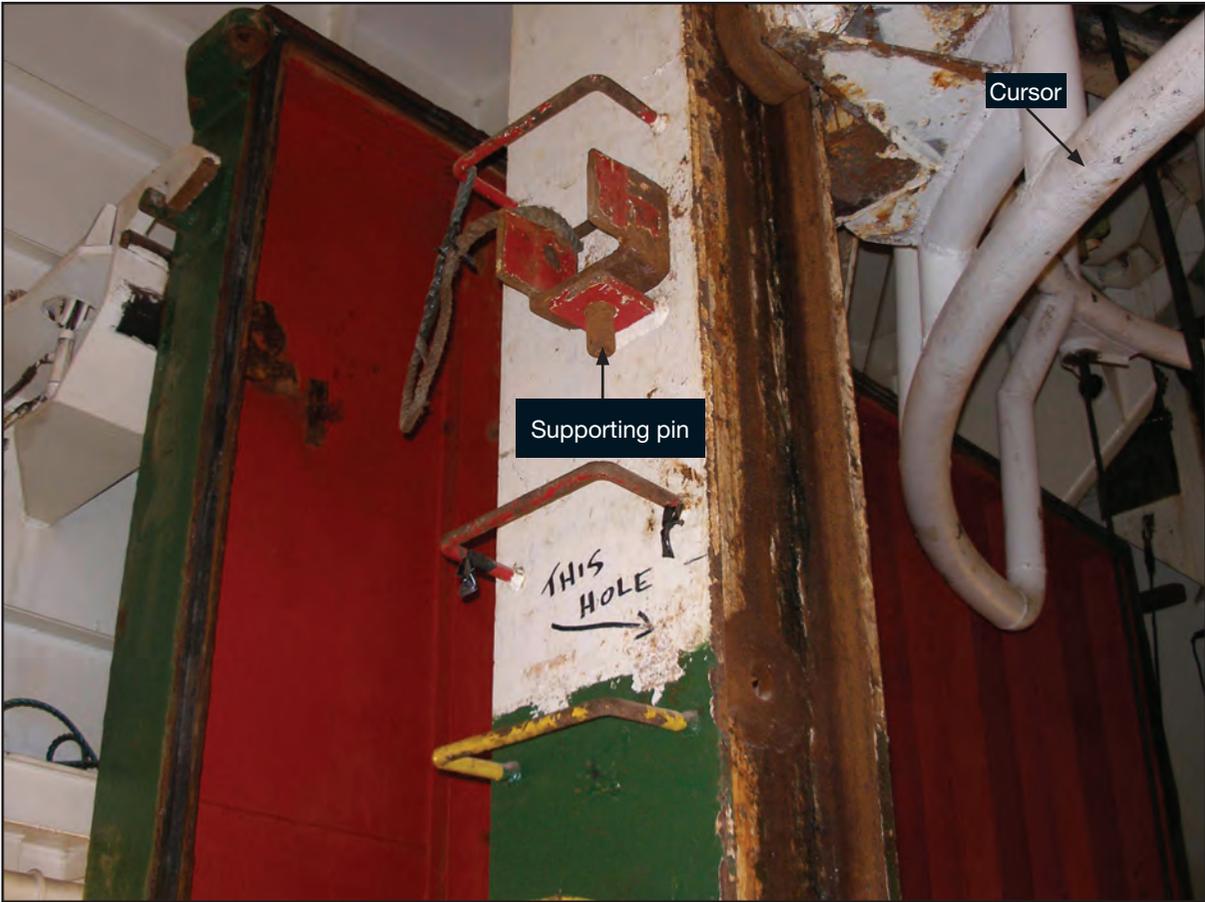
Figure 2: Bell trolley leg and cursor supporting pin (stowed position)

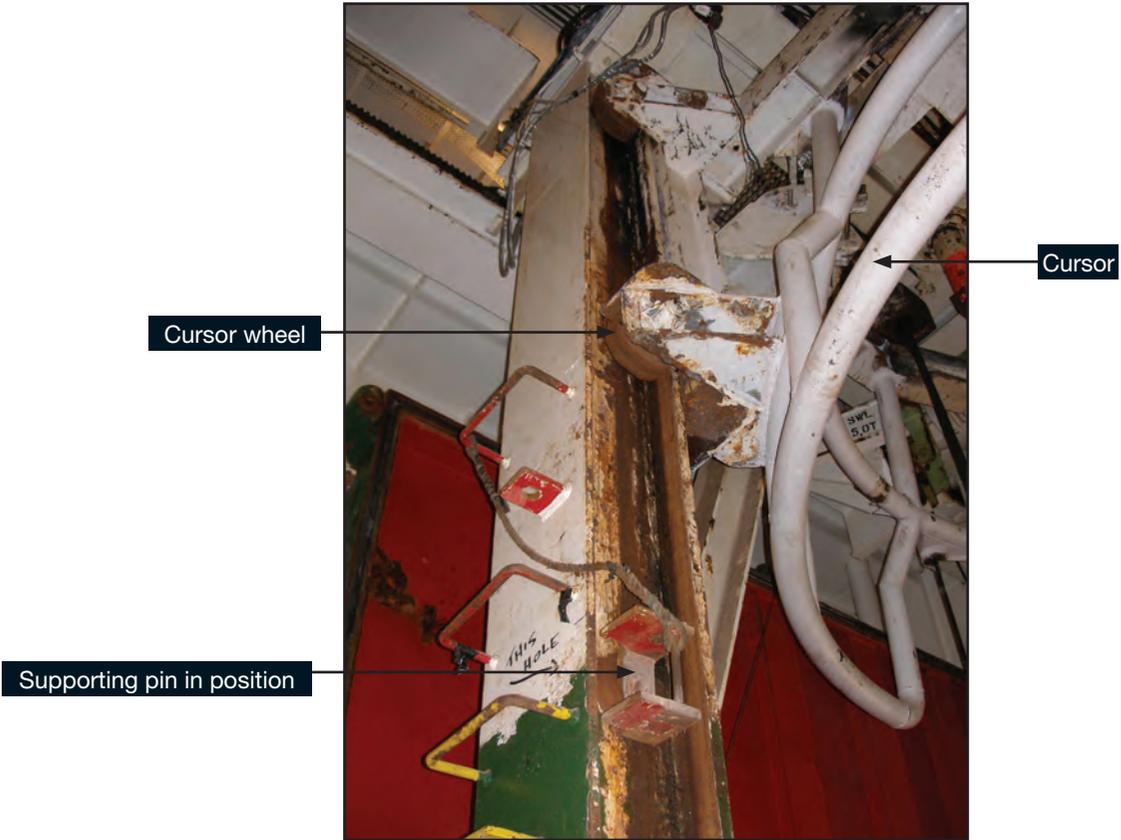
Figure 3: Bell trolley leg and cursor supporting pin in position below cursor wheels

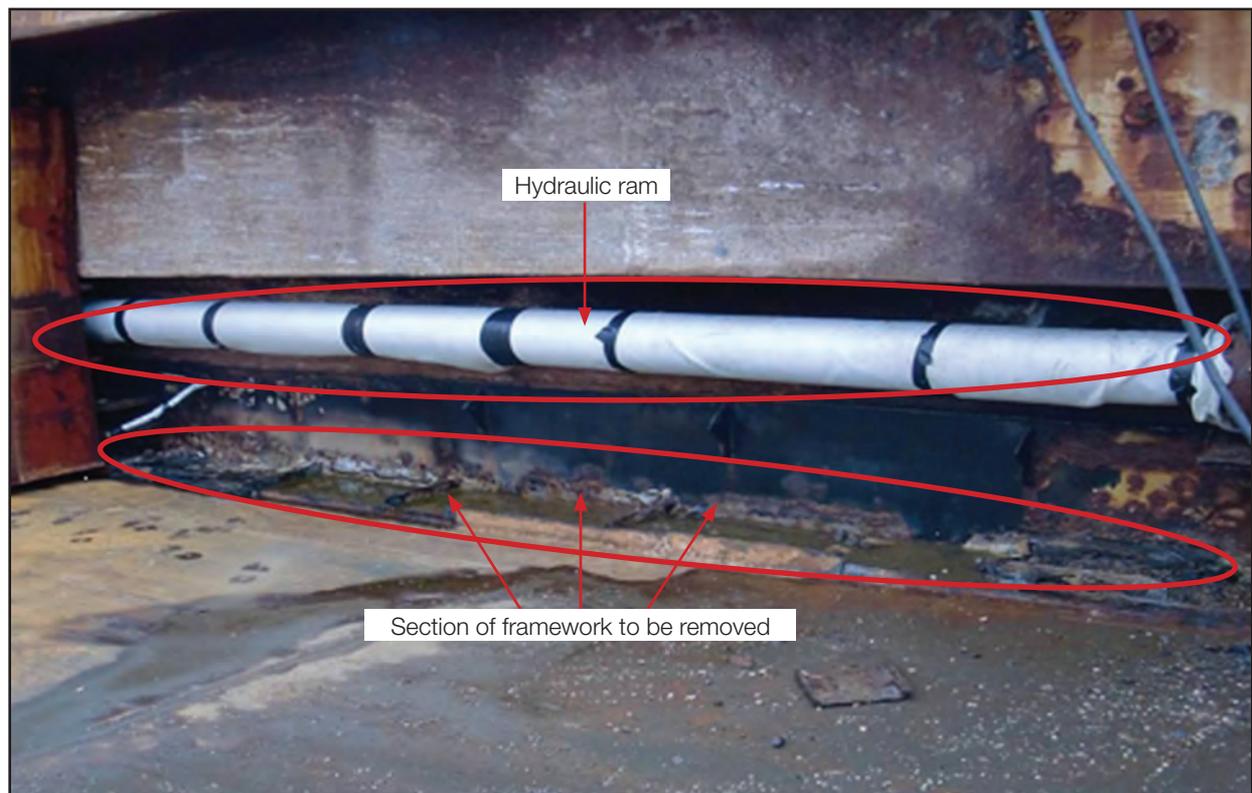
As the contractor set up the oxy-acetylene cutting gear, the chief officer instructed him to go ahead and start cutting off the framework from the main deck. However, neither the chief officer nor the contractor checked to see if a fire sentry was in place or if there were flammable materials in the spaces under the main deck.

Figure 1: Dumping door hydraulic ram and framework to be removed

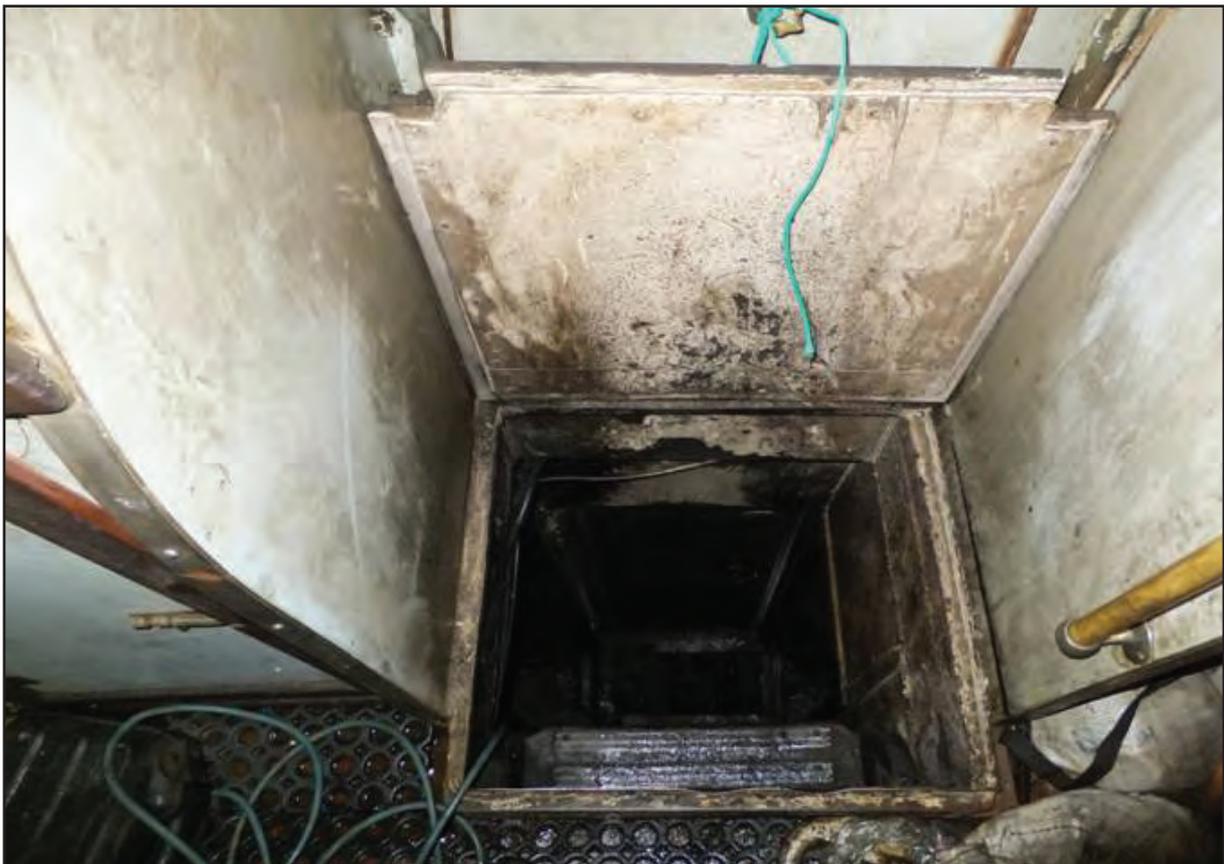
Until 1500 progress had been steady, but at about that time the engine room fire alarm sounded. The skipper had experienced a few previous spurious alarms. But this was different - the alarm would not reset. As the skipper went from the wheelhouse into the galley, to go down the vertical ladder (Figure 1) to the engine room lobby, he was joined by the mate. Once in the engine room, both of them noticed a pool of flames under the auxiliary engine. As it was a relatively small fire, the skipper opted to engage the main engine-driven deck-wash pump so that the crew could fill a bucket with water for him to douse the flames. This was despite a dry powder extinguisher (Figure 2) being immediately available in the engine room and a foam one being accessible in the adjacent accommodation space.

Figure 1: Access to engine room lobby

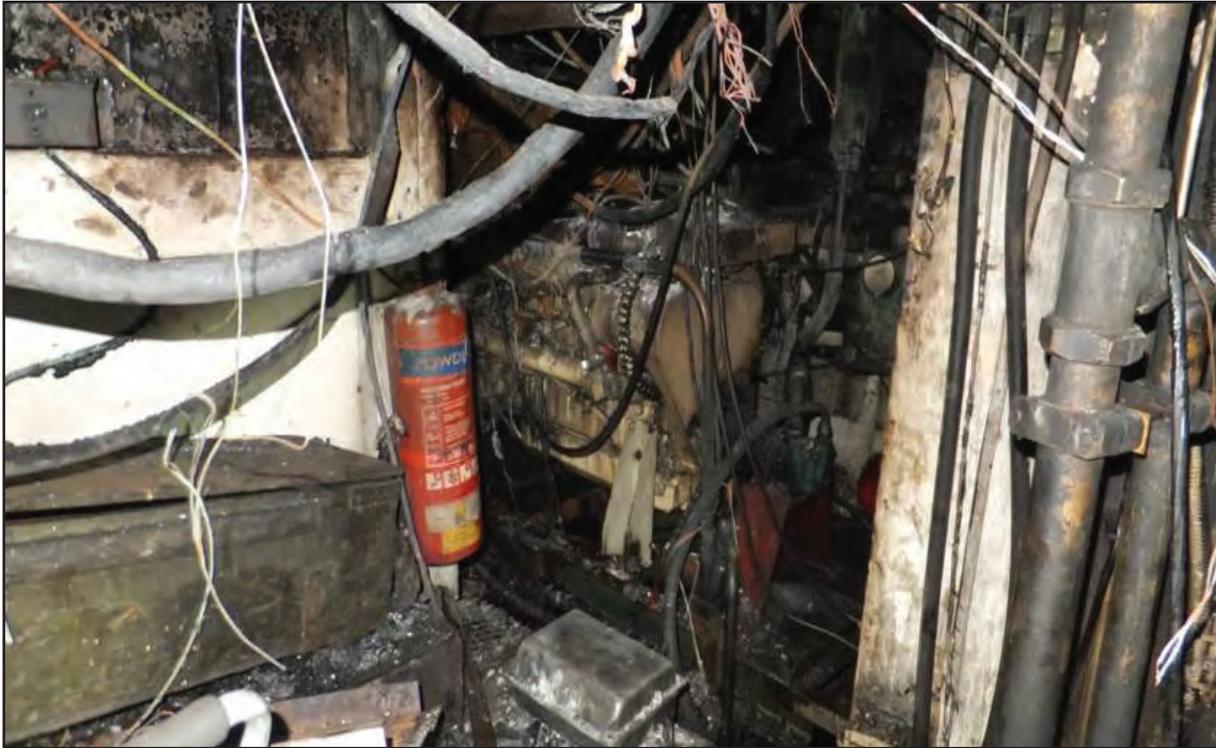
Figure 2: Auxiliary engine and dry powder extinguisher location

The bucket of water was thrown onto the flames, but this only broke them up into a number of smaller fires which then licked up the turn of bilge, outboard of the auxiliary engine. A second bucket of water was also unsuccessful and the fire intensified as though it was being fed from a liquid fuel source. The smoke density forced the skipper and mate from the engine room. The mate tried to close the engine room wooden door, but it was seized.

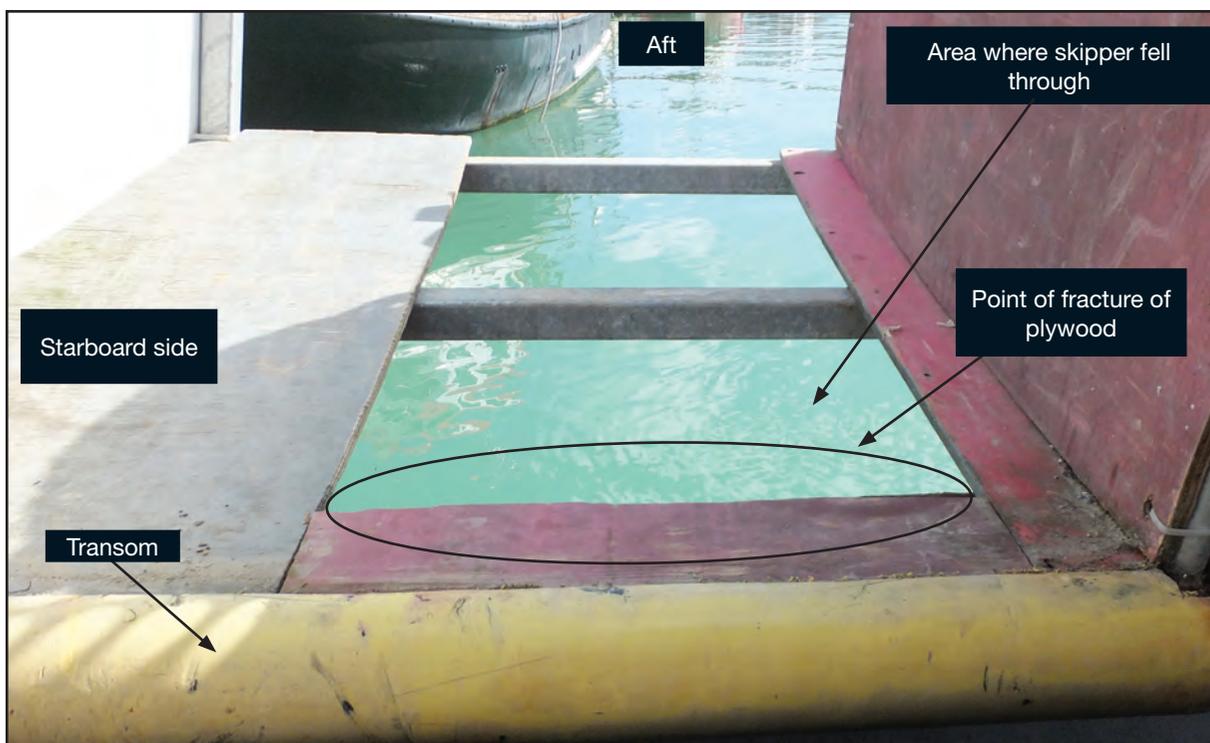
Having cleared the danger, he turned around and stepped forward. The plywood suddenly gave way and, just like a trap-door, opened up to the water below. The skipper fell straight through, fortunately managing to seize hold of a line attached to the net he had previously recovered.

Starboard side of 'cat catcher'

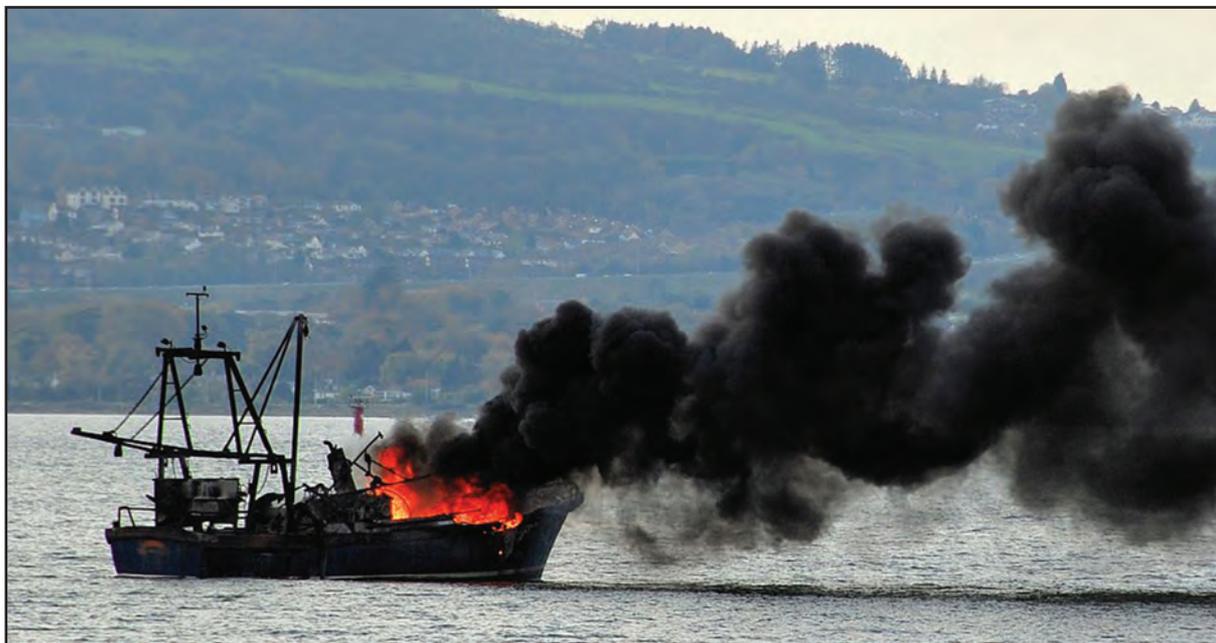
The vessel burned for several hours, and eventually sank while a harbour fire service vessel played water onto the flames.

Figure 1: Abandoned vessel

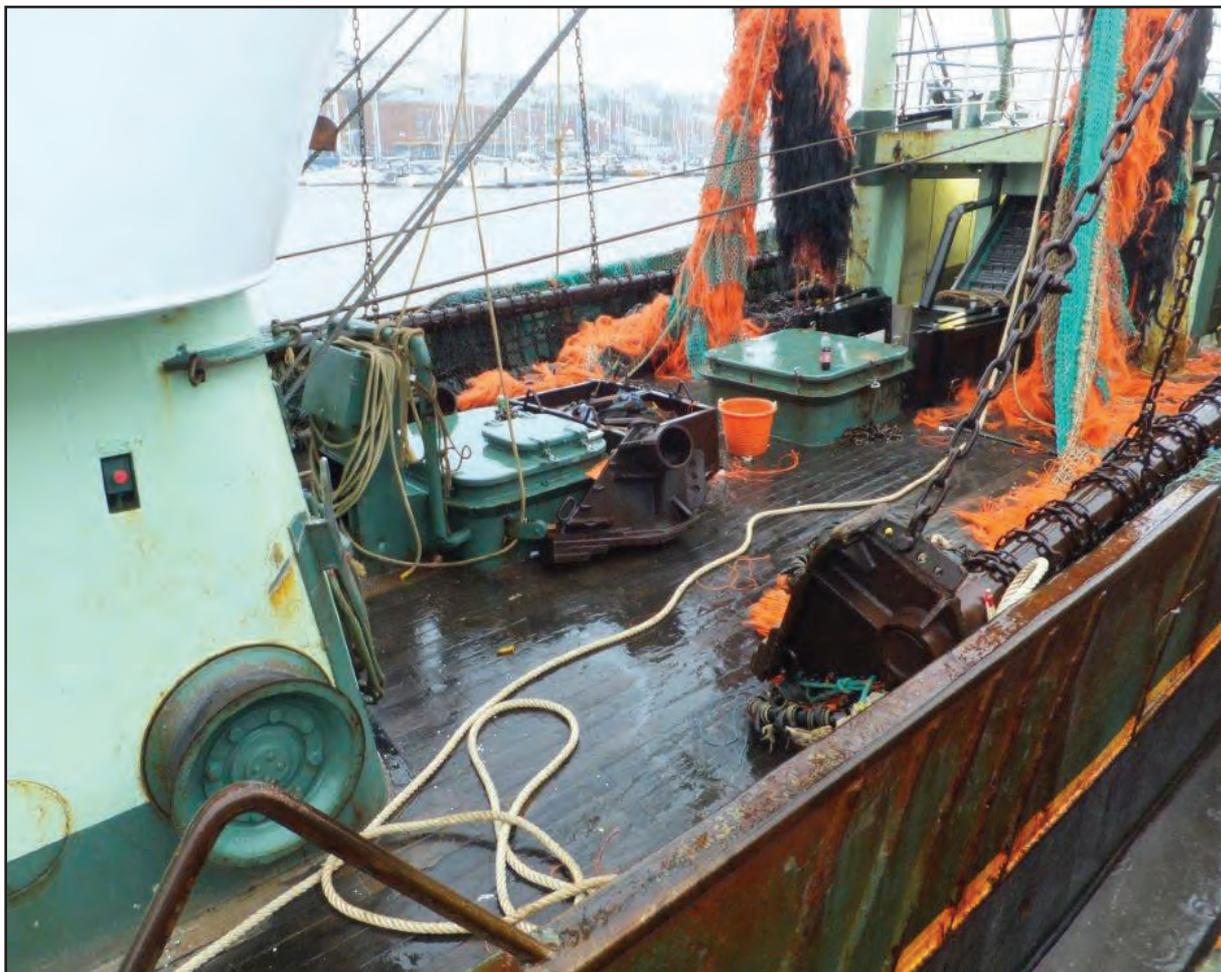
were too severe for the crew to work safely. In response, the skipper shouted to the crew to shelter in the accommodation. Two of the deckhands stowed their tools and made their way to the starboard side with the intention of climbing the aft stairs to the poop deck. However, as they reached the starboard side of the accommodation block, the vessel rolled heavily to starboard and the starboard side of the deck was swamped with water. One deckhand managed to grab a hand-hold (Figure 2) as he was lifted off his feet, but the second deckhand was washed overboard.

Figure 1: Foredeck

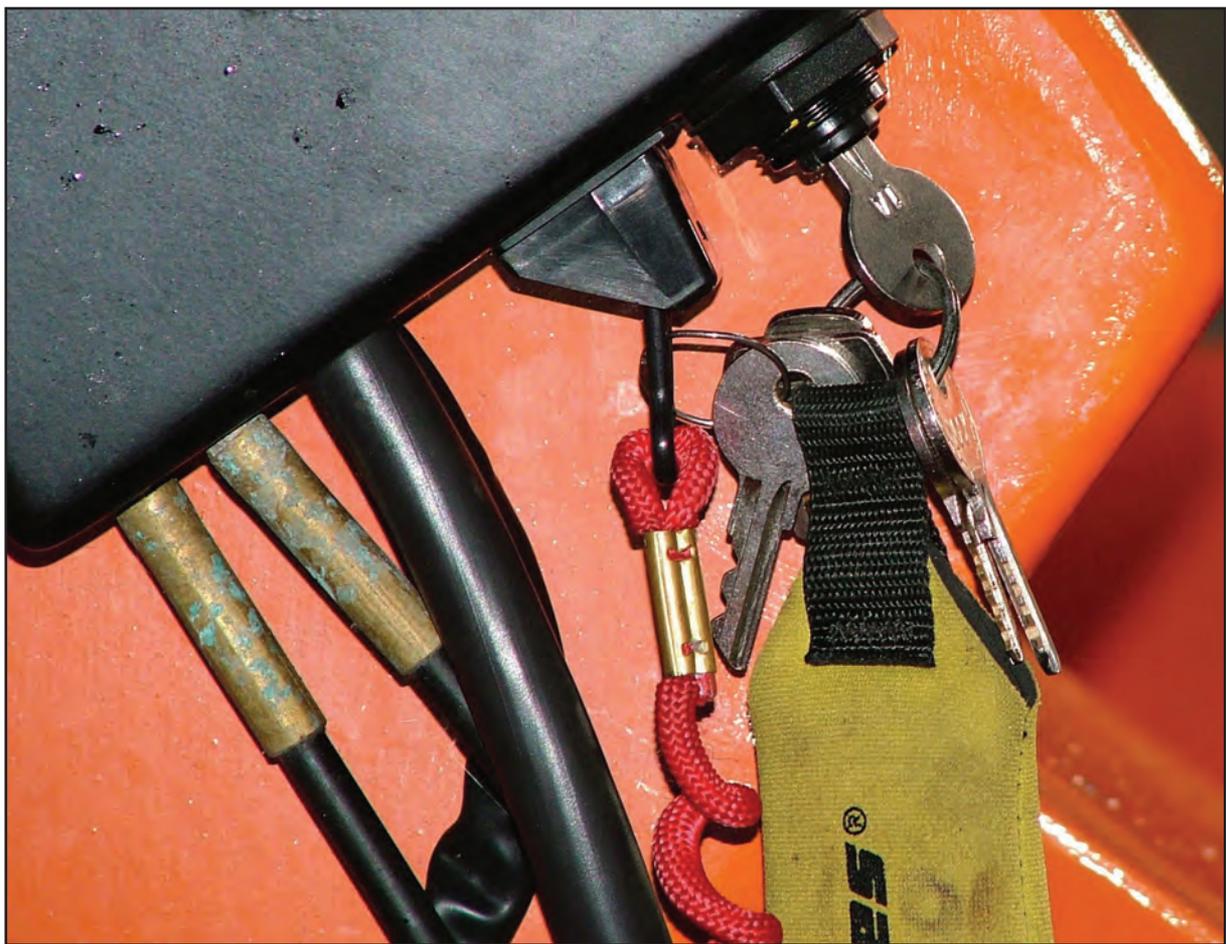
Figure 2: Kill cord toggle-type switch

been connected to the engine stop toggle switch, and fitted to one of those on board, the engine shutdown circuit would have operated as the person was thrown overboard.

All the indications suggest that this was an accident that occurred when wave jumping in a following sea. It is possible that the RIB stove into a wave, and if not already at full speed, the throttle might have been inadvertently shifted to the "full fuel" position, tipping both those on board into the sea. As the kill cord was not connected, the boat continued at high speed until it was snagged on the lobster pot lines.

1. Had the kill cord been used, the boat would have remained in the vicinity with its engine stopped, significantly improving the chances of survival. There are many configurations for fitting kill cords. Some operate a toggle type switch (Figure 2) and others hold off a spring-loaded engine circuit isolating switch. Whichever system you have, do check that your kill cord is free from abrasions and that the crimps securing the loops are tight. Always use the kill cord and make sure that it functions and that it is securely fitted to your body or to equipment that you are wearing. An example is at Figure 3.
