MARINE ACCIDENT
INVESTIGATION BRANCH

SAFETY DIGEST

Lessons from Marine
Accident Reports
1/2014

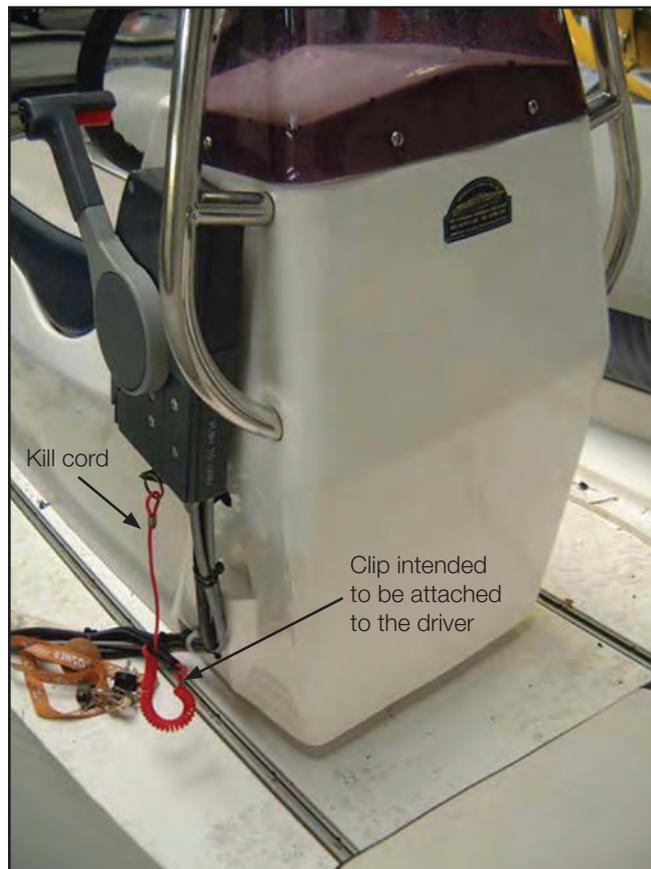
Figure 1: Photograph showing console and kill cord

boat, leaving the now unmanned RIB to circle in a clockwise direction, at a speed of between 10 knots and 15 knots. While circling, the RIB passed sufficiently close to the driver, who was assisting the injured passenger, for its propeller to rip his fleece top. None of the RIB's occupants were wearing buoyancy aids.

1. Had the kill cord fitted to the RIB been used, the injuries caused by the propeller would have been avoided. A RIB driver does not expect to be thrown from his or her boat, and therefore it is not difficult to see why some drivers might see the wearing of kill cords as unnecessary, or even as an insult to their ability. However, this accident shows that the unexpected does happen, and that people do get seriously injured as a consequence. It is common sense to use the kill cord; it is foolish not to.

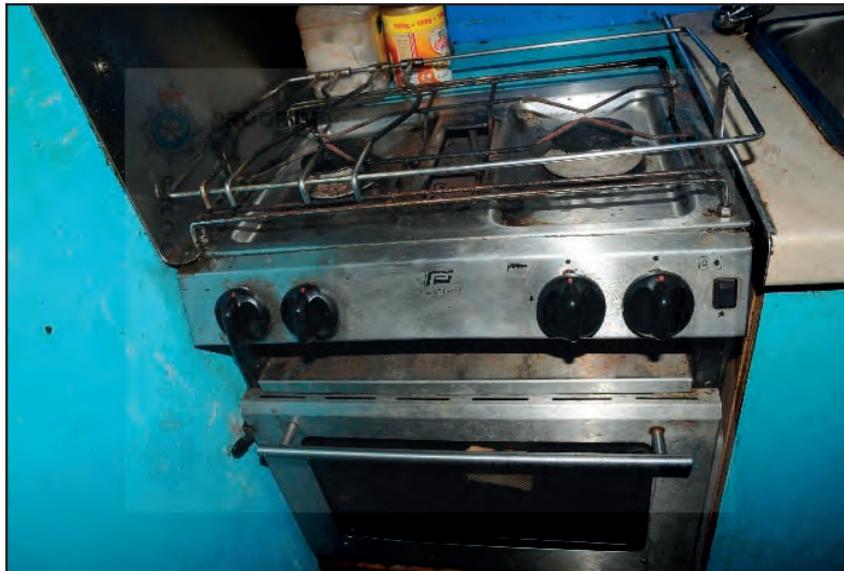
Figure 1

Before going to bed, the skipper (aged 26) and the crewman (aged 21) had lit the grill of a butane gas cooker fitted in the wheelhouse (**Figure 1**) in order to warm both the wheelhouse and the adjacent sleeping area. When they were not seen as expected the following morning, crewmen from fishing vessels tied up close by forced open the wheelhouse door. The gas grill was still lit (**Figure 2**) and the wheelhouse was full of fumes; the two men were dead in their bunks.

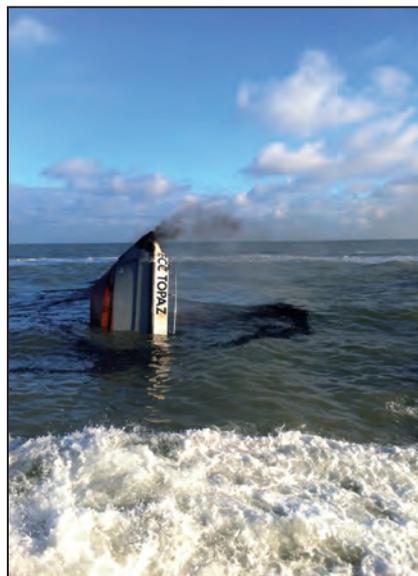
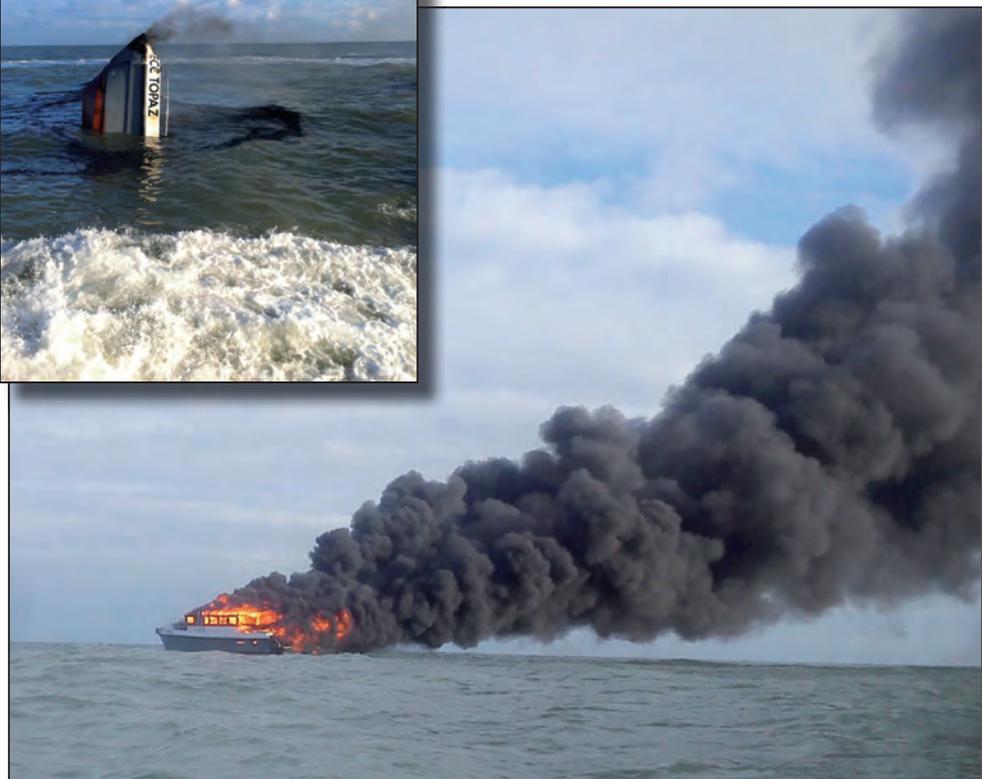
Figure 1: *ECC Topaz* on fire (inset: subsequent foundering)

There is compelling evidence to suggest the source of the fire was in way of an uninsulated section of the exhaust pipe from a diesel fired air heater that was situated in a compartment in the starboard hull, directly under the wheelhouse. A few days after the fire, the MAIB received information that crew on similar workboats had observed charring to the underside of main decks, where they were penetrated by the exhaust pipes from air heaters.

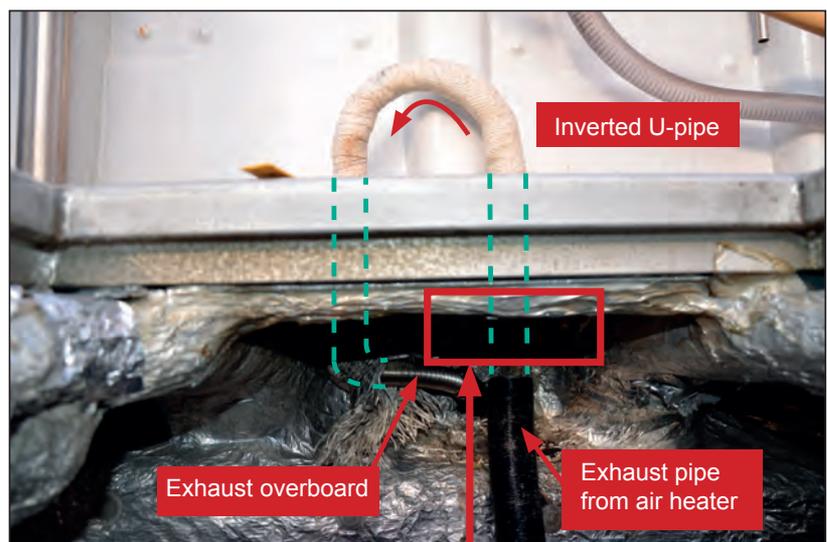
Detailed examination of one of these vessels revealed that the heater exhaust had been modified to route through a single walled, inverted U-pipe on the main deck (**Figure 2a**) to prevent sea water ingress from the exhaust overboard. As originally built, the exhaust pipe was insulated by woven glass lagging protected by an aluminium oversleeve (**Figure 3**) to prevent the hot exhaust gases (around 450°C) from heating the surrounding area. However, where the exhaust piping had been broken to route it through the main deck,

Figure 2a: Air heater exhaust pipe layout on similar vessel

the connection between the heater exhaust pipe and the inverted U-pipe was not insulated. Consequently, the uninsulated section of the hot exhaust pipe in close proximity to the plywood underside of the deck, caused the charring seen in **Figure 2b**.

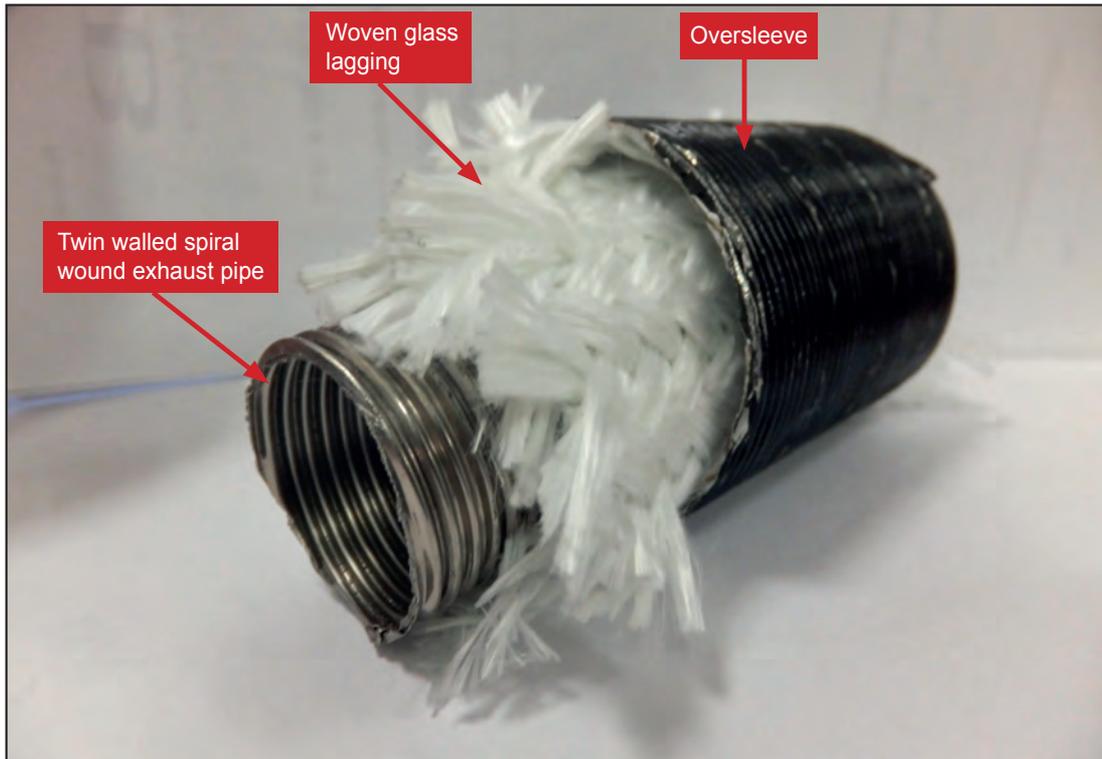
Figure 3: Heater manufacturer's supplied exhaust pipe with insulation
