MARINE ACCIDENT
INVESTIGATION BRANCH

SAFETY DIGEST

**Lessons from Marine
Accident Reports
1/2010**

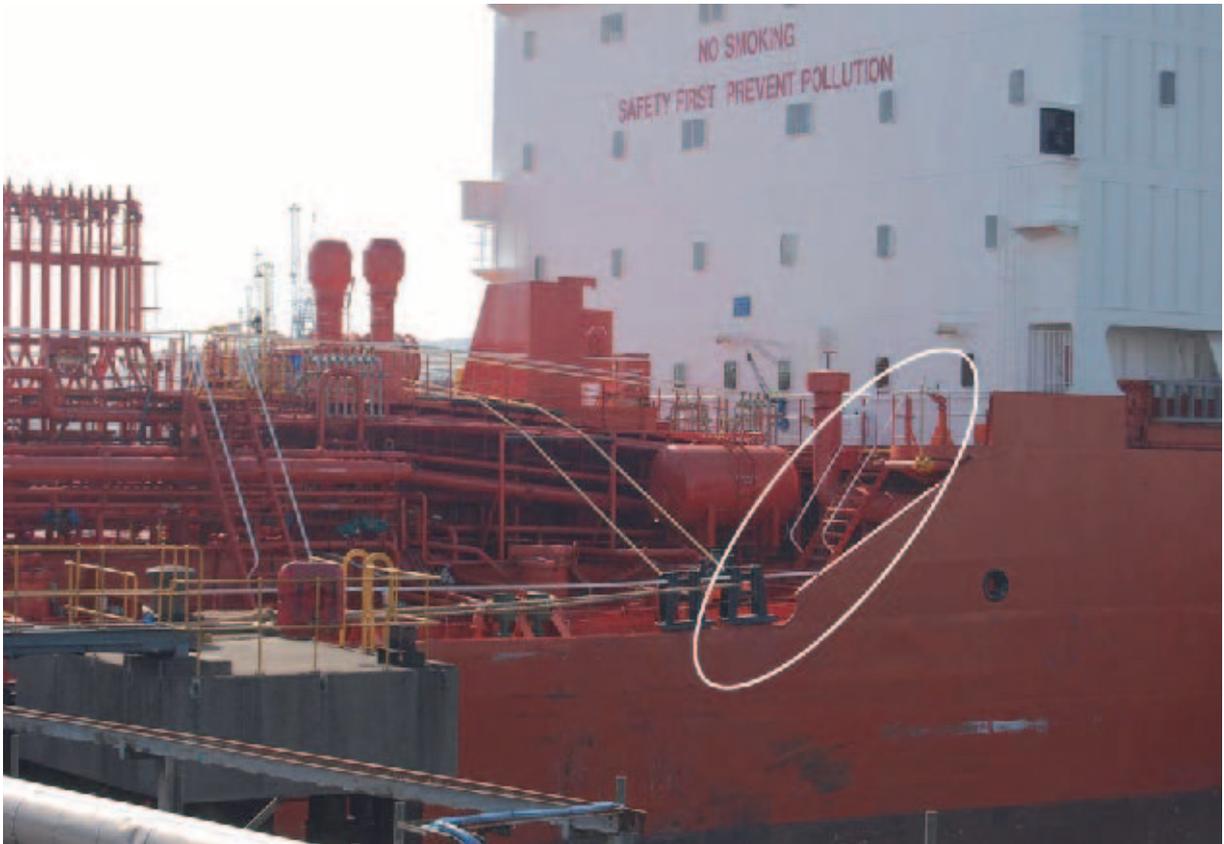
Figure 3: Port bulwark flair

Although part of the upper deck, the area around the hatch fell into the International Maritime Organization's definition of an enclosed space: there were limited openings, unfavourable natural ventilation and the area was not designed for continuous worker occupancy (Figure 2). The surrounding construction and the flair of the port bulwark (Figure 3) impeded air flows from dissipating cargo vapours. However, the crew did not recognize this, so there were no warning signs. Despite the strong pungent smell of the released vapours, the hazards were not investigated, so there was no direction on the use of BA. It is notable that the casualties exhibited the classic signs of H₂S/mercaptan inhalation.

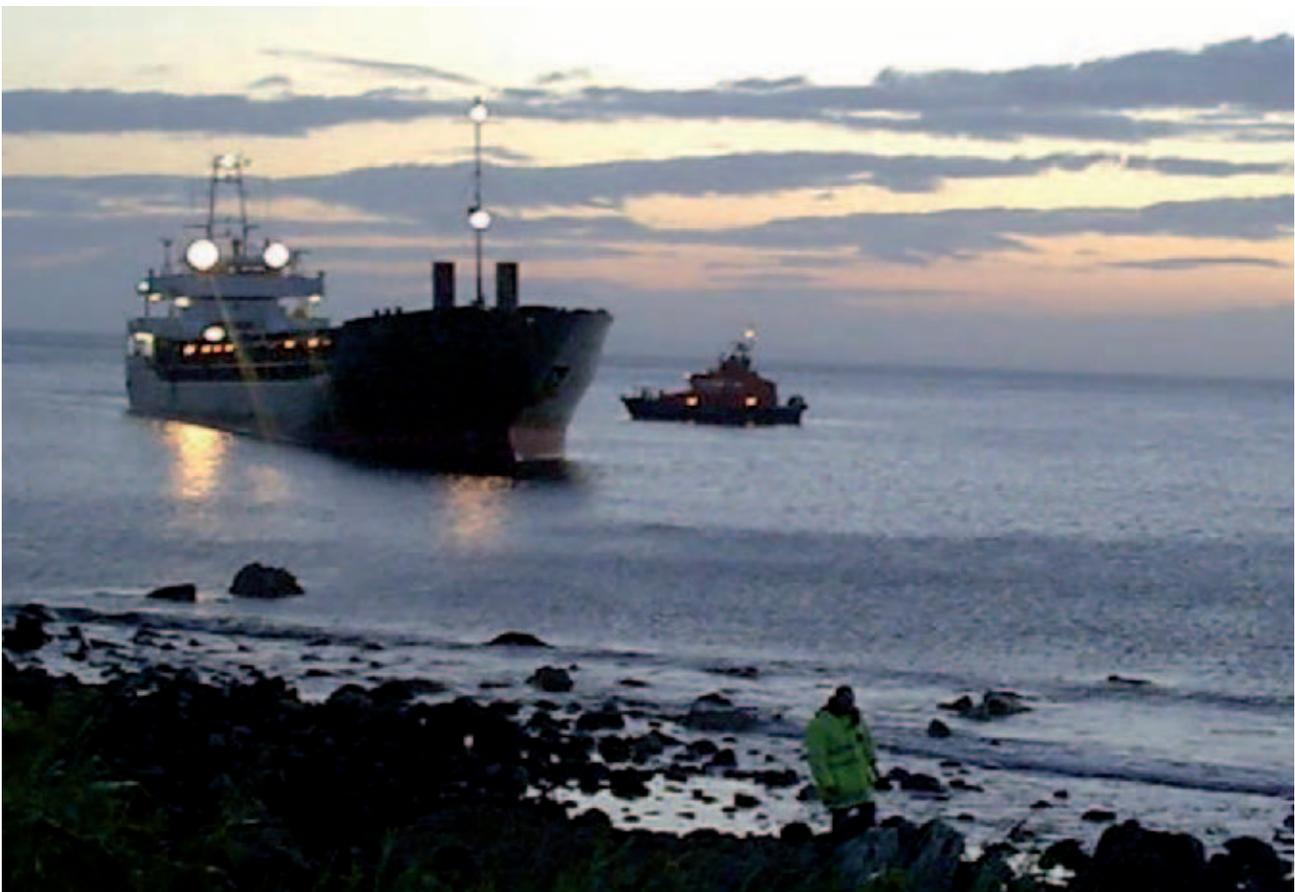
there was no pollution. However, the vessel's hull suffered indentation damage over 70% of her length, and she underwent 4 weeks of repairs which required 25 tonnes of new steelwork to be fitted before she was approved to resume service.

Figure 2: Vessel aground

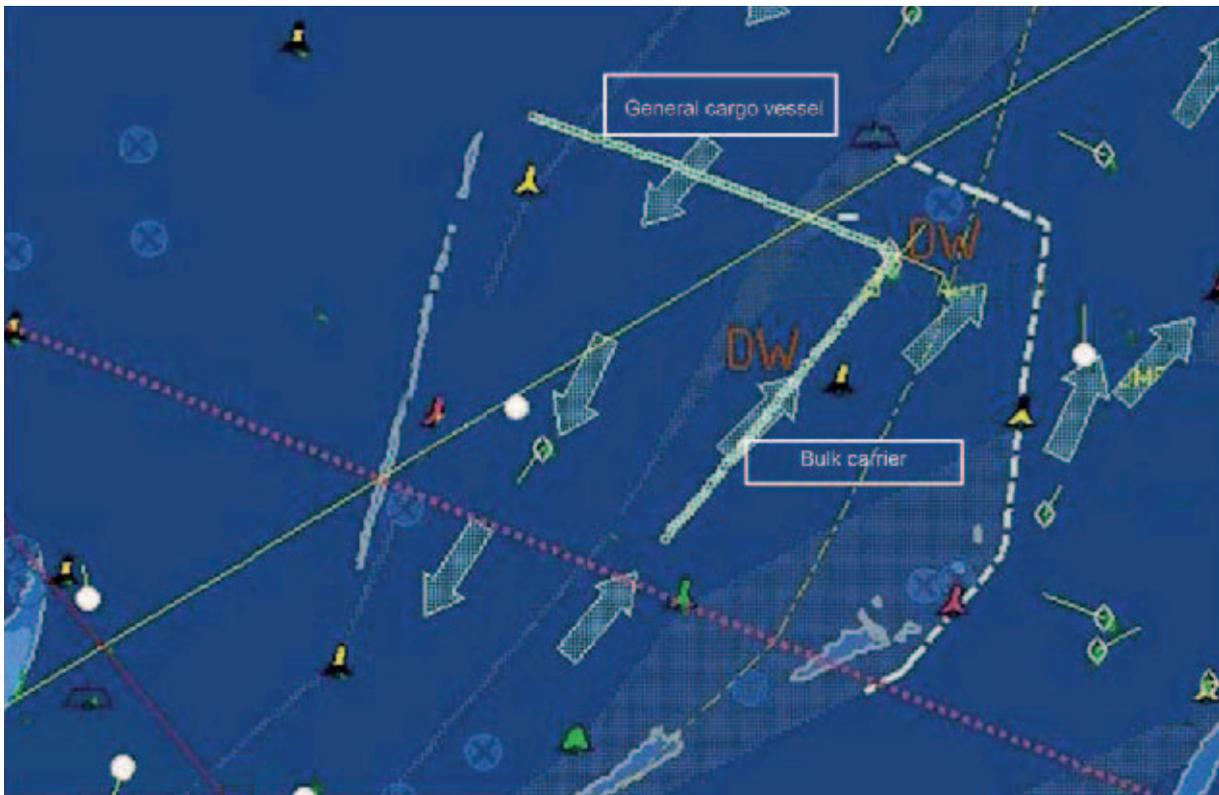
Figure 1: CNIS track showing the courses taken by the two vessels involved

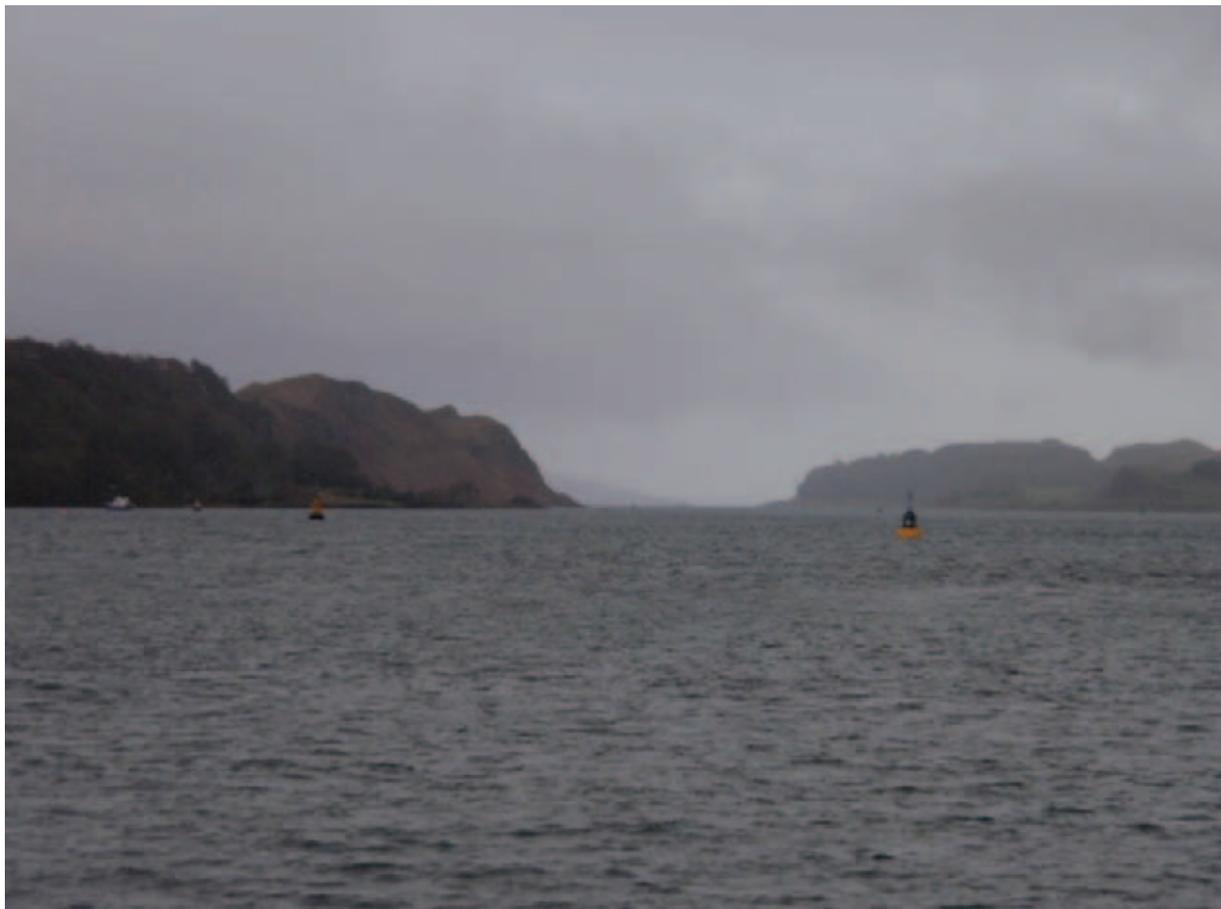
north and south cardinal marks (Figure 1). He then moved inside and to the front of the bridge, from where he intended to navigate the vessel.

Figure 1: The north and south cardinals

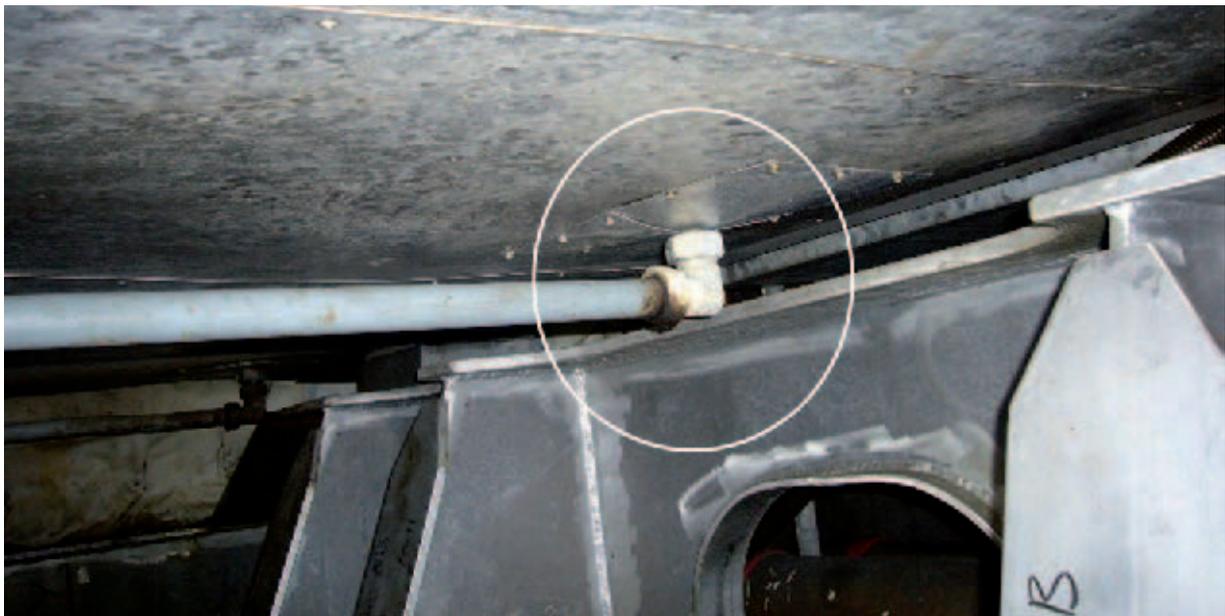
Figure 1: Module drain

On investigation it was found that the module power turbine channel plate recess had some oil residue in it because the module drain had been partially blocked by debris (Figure 1). A small amount of oil had been soaked up by the acoustic lining and turbine exhaust lagging, and had ignited. The ignition heat source was a hot gas leak from around the “plenum seal” (Figure 2). There was no damage except for a small scorch mark identifying the source of the gas leak, and some minor lagging damage (Figure 3).

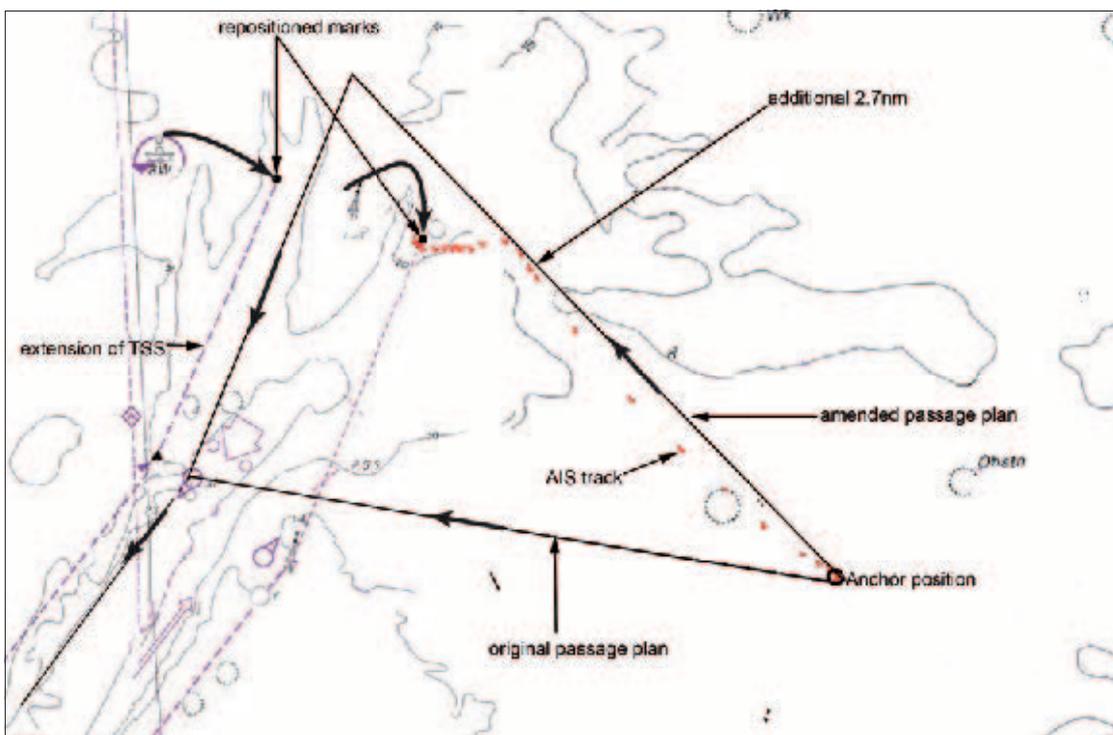
The master reduced speed to 6 knots and ordered the wheel to hard-a-port with the aim of conducting a stepped turn and then entering the inbound traffic lane earlier than planned. As the vessel was swinging to port, he reduced the helm order to port 10° and then engaged in a VHF radio conversation to arrange passing with an outbound vessel, while the second officer plotted a position on the chart. Having completed the conversation, the master realised that he had overshot his next planned course of 290°. He ordered hard-a-starboard and increased engine speed, but reduced both as soon as the bow started to swing to starboard. Under the influence of the strong tidal stream, and without the master fully appreciating the situation, the vessel continued to be set down onto the North Cardinal buoy marking the channel (Figure 1).

Figure 1: Passage plan showing amended route of vessel

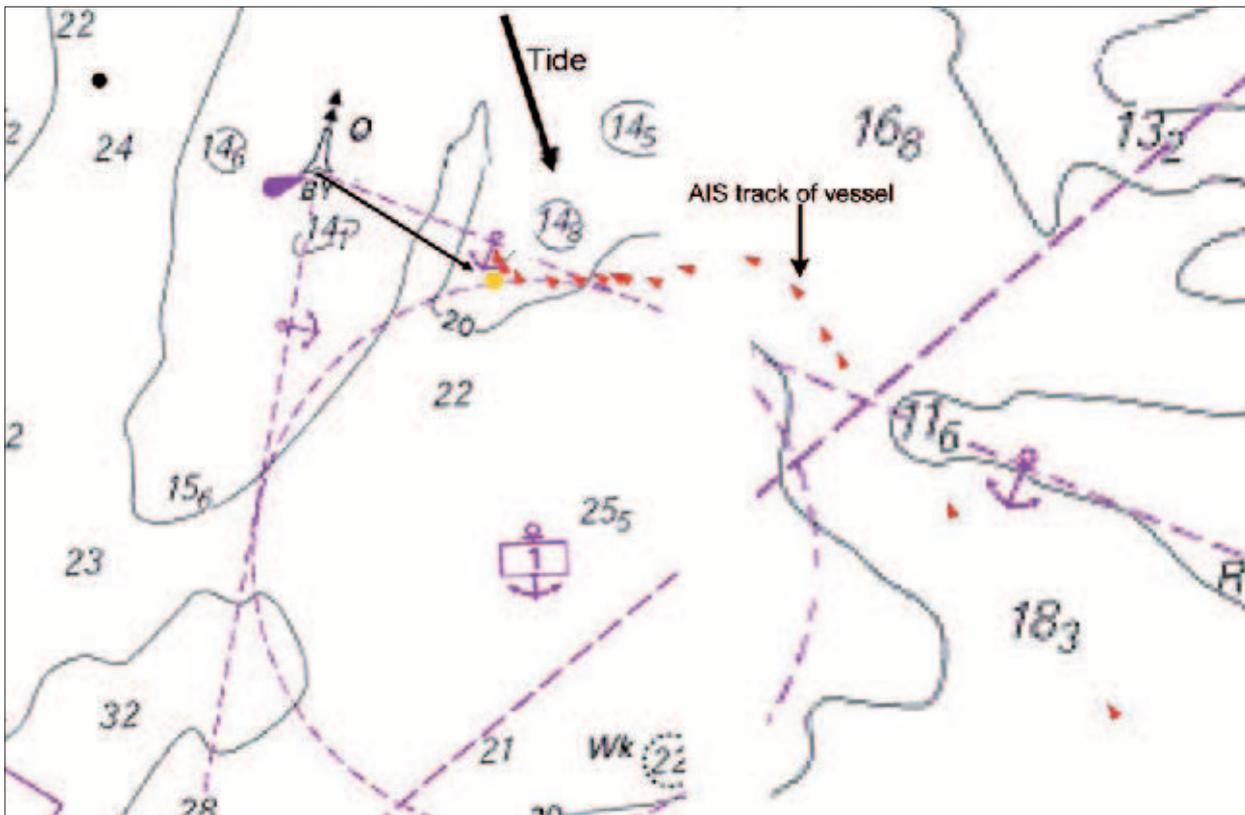
Figure 2: AIS track of vessel's route

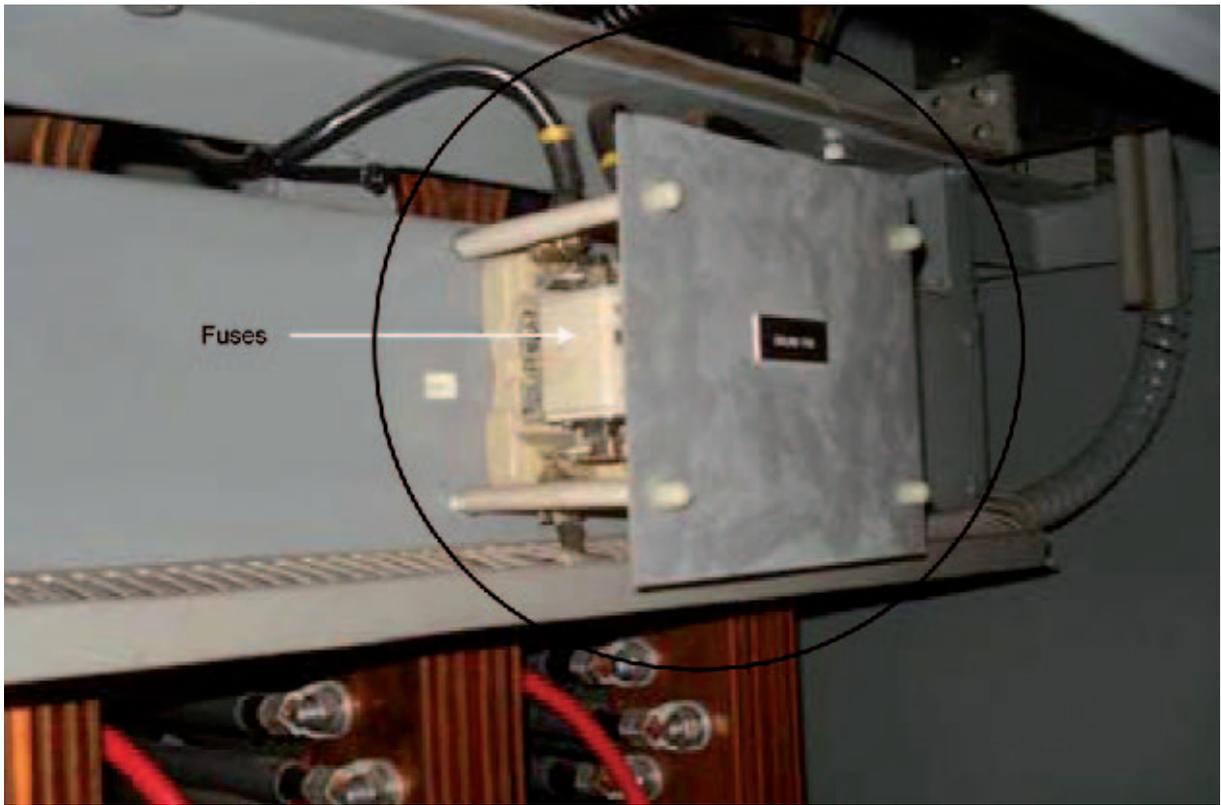
Figure 1: Supply fuse enclosure

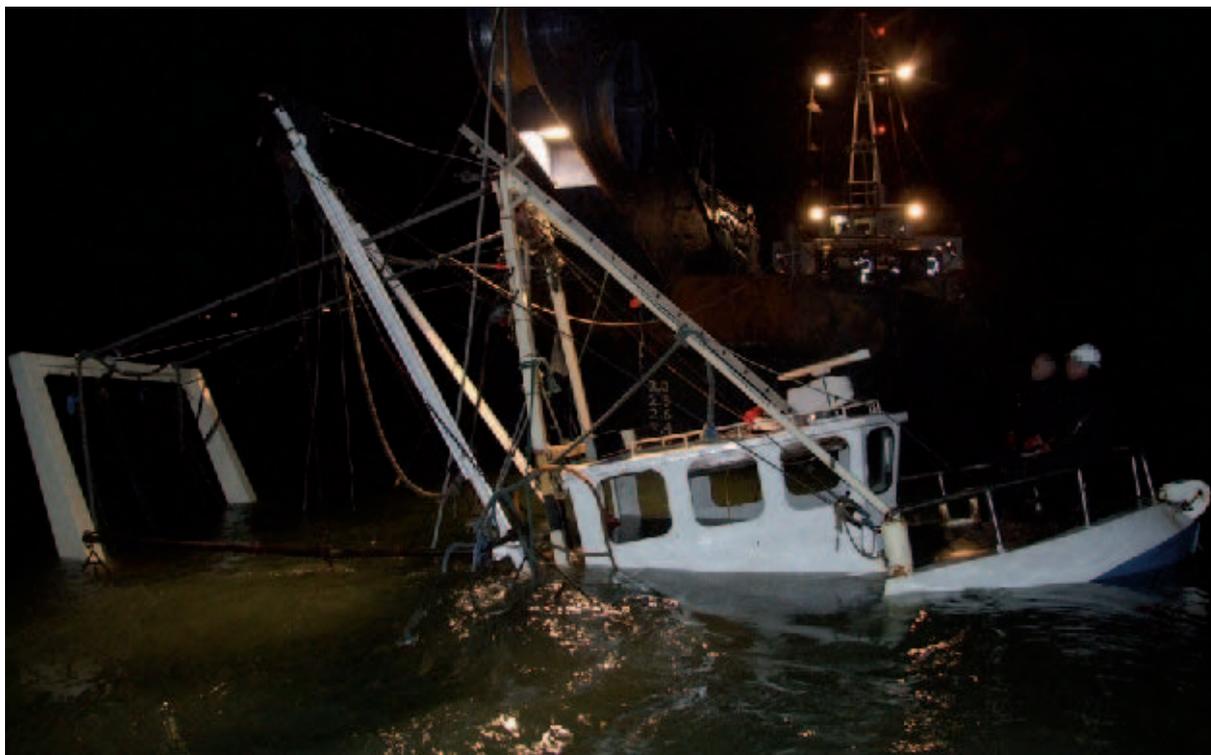
Subsequent examination of the vessel found that the hull was intact, with both of the deck hatches in place and with no obvious source of initial downflooding that might have contributed to the loss. The wheelhouse door was, however, missing and the displacement of some of the wheelhouse windows from their frames, along with the movement of other items on board, suggested that the vessel had most likely been overcome by the seas, and had capsized suddenly.

Figure 1: The fishing vessel being recovered

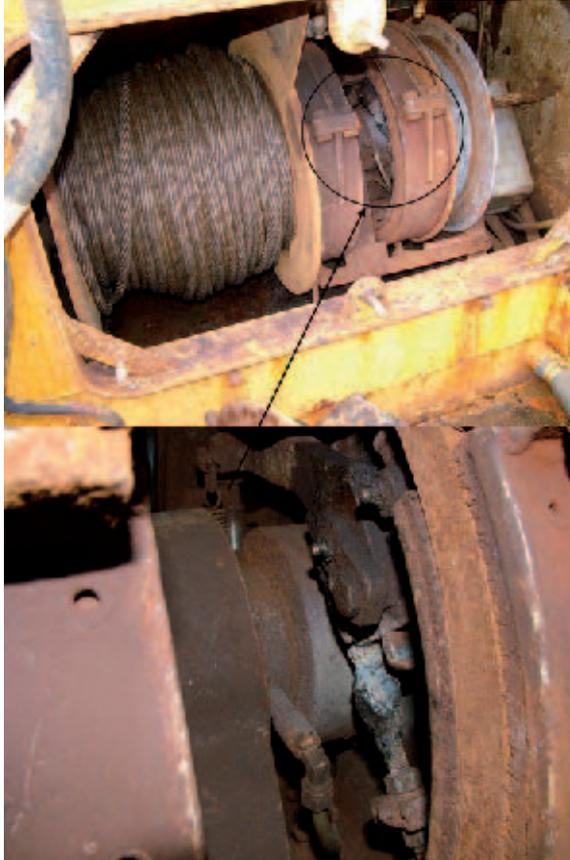
Figure 1: Close-up of auto tensioner

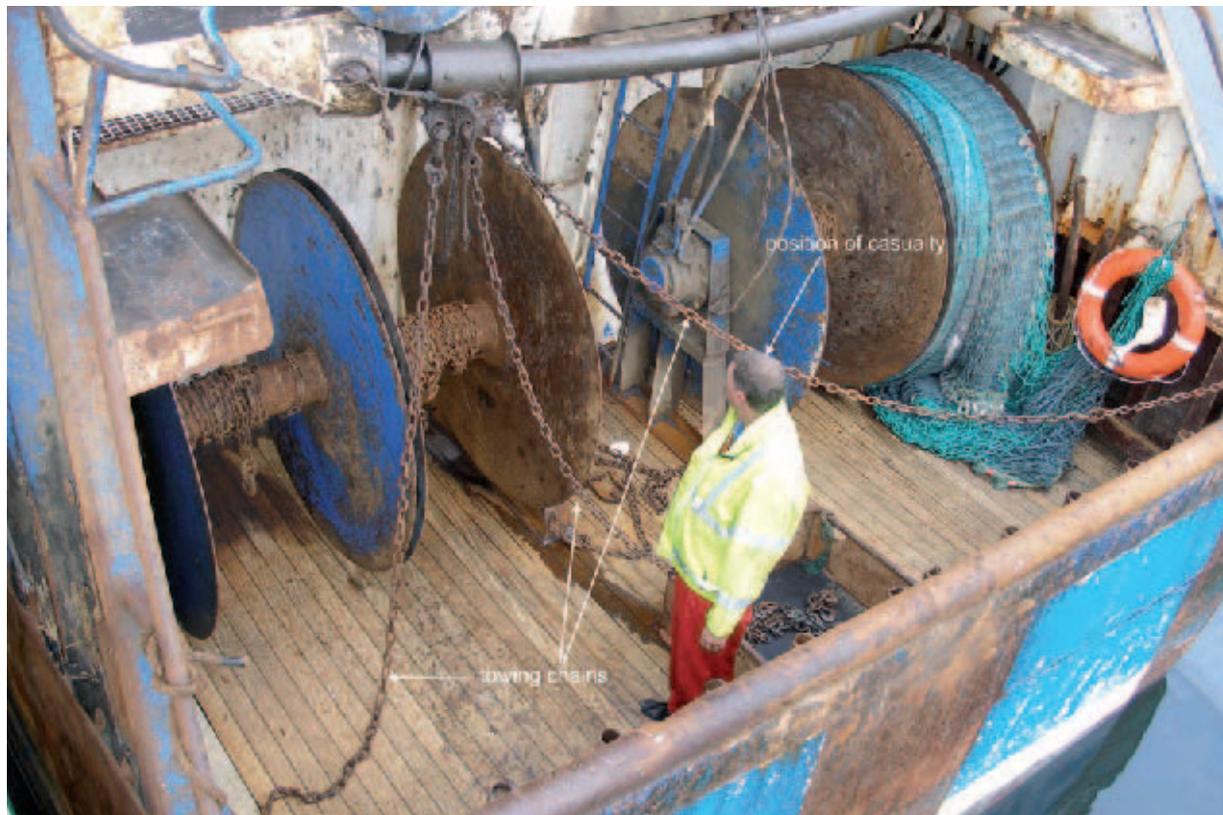
Demonstration of where the crewman was standing at the time of the incident

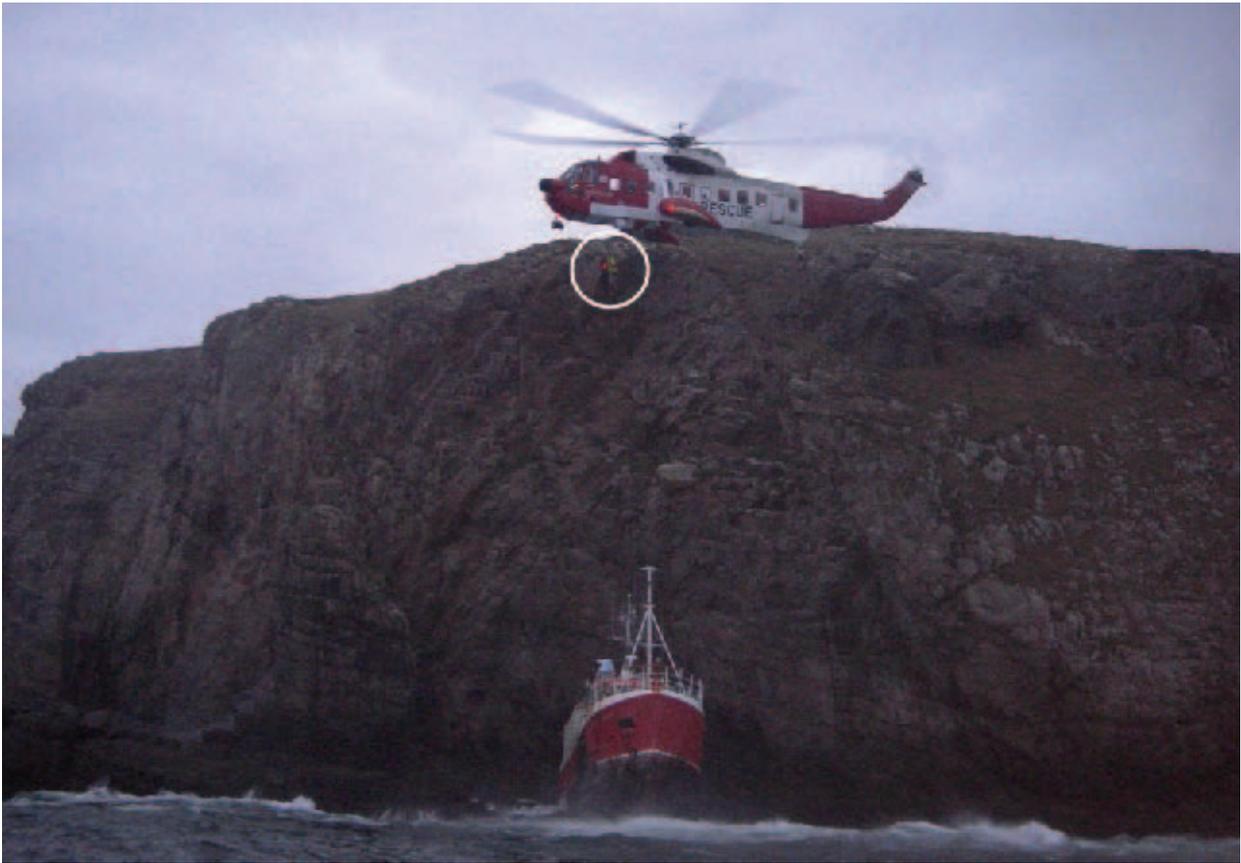
Figure 2: The crew being winched from the vessel by the coastguard

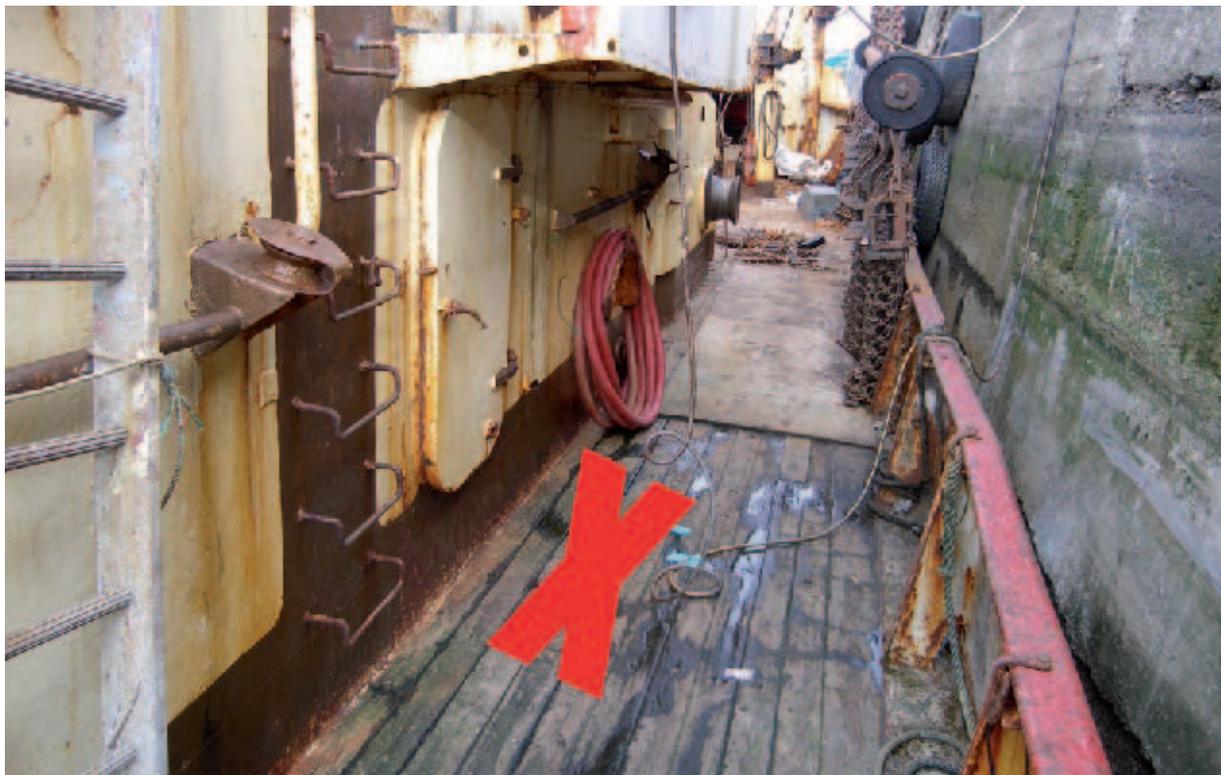
The position where the crewman was found lying on the accommodation deck

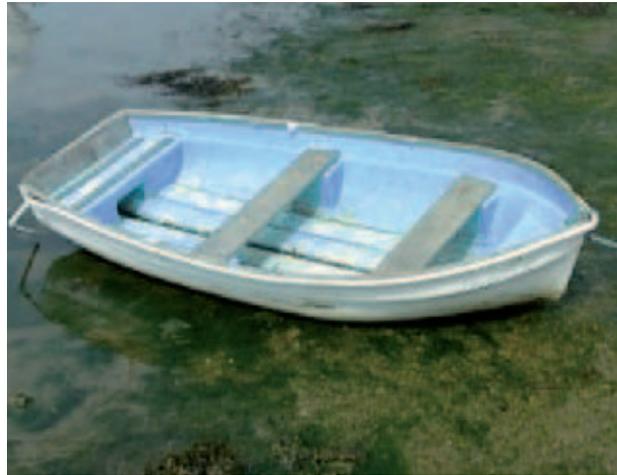
Photograph of the tender

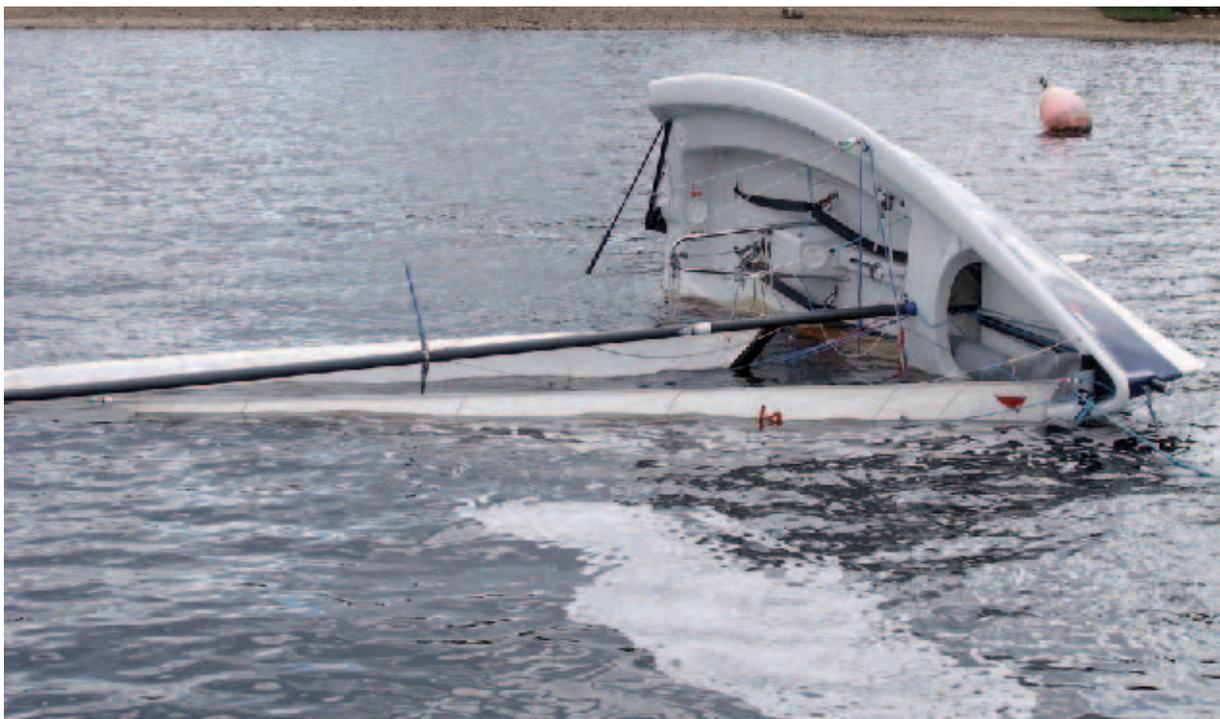
By the time the safety boat arrived on scene, the dinghy had inverted, the centreboard had dropped into its slot and there was no sign of either of the crew. The safety boat crew could not right the capsized dinghy, so collected the race officer from the committee boat and, with his help, brought the dinghy back to the horizontal with the mainsail near the water surface.

The helmsman's body was found immediately and he was taken on board the safety boat. The crew was also on the surface, but her ankle was found entangled in the port trapeze wire some way up the mast near the spreaders. Another race competitor passing the scene jumped into the water to assist and he released the crew's ankle from the trapeze wire so that she could be lifted on board the safety boat. CPR was conducted on both helmsman and crew, on board the safety boat, and on the sailing club jetty until the emergency services arrived and took over. Sadly neither of them survived. Postmortems revealed they had both drowned.

Photograph of the dinghy in the capsize position

1. The dinghy's crew were well prepared and had put some thought into the dangers of entrapment: the crew was wearing a quick release trapeze hook, and both were carrying knives. However, in this case these precautions were of little use. Although it is natural to go to the aid of an entangled crew member if circumstances allow, the person in difficulty can often best be helped by the other crew member stopping the boat from inverting. This action ensures the entrapped crew has time to sort themselves out or be assisted by the safety boat. Remember, nearly all dinghies will invert given the right circumstances.

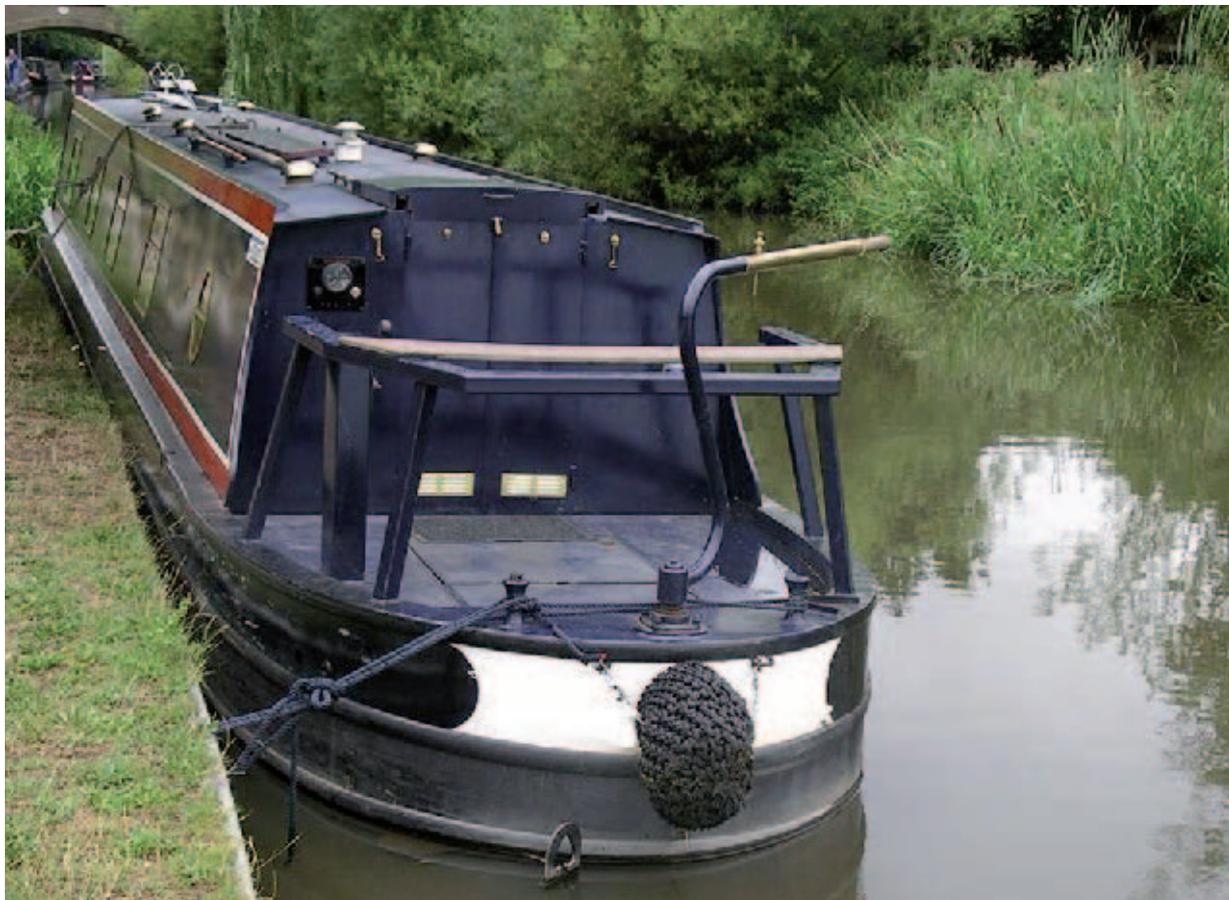
As he stepped onto the bank, with both hands full of equipment, he slipped and fell. He landed heavily on his chest and then entered the water. As a result of the fall he fractured his pelvis, left foot and three ribs and had to be airlifted to hospital.

The stern of the canal boat

1. The hirer was attempting to do too much in jumping across the gap between the boat and the bank while carrying all the equipment required to moor a canal boat. This incident demonstrates that, even on the sheltered waters of a canal the traditional cautionary saying of “one hand for yourself and one for the ship” holds true.
2. There was nobody on board who could assist the hirer to moor the boat; when undertaking such tasks on your own, take extra time to manoeuvre the boat into a position such that you can safely step ashore.
